# Failure Analysis and Mechanical Tests of Failed Aluminum Alloy 7277 Rivets on Armored Vehicle Launched Bridges

Howard E. Horner

ARL-TR-1195

September 1996

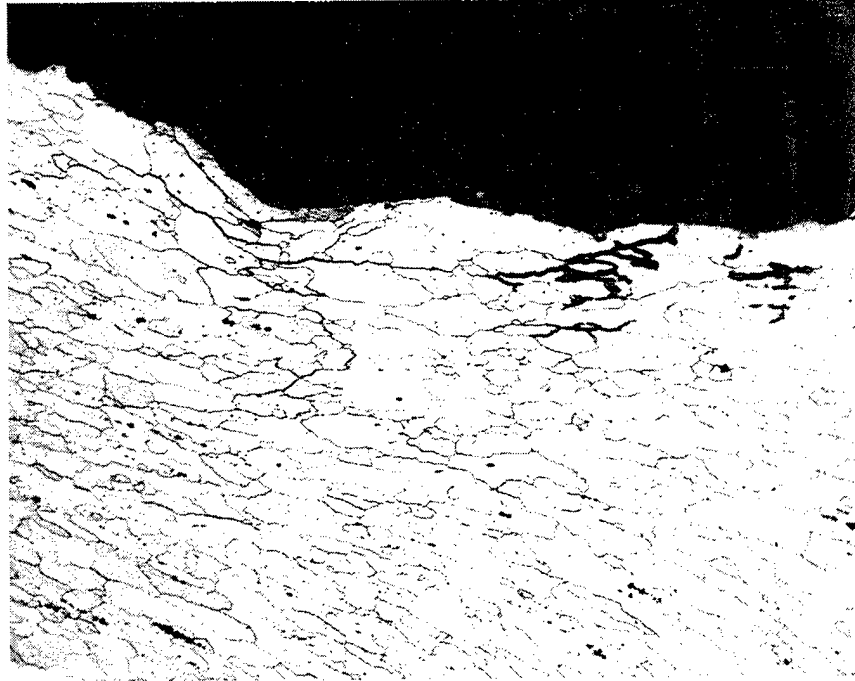
Figure 9. As-polished microstructure of the aluminum rivet in Figure 8. Intergranular corrosion and cracks are present in the small corroded area in head-to-shank fillet, indicative of stress corrosion cracking. Magnification: 170x.

Figure 10. Etched microstructure of the same area in Figure 9. Magnification: 170x. Keller's etchant.

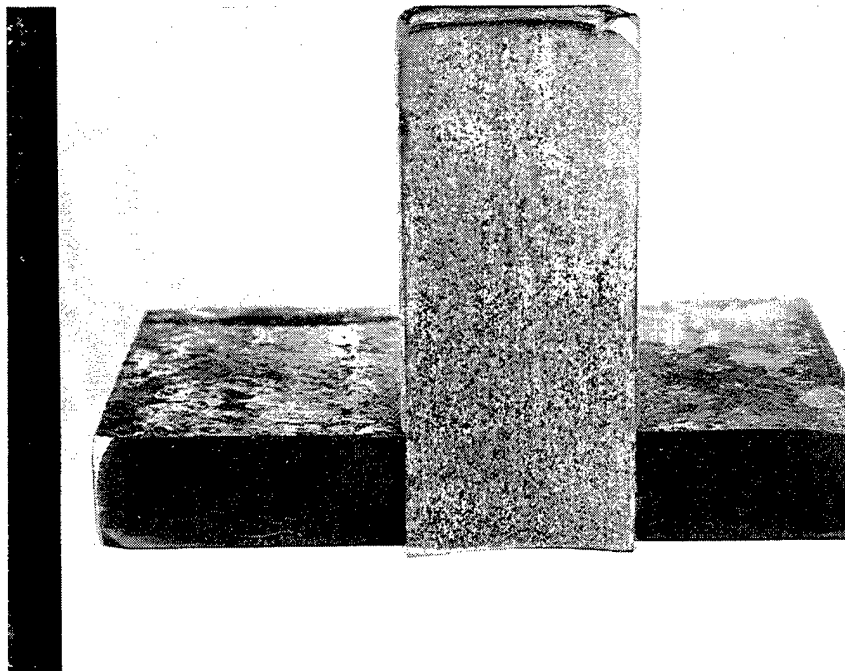
Another sample examined was the corroded aluminum rivet with its one end still in a rivet hole of an aluminum spacer bar (see Figures 14 and 15). Both rivet shank and spacer bar were heavily covered with white corrosion products. Figure 16 shows the microstructure containing small corrosion pittings in the surface of the corroded rivet shank in the rivet hole. Small cracks had initiated from the bottom of the pits.

Figure 15. Etched cross section of the sample in Figure 14 to show end of the rivet shank still in the rivet hole of the spacer bar. Magnification: approximately 1.6x. Keller's etchant.

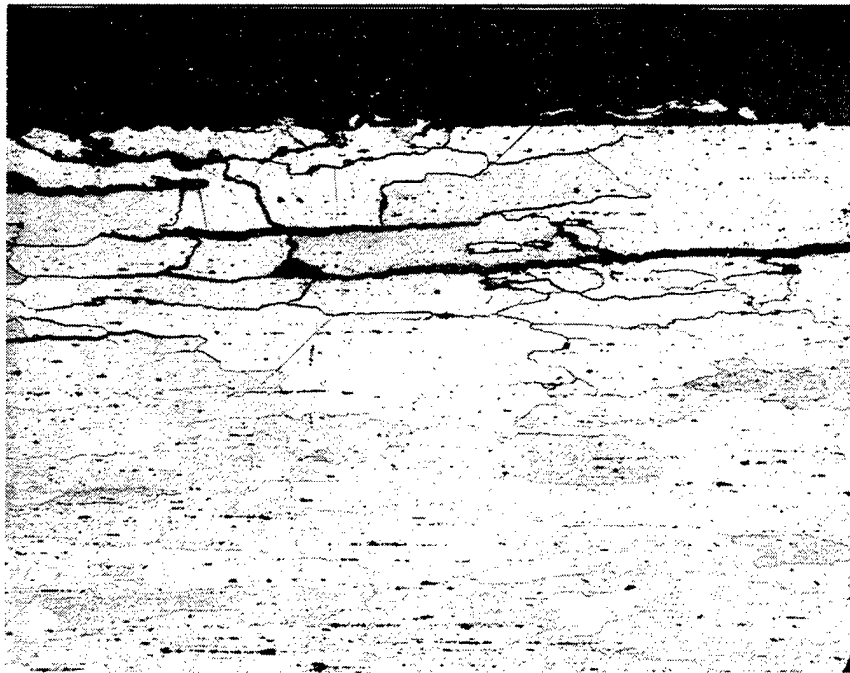
A 4-in-long corroded aluminum rivet sample with heavy white corrosion deposits on the surface of its shank also was examined (see Figure 17). Figures 18 and 19 are the microstructure of a corroded area on the shank surface. Intergranular corrosion and cracks were present on the corroded surface.

Figure 19. Etched microstructure of the same area in Figure 8. Magnification: 100 $\times$ . Keller's etchant.

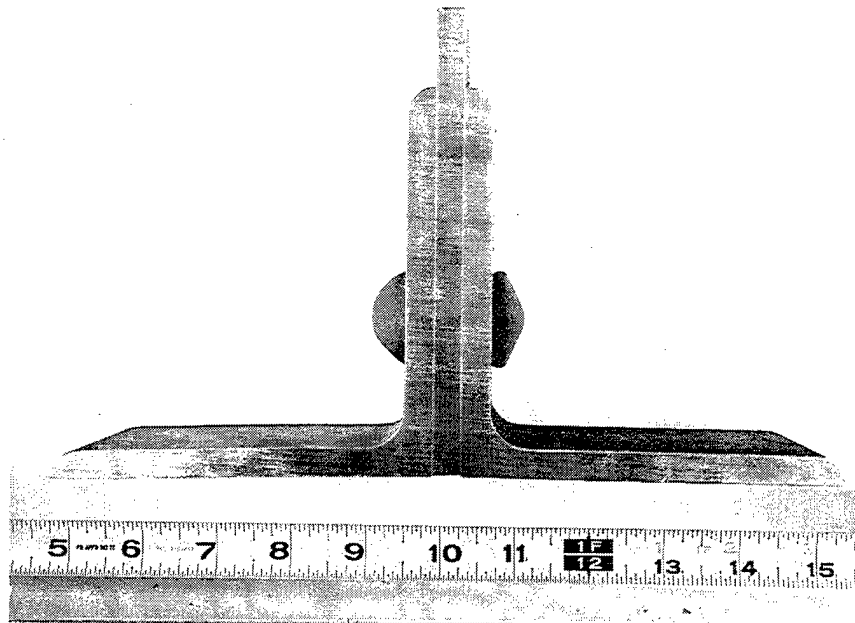
Figure 20. A shear aluminum test specimen cut from AVLB panel assembly, showing the rivet at the low position. The specimen was composed of two angles with the middle girder plate to serve as a plunger to shear the rivet.

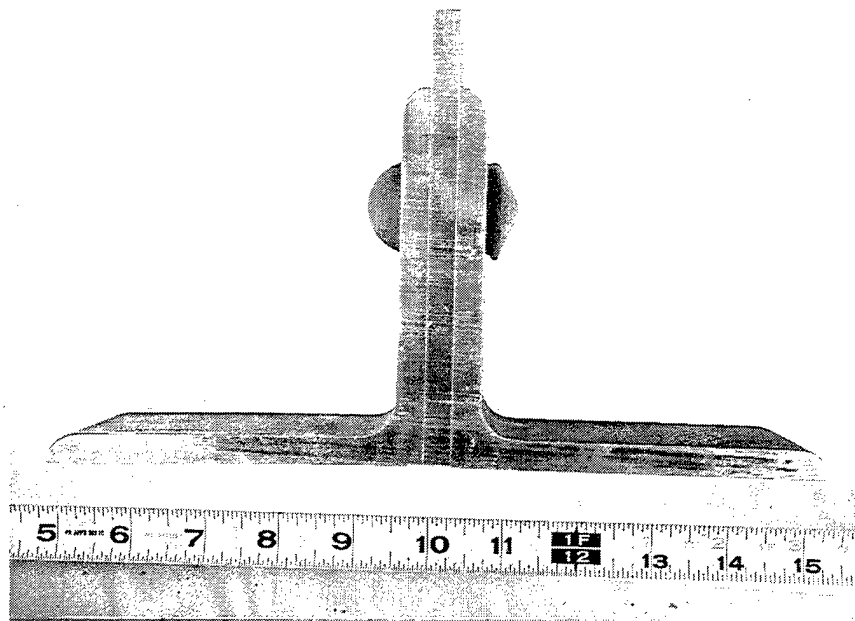
Figure 21. A shear aluminum test specimen showing the rivet at the high position.

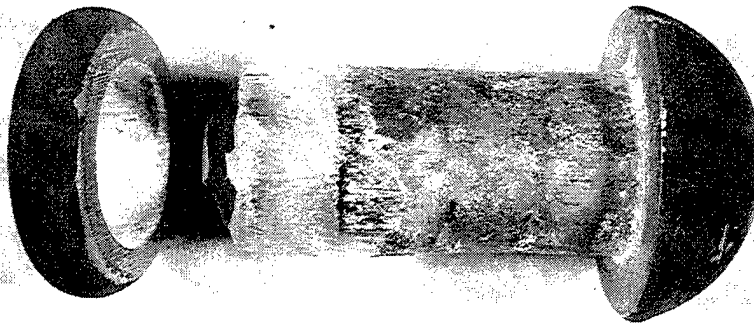
Figure 30. A view of the rivet (specimen D) with the sheared driven end (left) after the pull test.

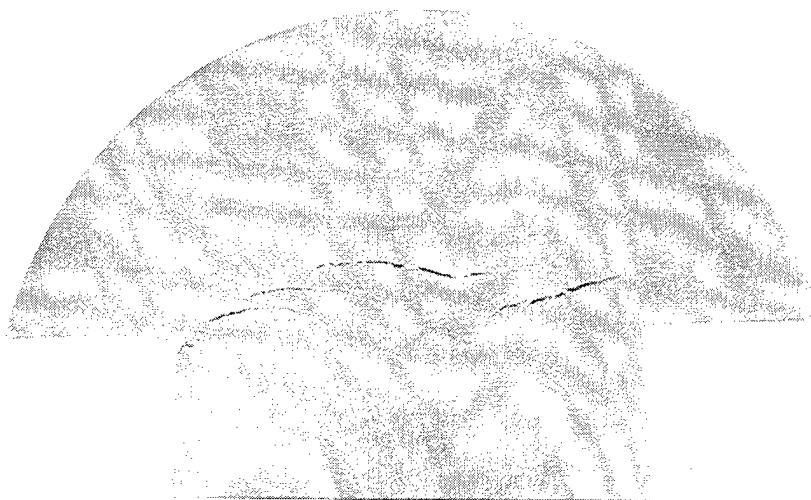
Figure 32. A view of the rivet that was rough cut in half lengthwise in the top connector of the AVL B, thus revealing large cracks in the head. The crack initiated in the fillet. See Figure 33 for polished surface of the same rivet.

Figure 33. Same rivet in Figure 32, except with as-polished surface of the cut areas.

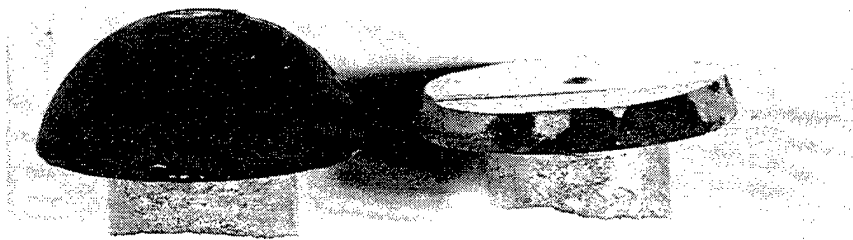
Figure 34. A view of two rivet heads (specimen B on left and specimen D on right) after the shear tests. A portion of specimen D rivet head was inadvertently cut off during the specimen preparation prior to the pull and shear tests.

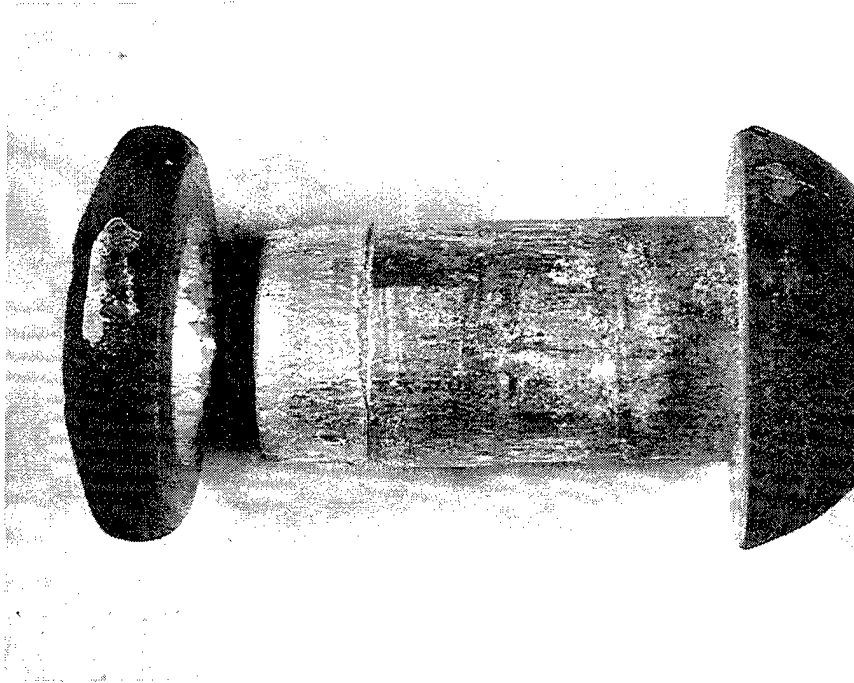
Figure 35. Enlarged view of specimen A "Good" rivet which sheared at its driven end through the rivet hole of the angle leg during the pull test. Magnification: approximately 2x.

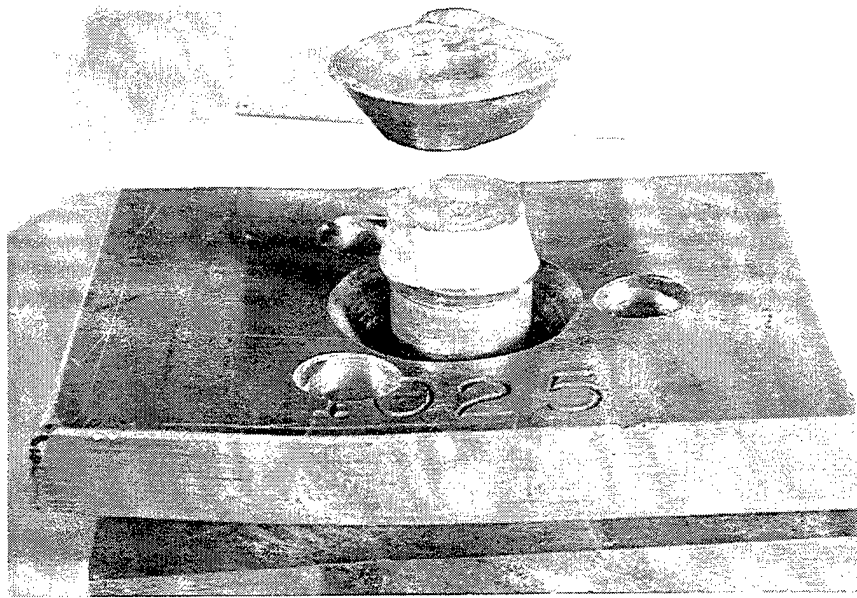
Figure 39. An example of the shearing at the flat countersunk head of unpainted 1,025° F rivet sample.

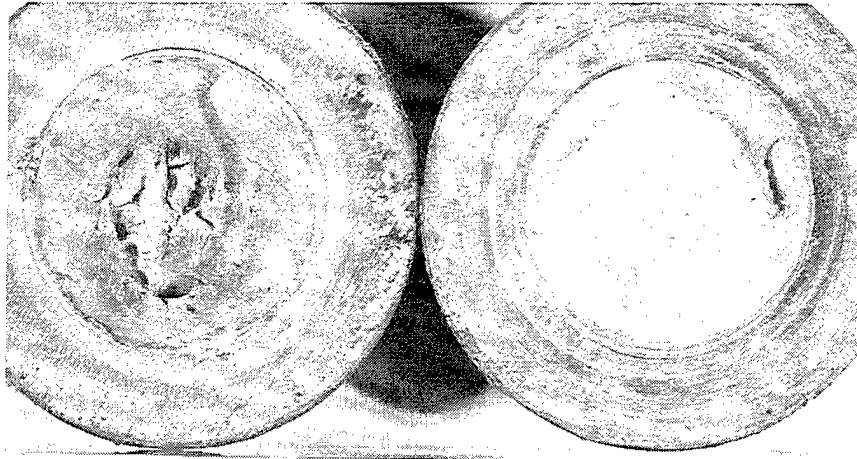
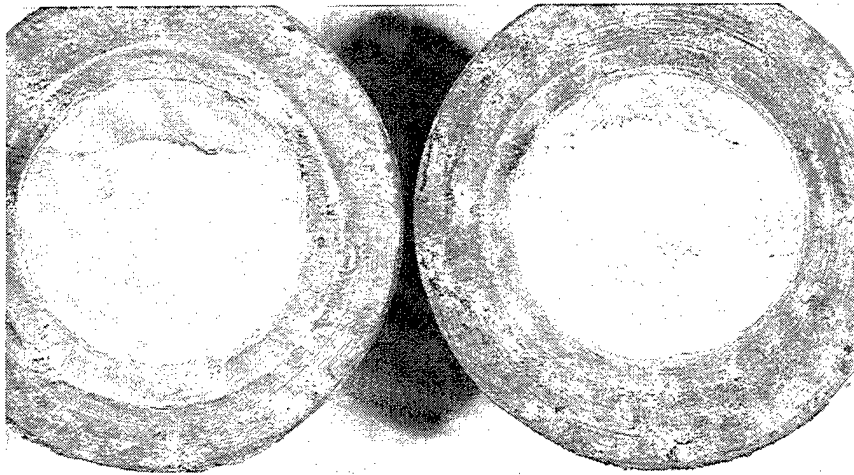
Depending on the extent of prior cracks from corrosion (stress corrosion cracking), all "Moderate" and "Bad" rivet samples broke at the fillet under the head during the pull tests, with the breaking loads ranging from 5,500 to 26,550 lb. "Bad" rivet samples nos. 4 and 9 broke at much lower loads because of large cracks as compared to those in other rivet samples that broke at higher loads. Figures 40 and 41 show the enlarged views of the fracture surfaces, revealing the sizes of the cracks from corrosion in eight samples that broke at the fillet under the head. The estimated percentages of the corroded cracks observed in the fractures of the rivets ranged from 8 to 95.

Figure 40. Enlarged views of the fracture surface under the buttonhead of four rivet samples after the pull tests revealing the extent of cracks (darkened area) observed due to corrosion. Sample 4 (95.37%), no. 14 (26.95%), no. 6 (19.62%), and no. 8 (11.60%).

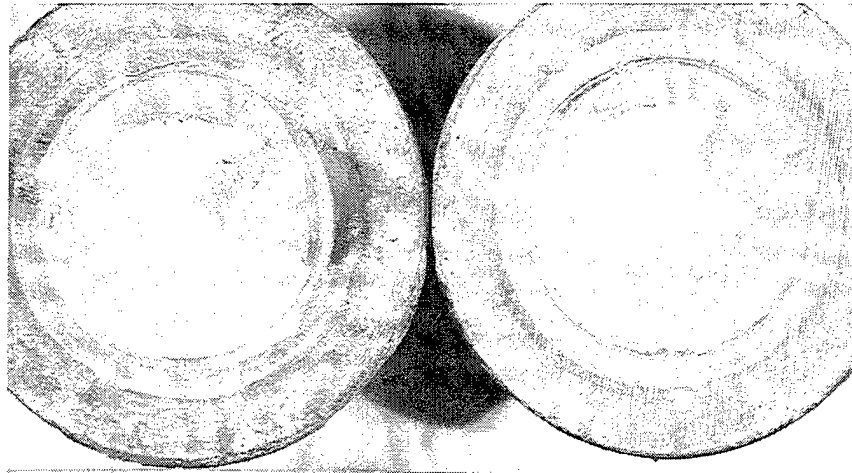
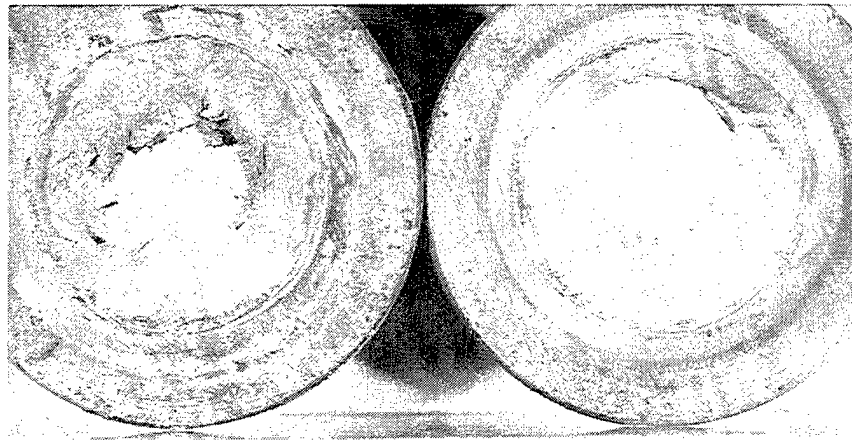
Figure 41. Enlarged views of the fracture surface under the buttonhead of four rivet samples after the pull tests, revealing the extent of the cracks (darkened areas) observed. Sample no. 7 (11.39%), no. 17 (8.45%), no. 9 (67.76%), and no. 18 (17.73%).

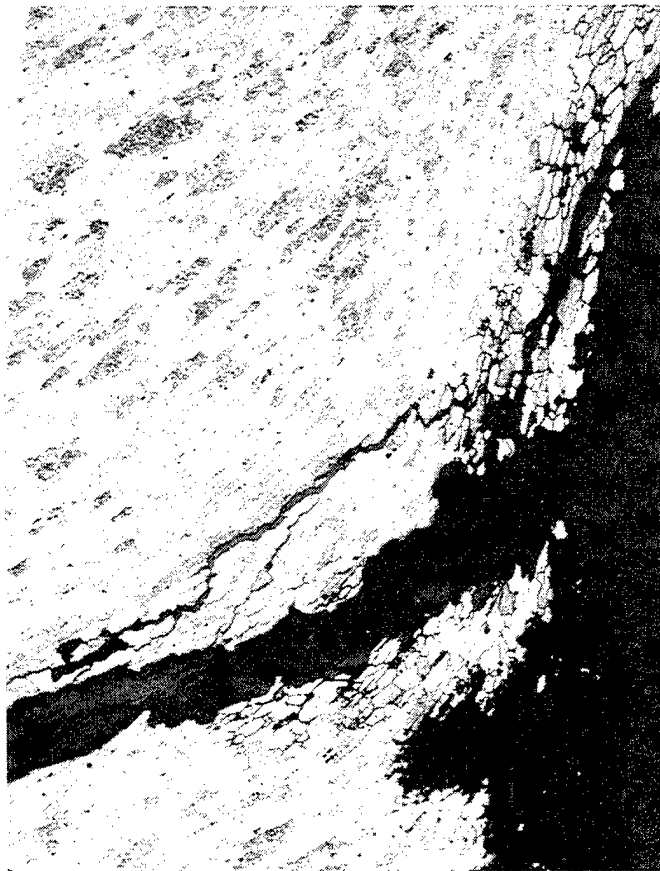
Figure 45. Etched microstructure of the same area in Figure 44, showing the grain flow formed by the head-forming operation. Magnification: 100×. Keller's etchant.

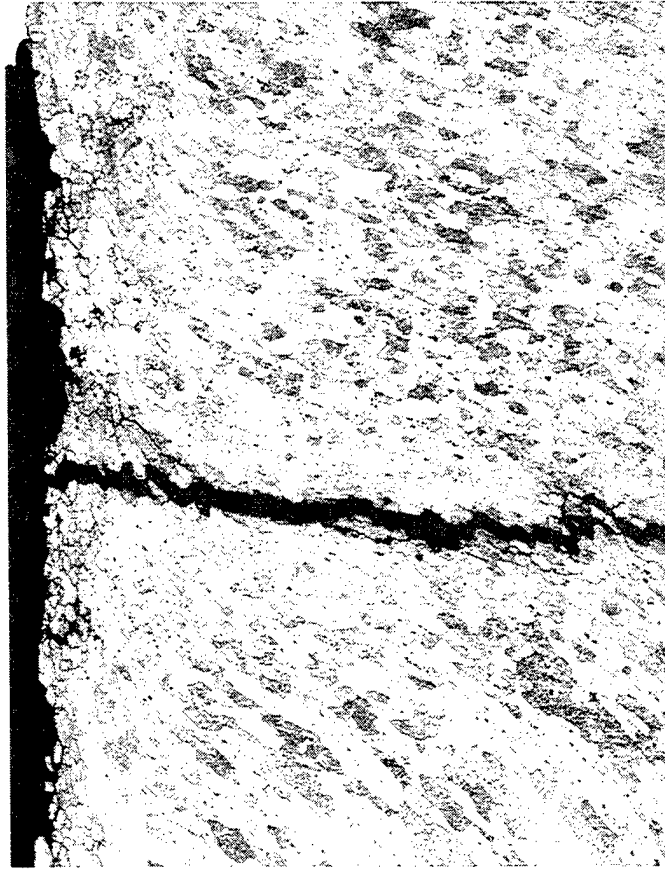
Figure 47. Etched microstructure of the same area in Figure 46, showing the grain flow formed by the head-forming operation. Magnification: 100 $\times$ . Keller's etchant.

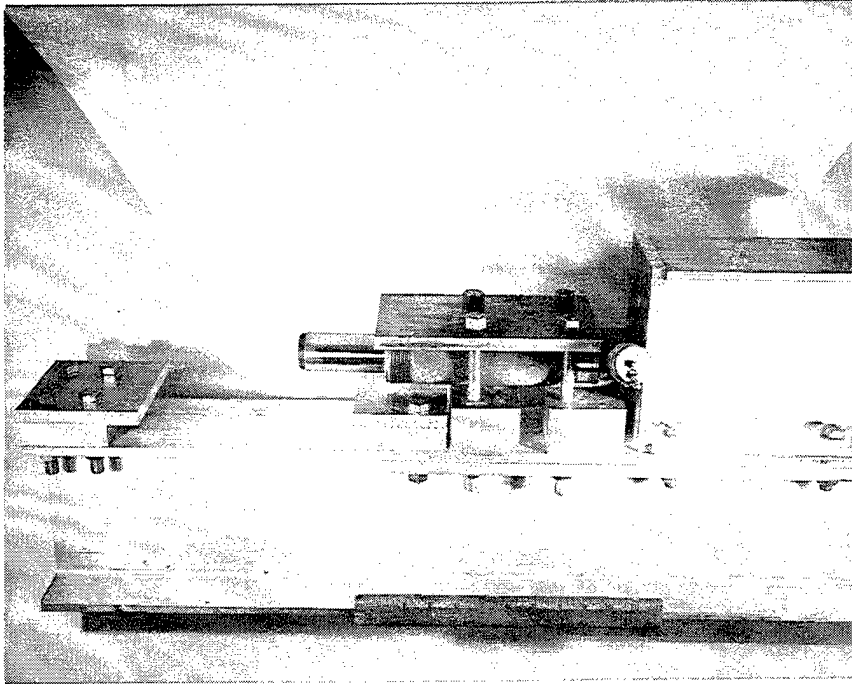
Figure 48. A view of the special push load jig after the fabrication. A small hydraulic cylinder is clamped to the aluminum I-beam with aluminum plate and blocks and steel bolts. It is butted against the upper I-beam, serving as a backstop.

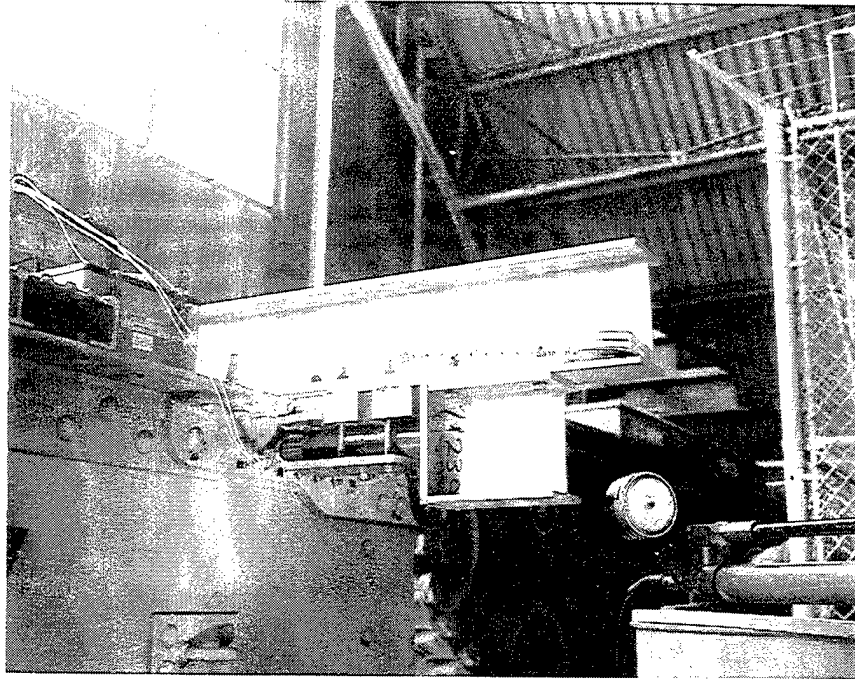
Figure 49. Overall view of the special load jig clamped to the top outboard male connector of the AVLB female center panel assembly by means of bolts and plates. The hydraulic cylinder and its hand pump are seen in this photograph. Three extruded aluminum deck panels had to be removed from the top of panel assembly in order to perform the test.

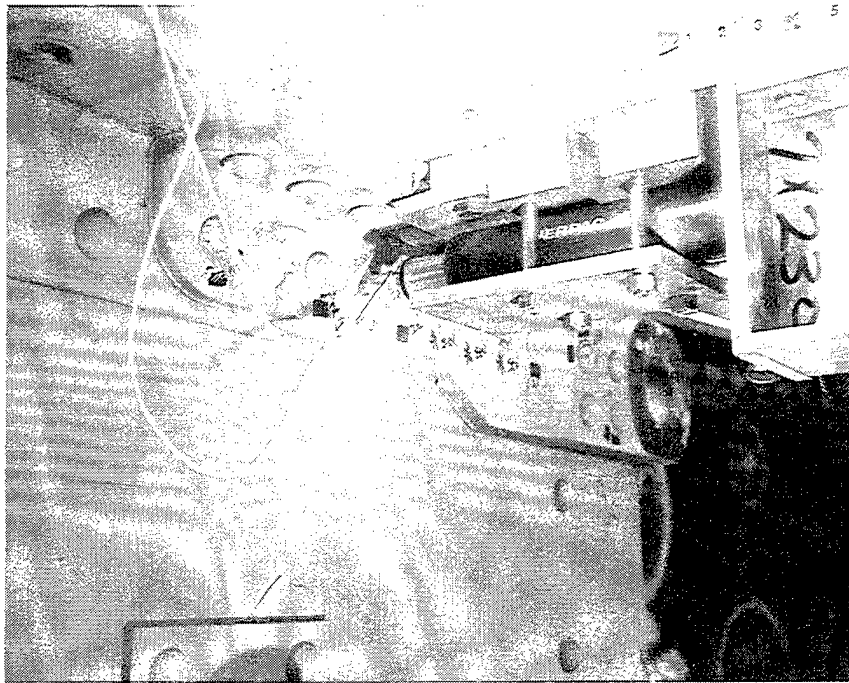
Figure 50. Closeup view of the special jig in Figure 49, showing the placement of the 0.5-in-diameter steel pin (with two strain gauges) between the headless end of the rivet and the plunger end of the hydraulic cylinder. This jig was setup for the testing of the no. 4 rivet. The cables from the strain gauges were connected to the strain indicator not seen in this photograph.

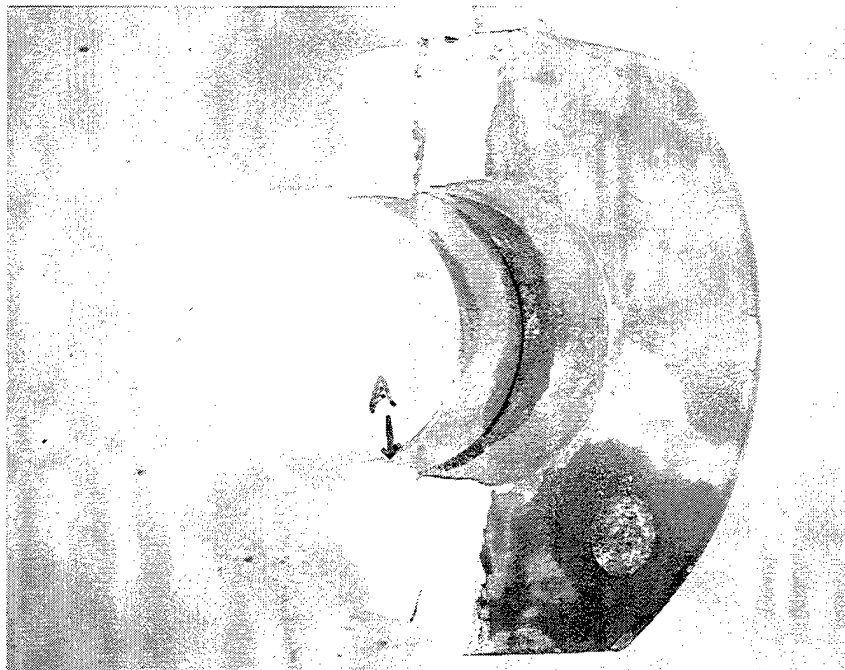
outboard male connector broke at the sharp fillets machined on the sides of the connector forgings (see Figure 53). The eyes of the inboard male connector broke in half through the hole seen in Figure 54. Visual examination was made on the fractured surfaces of the major failed components. Figures 55 and 56 reveal that the initiation sites of the brittle fractures of the outer female center hinge had occurred at a small fatigue crack at the surface of the eyehole. Figures 57 and 58 reveal the small fatigue cracks initiated at the sharp machined fillets that led to the brittle failure of the outboard male connector eyes. Figure 59 shows small fatigue cracks at the surface of the eyehole of the inboard male connector. The samples containing the crack in the bottom chord angles found during the visual inspection before the overload test were cut out in order to view the fractured surfaces (see Figure 60). Again, small fatigue cracks were observed initiating at the bottom of the countersunk rivet hole of one sample (see Figure 61). Figure 62 shows the extent of corrosion on the underlying surfaces next to the aluminum connector forging.

Figure 54. View of broken inboard bottom chord male connector eyes from the female center panel assembly. See Figure 59 for closeup view of the crack initiation site at A.

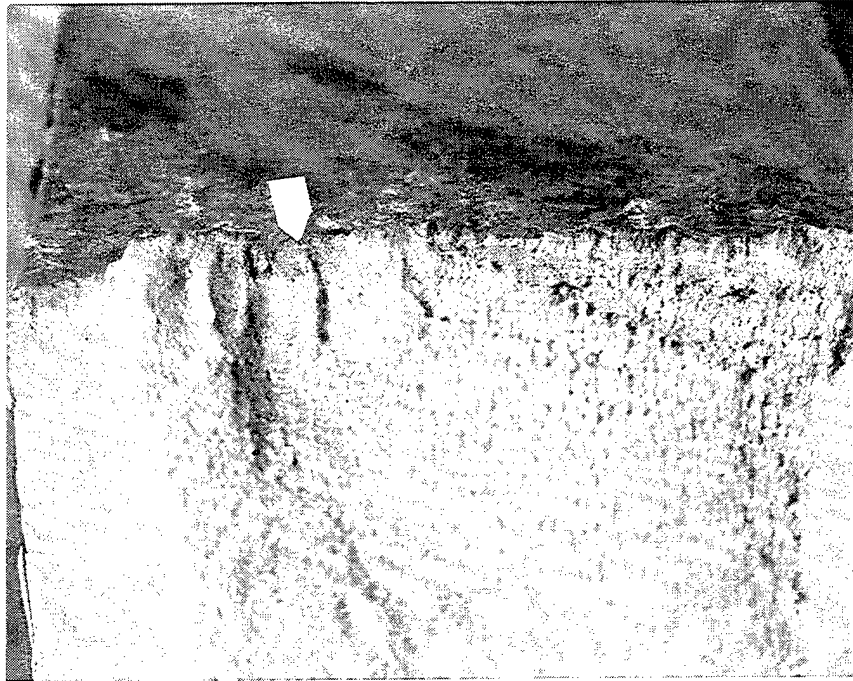
Figure 59. Closeup view of the fracture at A in Figure 54 showing small fatigue cracks (top edge) in the eyehole where the brittle fracture initiated in the connector.

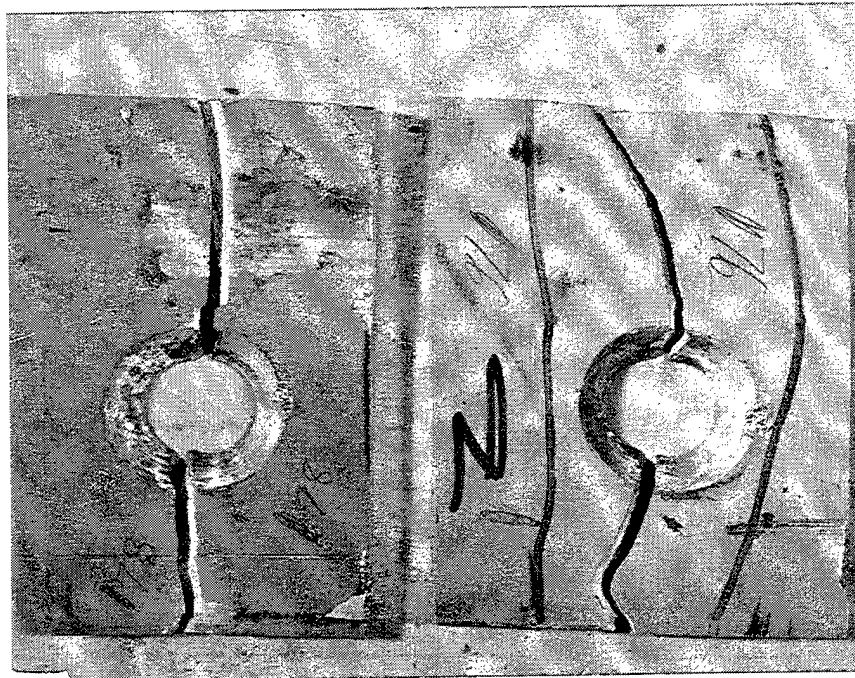
2.14 Metallurgical Examination of the Fractures of Several Failed Major Aluminum Components of Corroded AVL Bridge After the Overload Test. After a series of fatigue tests to simulate 3,000 crossings was performed on the corroded AVLB (from Fort Stewart) under the load frame at the Belvoir Center Bridge Hangar, a visual inspection of this bridge for new cracks was performed before the static overload test to failure. A major crack was found on the inner aluminum angle of the inboard bottom chord at the first rivet hole in the forged aluminum center hinge of two male center panel assemblies S/N 176 and S/N 178 (Contract DAAE07-86-C-2797). It was speculated that a catastrophic failure of the bridge may occur at one of those two cracks in the bottom chord angles during the overload test. A series of major component failures occurred on the bridge as the static loads increased during the test, but the final catastrophic failures did not occur in either crack located in the cracked bottom chord angles.

Figure 60. Prior cracks at first countersunk hole of the inner outboard bottom chord angles of the male center panel assemblies that had occurred during the fatigue test of 3,000 simulated MLC-70 tons crossings. See Figure 62 on the extent of corrosion on the surfaces of the other side.

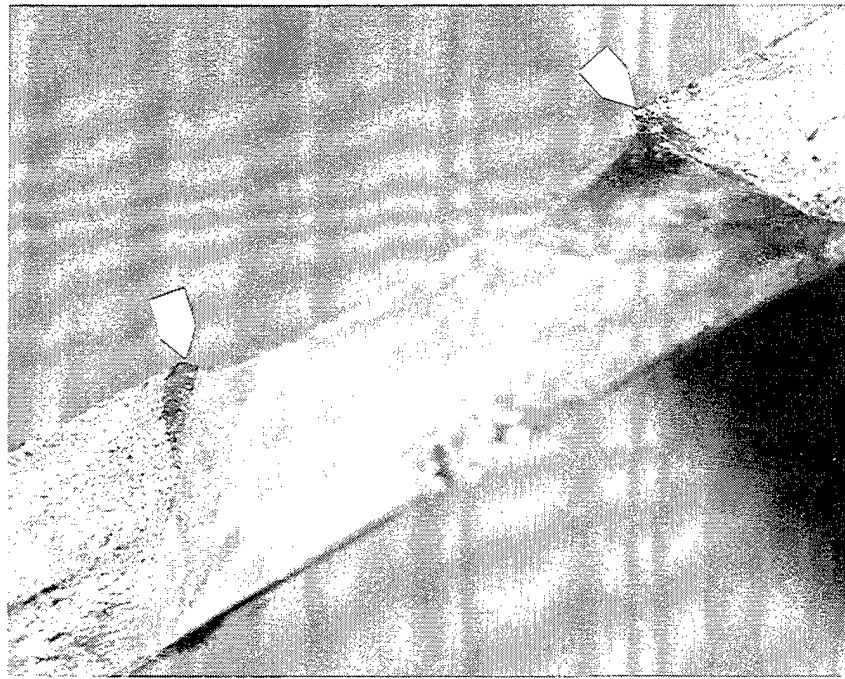
Figure 61. Closeup view of the fracture at the rivet hole of S/N 176 cracked angle leg in Figure 60, showing small cracks at upper corners of the hole. Corrosion may be the initiation sites for the cracks.

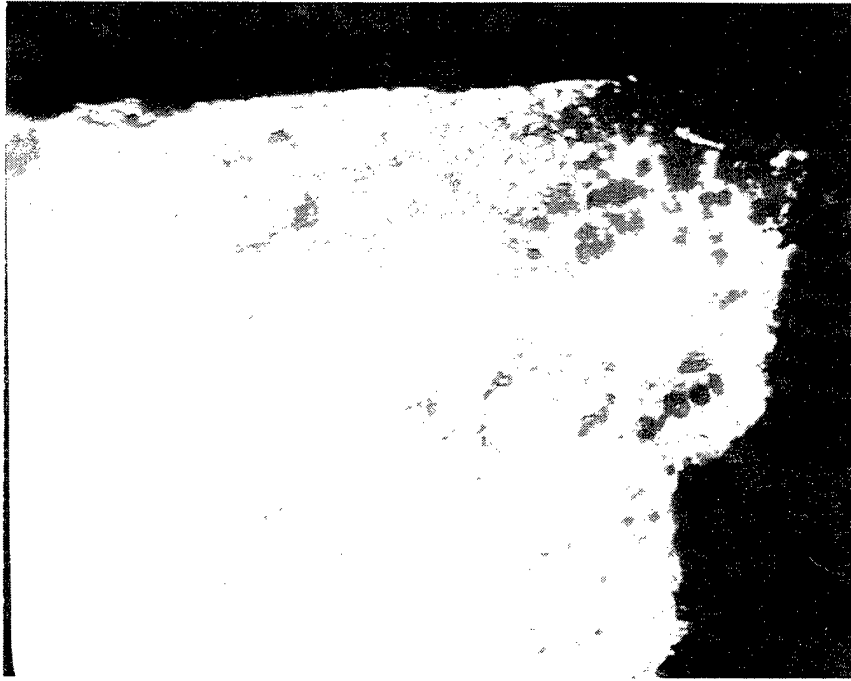
Small metallographic specimens for microstructural examination were cut from the fractured surfaces of the selected major bridge components in the areas where the cracks initiated. Figure 63 reveals the extensive network of intergranular corrosion at the initiation site of the fatigue crack at point A in Figure 52, the broken inboard female center hinge eye. Figures 64 and 65 show some intergranular corrosion on the corroded surfaces of both bottom chord angle samples in Figure 60 near the crack initiation sites of the fractures in the rivet holes.

Figure 63. Microstructure of the fracture at A of the broken inboard female center hinge eye in Figure 1.

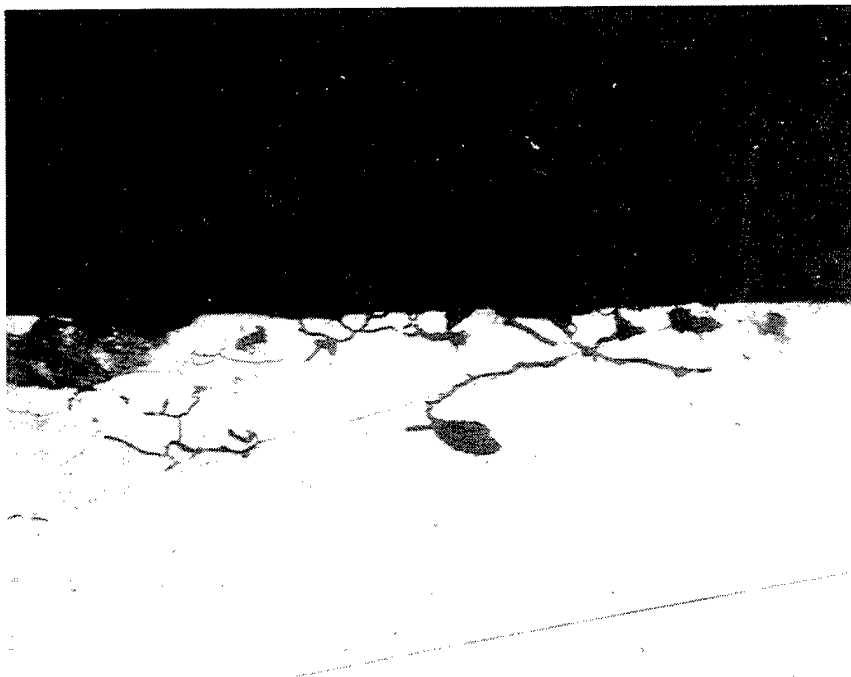
Figure 64. Microstructure of the corroded surface (top edge) near the fracture of the cracked bottom chord angle from male center panel assembly S/N 176 in Figure 62. Note the intergranular corrosion on the surface. Magnification: 160 $\times$ . As-polished.
