# ***GALLIPOLIS LOCKS AND DAM***

**FOUNDATION REPORT**

**VOLUME 4 PHOTOGRAPHS**

**CONSTRUCTION OF TWO PARALLEL LOCKS AND CANAL**

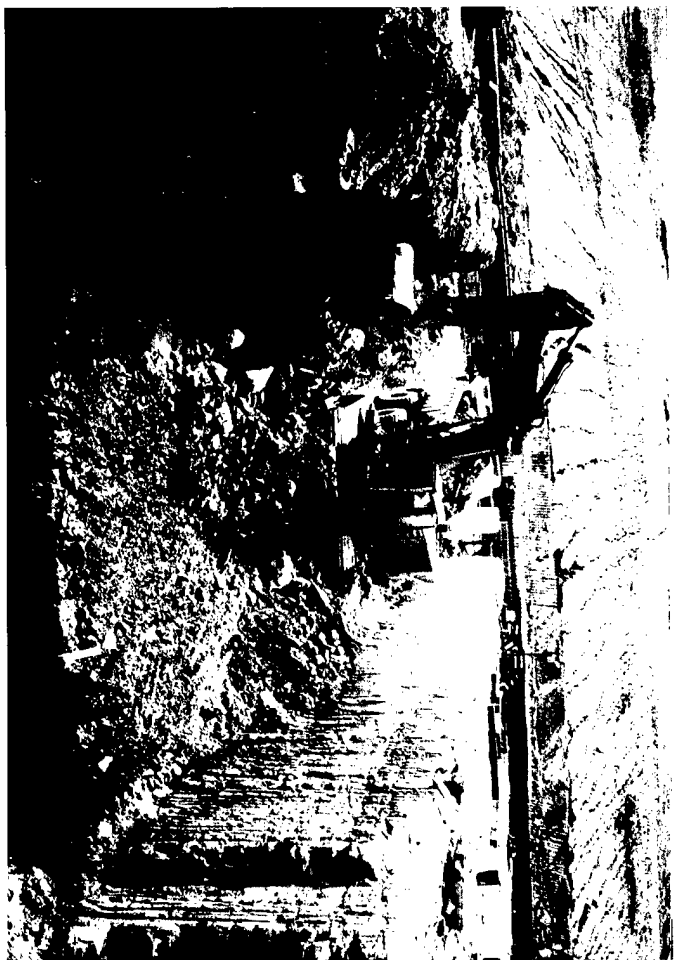
(20) Blast #27 surface heave

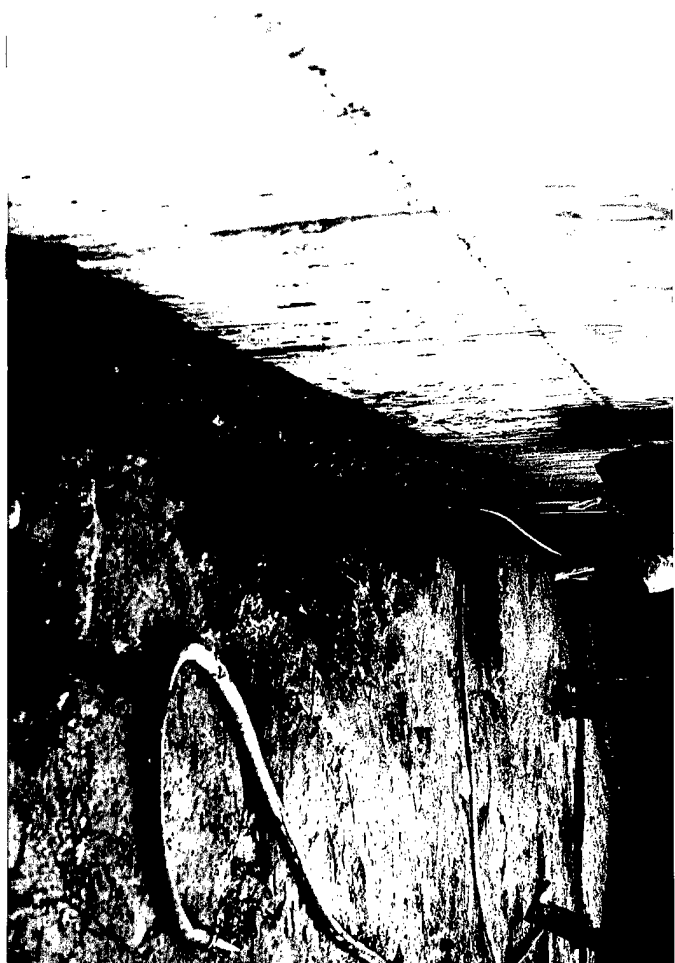
(215) R-46 Invert view looking West

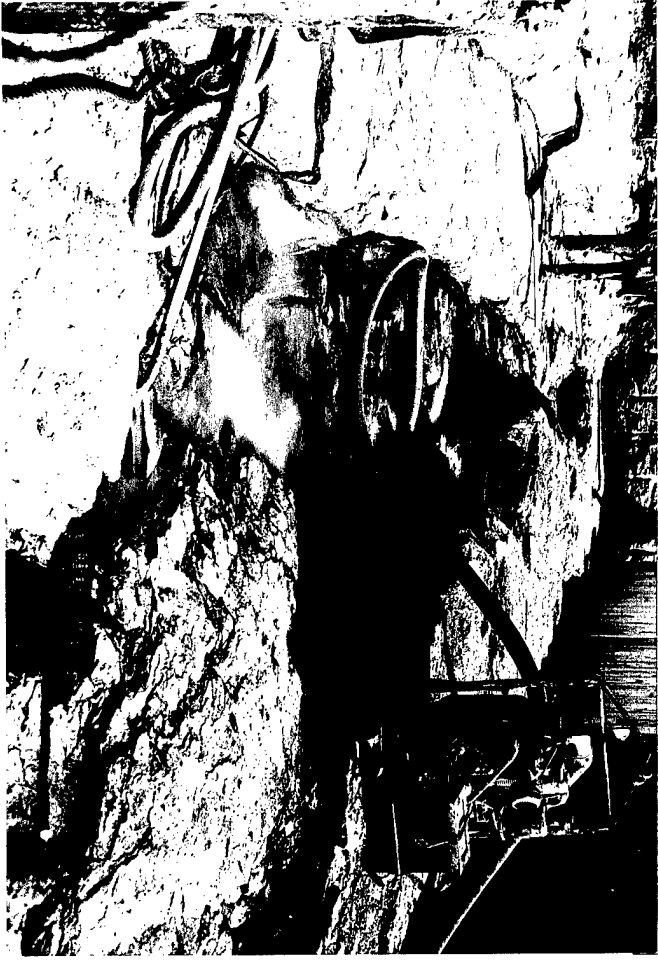
(216) R-51 Invert view looking East

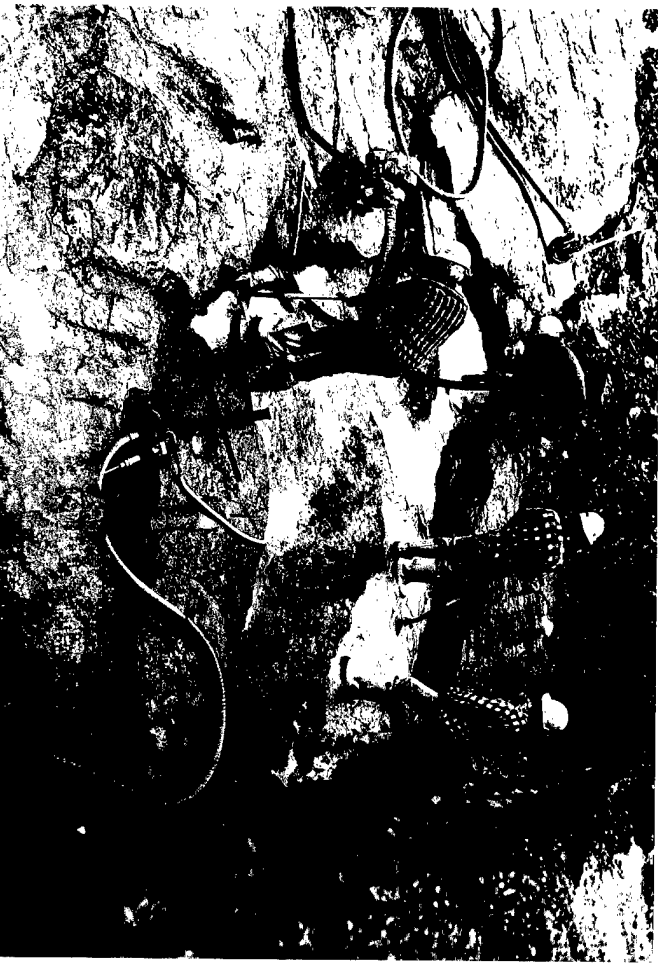
(217) R-82 Invert view looking North

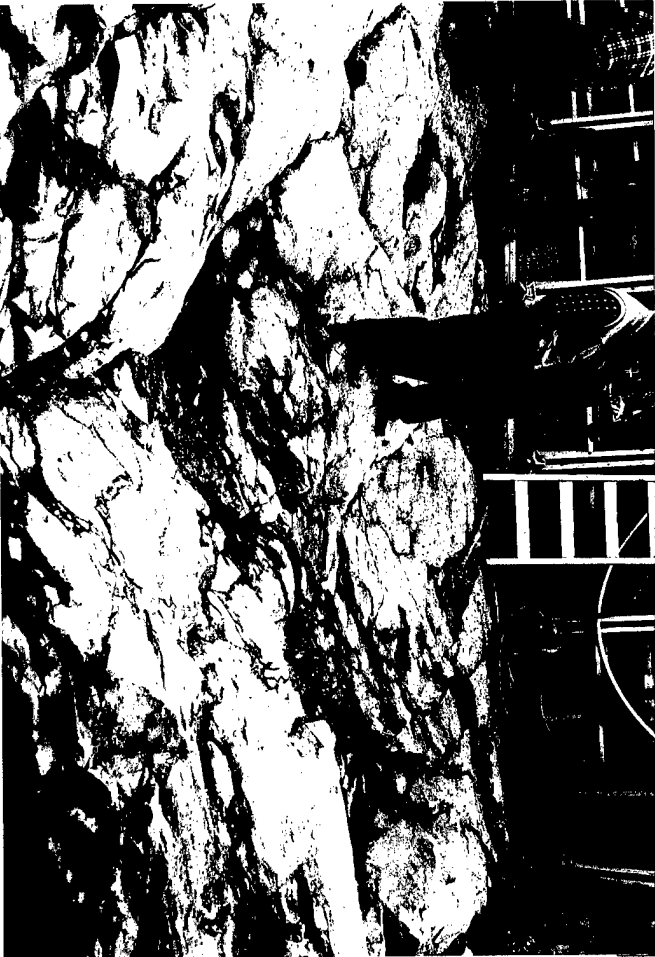
(240) MC-20 Invert view of North corner

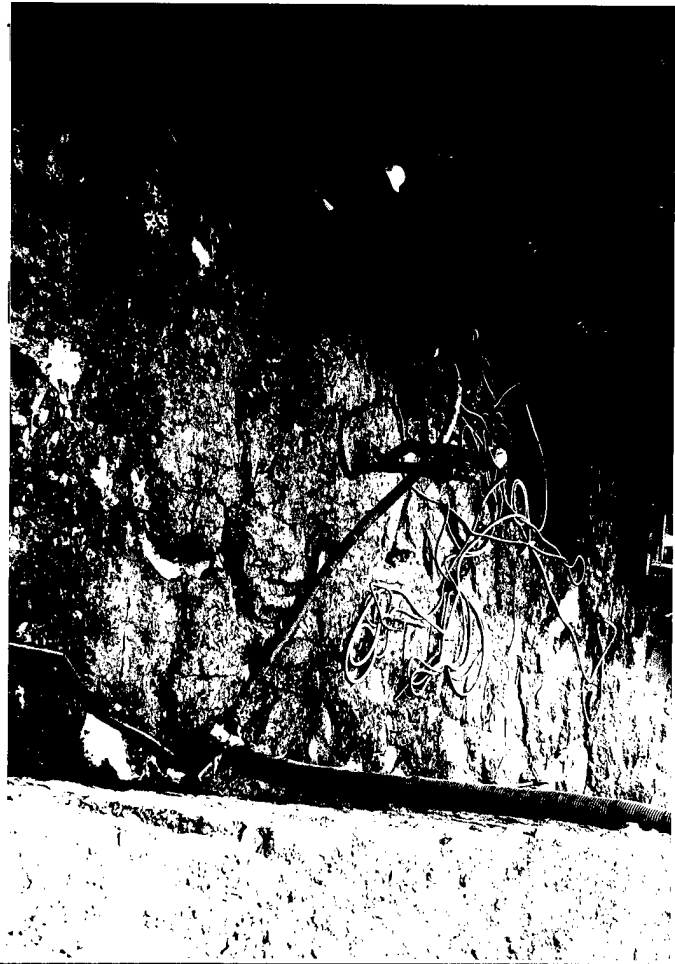
(241) MC-20 Invert view of Northwest corner after repair

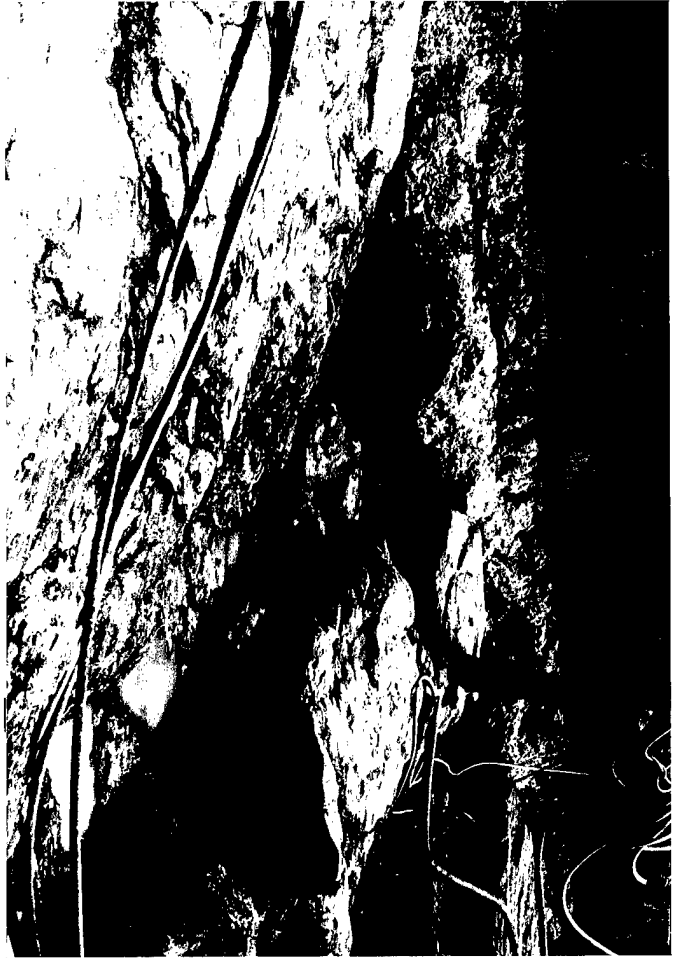
(246) Baffle Area Invert view looking Southwest

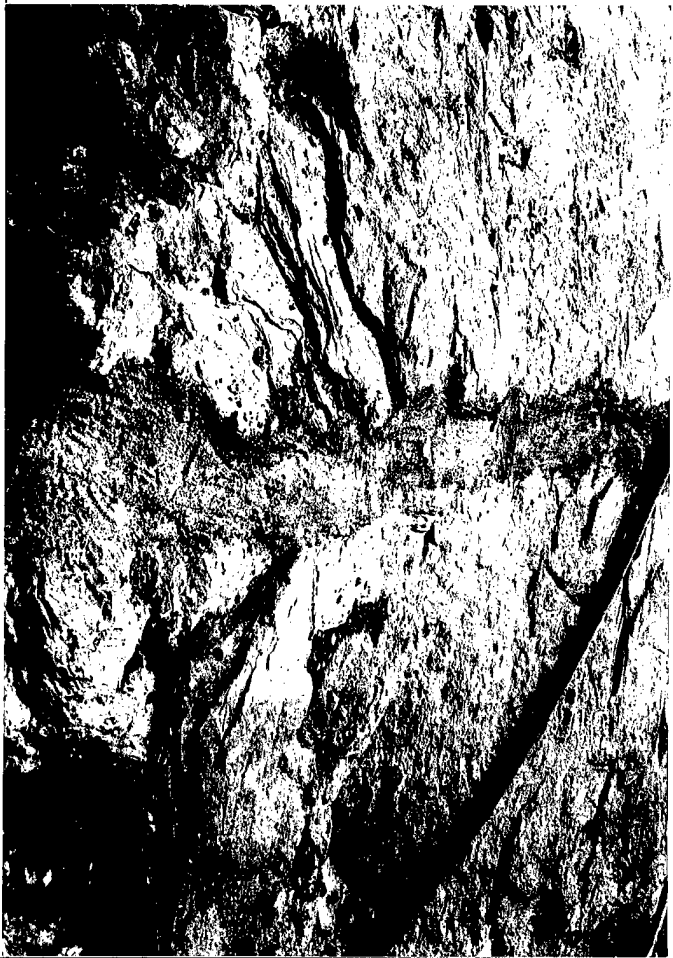
(247) L-13 Neat gROUT in an open joint
