**Reconnaissance Report of Damage  
to Historic Monuments in Cairo, Egypt  
Following the October 12, 1992 Dahshur Earthquake**

**D. Sykora, D. Look, G. Croci, E. Karaesmen and E. Karaesmen**

Technical Report NCEER-93-0016

**August 19, 1993**

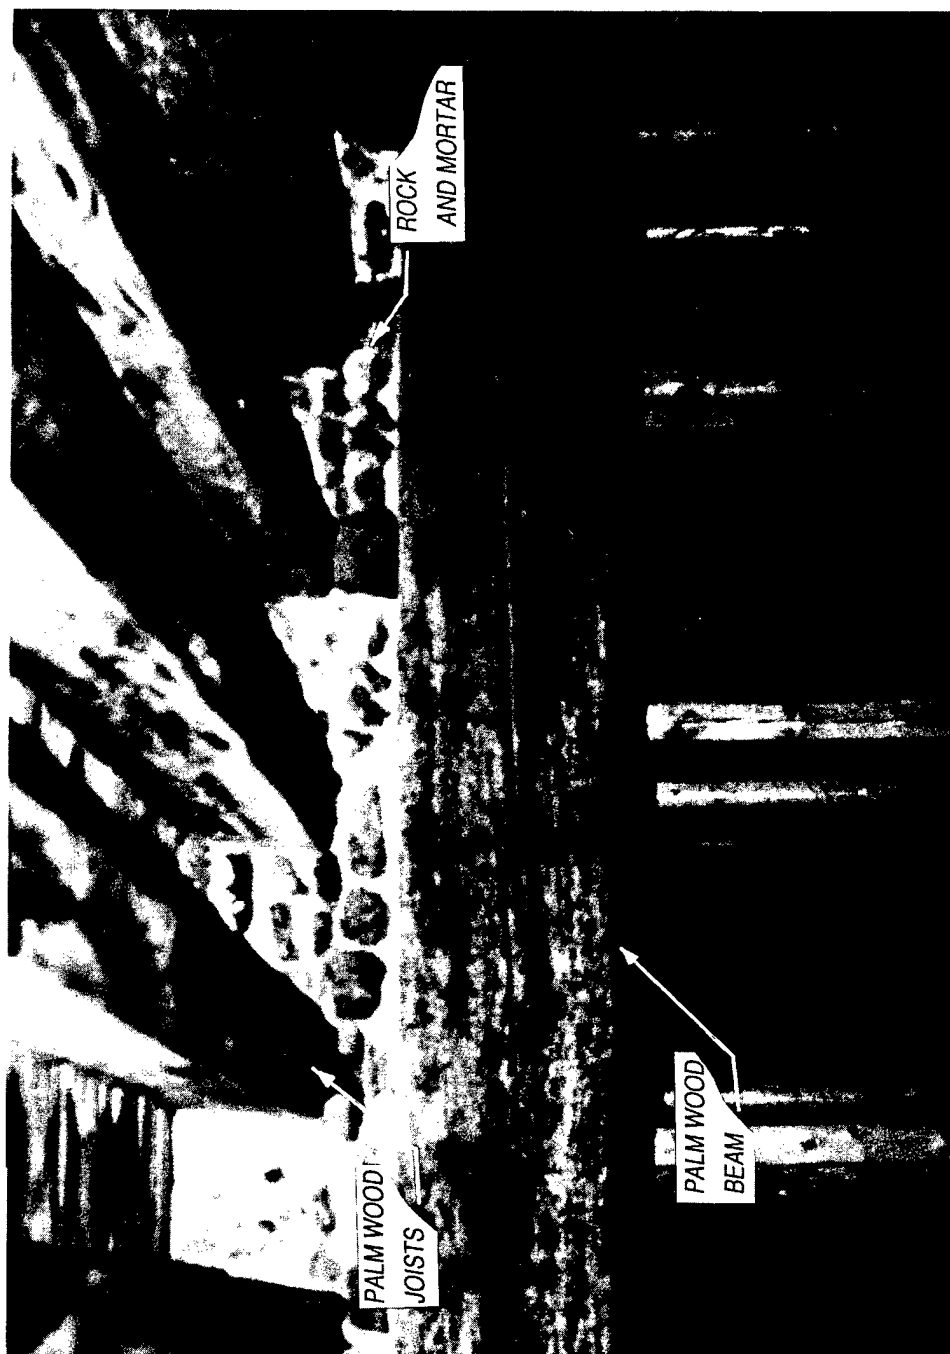
Groundwater is very close to the ground surface at many monuments and likely to be at or above footing level. The masonry (limestone) block acts like a wick from capillary action (sometimes referred to as rising damp). Moisture continues to creep vertically in the stone until the capillary pressures equilibrate, generally well above the ground surface. Excessive moisture is evident up to a couple of meters above the ground level in the walls of several historic monuments. An example is shown in figure 4-4. The impact of groundwater is detrimental not only to masonry block but to wood, too. The increased humidity caused by evaporation of water in the foundation of the el-Moalloqa Church (shown in figure 4-5) has caused the rapid deterioration of palm wood floor joists.

**FIGURE 4-5** Structural floor system at el-Moalloqa Church

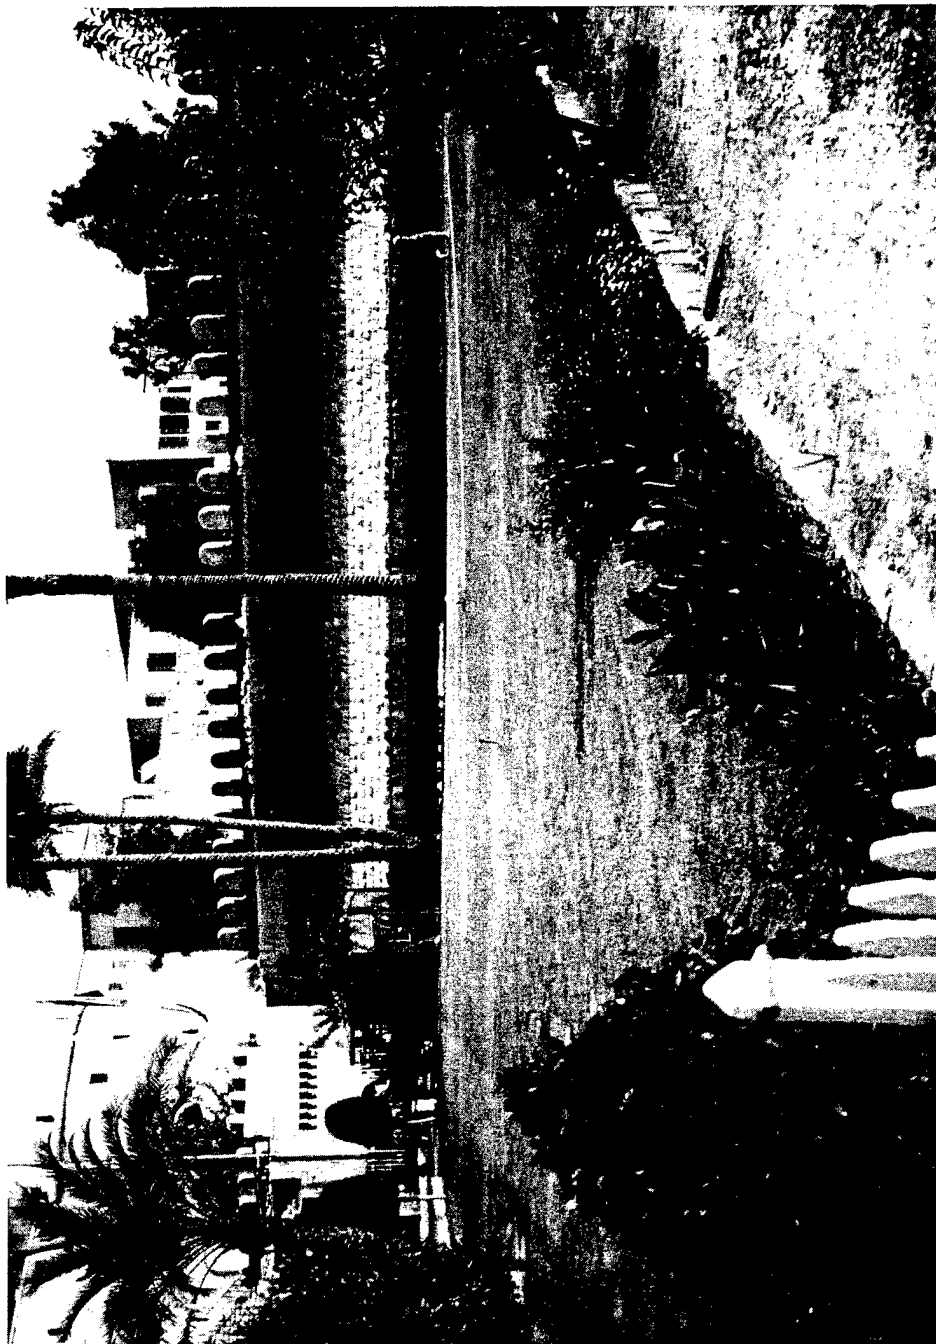
Watering is also taking its toll on masonry retaining walls at the Citadel. The custodians maintain lush grass, bushes, and trees within the complex as shown in figure 4-8 from extensive watering. These gardens and lawns apparently were created in 1984 (SPARE 1984b). The consequence of watering is the steady seepage of water through the walls of the Citadel. This is clearly evident on the east and west sides. A view of the western portion of the wall is shown in figure 4-9. The preservation of the masonry stone will require a change in the current practice of maintaining the flora at the Citadel or a return to a more historic appearance with drought-resistant plants and trees.

**FIGURE 4-8** Manicured lawn of Citadel in Southern Enclosure looking  
northeast toward Bâb al-Gabal

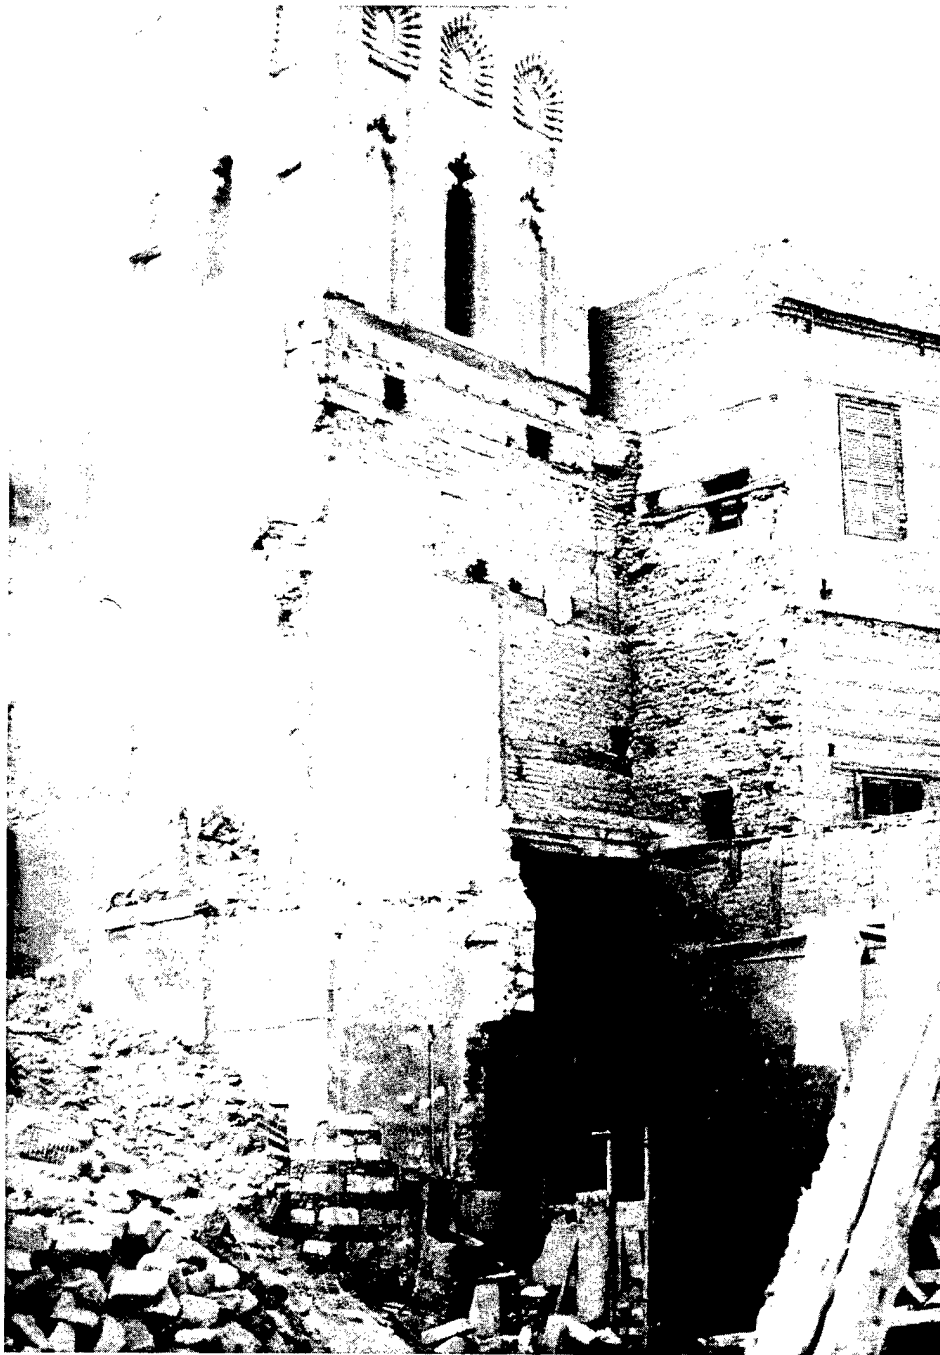
This *mabkhara*-style minaret is about all that remains of the madrasa bearing the same name and is the only minaret of the Ayyubid Period to survive intact (Behrens-Abouseif 1989). Moreover, this minaret is one of only fifteen monuments remaining from the Ayyubid Period. A view of the base of the minaret looking from the remains of the interior of the madrasa is shown in figure 4-17. There is little lateral support at the base of the minaret since the madrasa is no longer present. The remnant unreinforced masonry walls are evident.

The recent earthquake caused existing cracks to be significantly widened and extended. Some of the cracks may have formed as the madrasa progressively deteriorated and collapsed. An inhabited residential building behind the remnant madrasa also shows similar disrepair and signs of distress as seen in figure 4-18 and should be evacuated. The minaret is also reported to be leaning. The upper portion of the minaret, which has a smaller cross section, is leaning observably more than the lower portion, which has a larger cross section. Access to the interior or base of the minaret was not made available.

**FIGURE 4-17** Base of Minaret of as-Sālih Negm ad-Din Ayyūb  
looking north from remains of madrasa
