**DOT/FAA/AR-95/49**

# **A Study of the Continued Fire Worthiness of Aircraft Seat Cushion Fire-Blocking Layers**

March 1997

Final Report

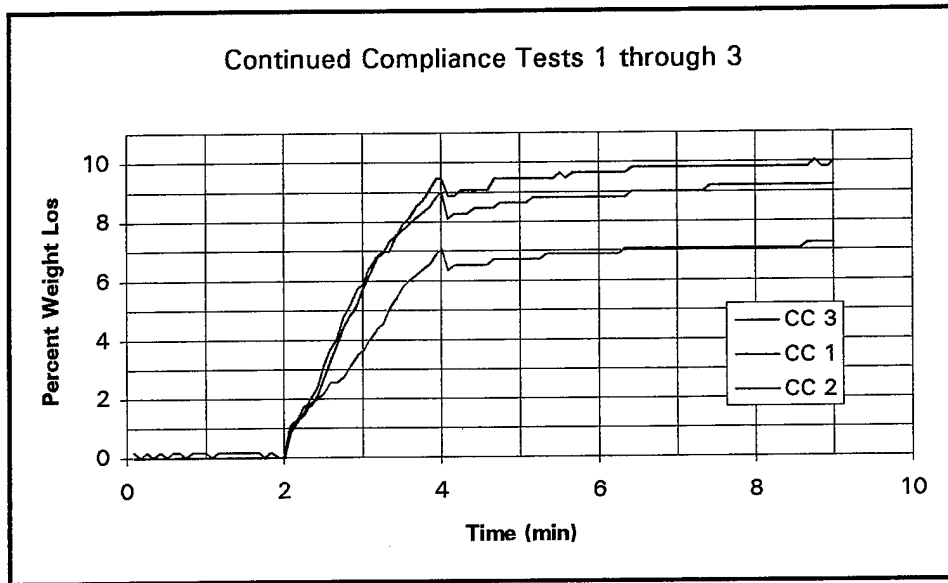
FIGURE 1. PERCENT WEIGHT LOSS PROFILES, TESTS 1 THROUGH 3

Stock Test Results. The weight loss profiles of the stock tests are shown in figures 1 and 2. The eight stock tests resulted in five tests exceeding 10 percent weight loss. The stock cushion tests did result in several instances where burn lengths exceeded the 17 inch (43.2 cm) requirement. In either case, the standard pass/fail criteria has no relevance in the stock configuration tests, which are expected to have higher test values. The data scatter was wide for both stock test series A and B, as seen in tables 4 and 5. Excluding test number five, no unusual fire behavior was observed during the testing.

When examining figures 1, 2, and 4 through 9, the percent weight loss values at the oil burner initial and final impingement times exhibit discontinuities. The discontinuities allude to instantaneous decreases or increases in the cushion mass. Physically, this is not possible. These discontinuities are a result of the fluid dynamics of the burner jet impacting the seat test fixture on the scale. Analyzing the initial and final impingement, the associated drop and gain in the weight of the cushion set is nearly offset. By canceling these discontinuities, since the direction and magnitude of the discontinuities are opposing, then adjusting for the differences, the percent weight loss trend portrays a more realistic behavior.

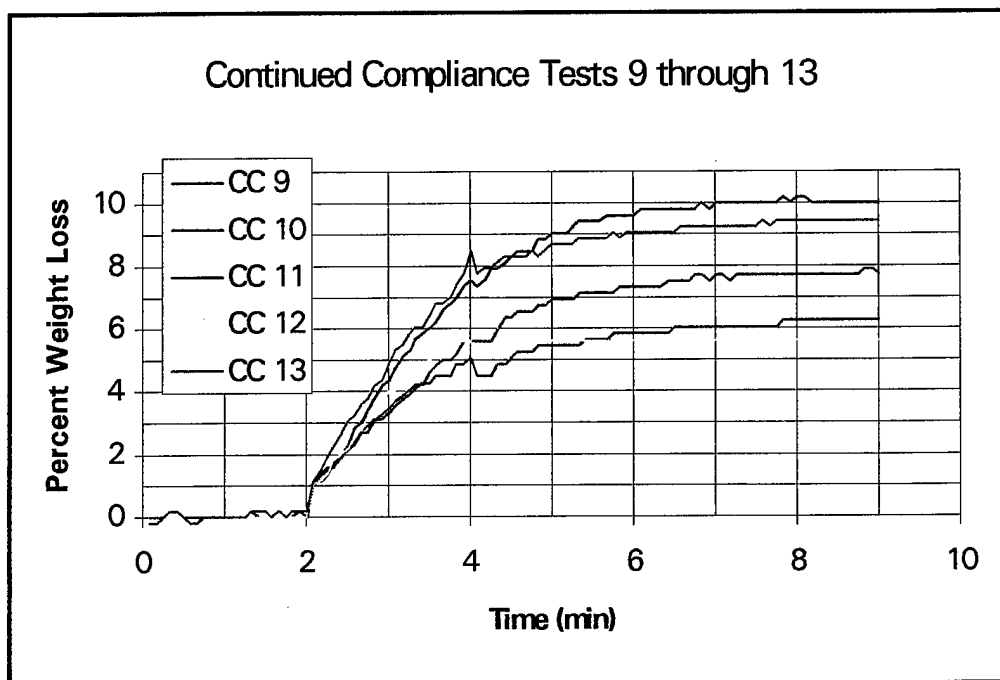
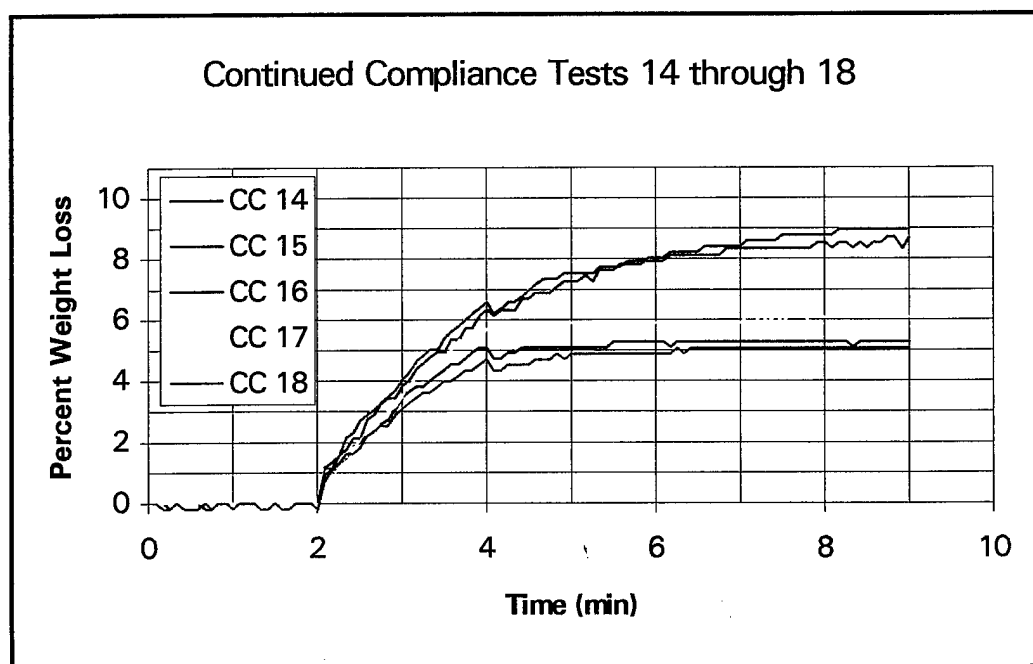
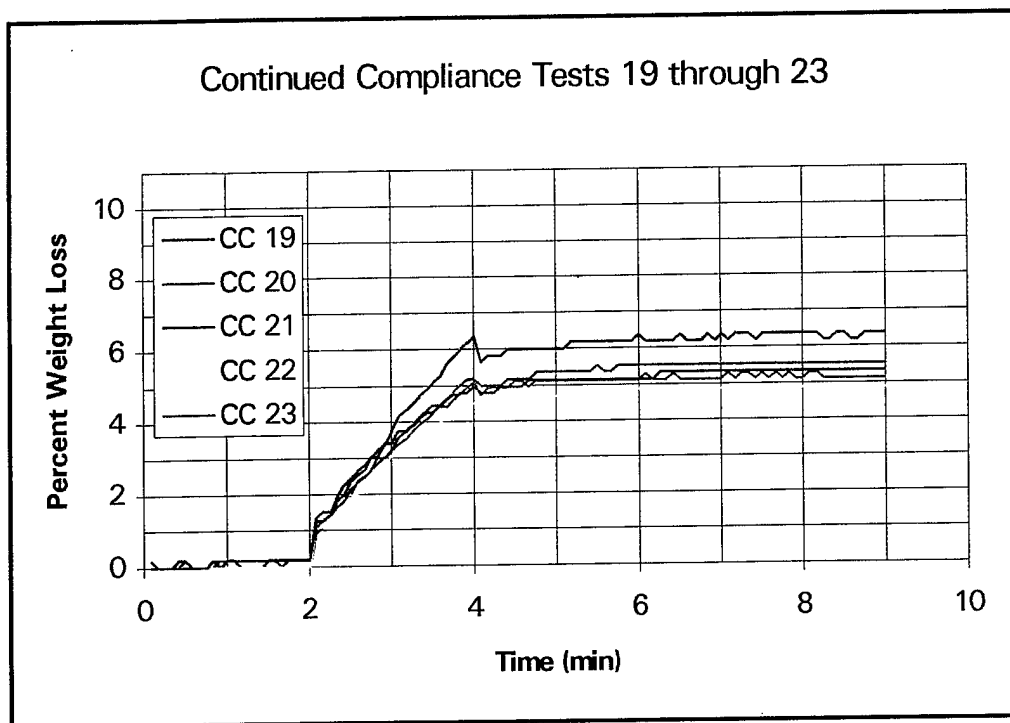
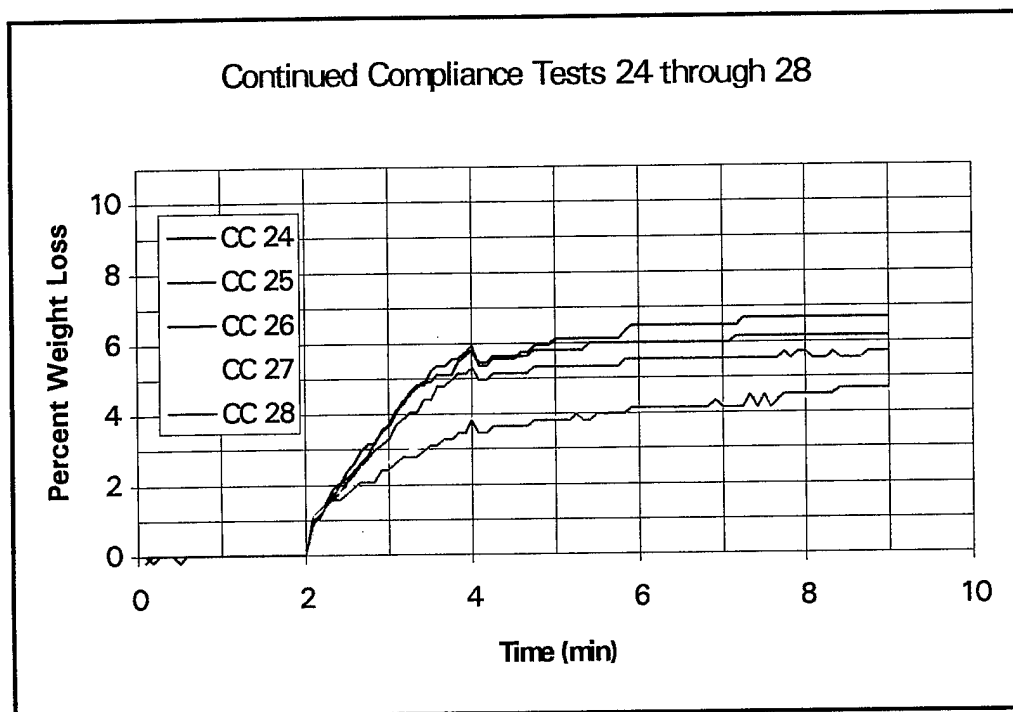
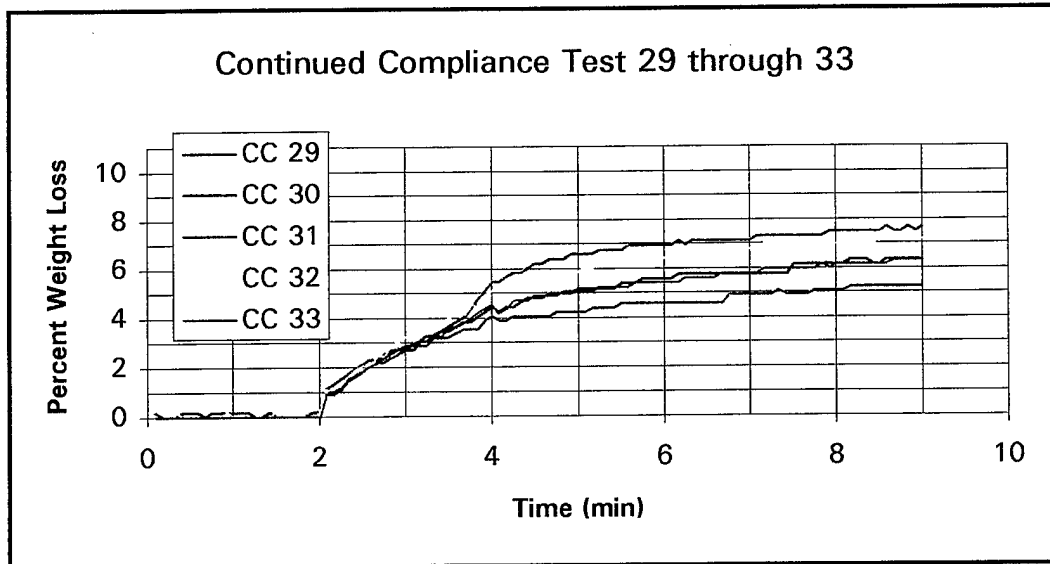
Modified Test Results. The weight loss profiles of the modified tests are shown in figures 4 through 9. The 30 modified shaped cushion tests yielded one failure and that was for a weight loss greater than 10 percent (see table 4). There were no differences noted in the test performance based on the lack of or the presence of the strapping affixed to the horizontal cushions for flotation purposes.

The percent weight loss was 10.87 for test number 36. This test was one of the final four tests performed which had reused vertical cushions. In review of this test, the final weight loss was mainly affected by the involvement of the reused vertical cushion. Had the vertical cushion been in an untested condition, the entire cushion set would have been expected to pass in the same manner as the other 29 tests.

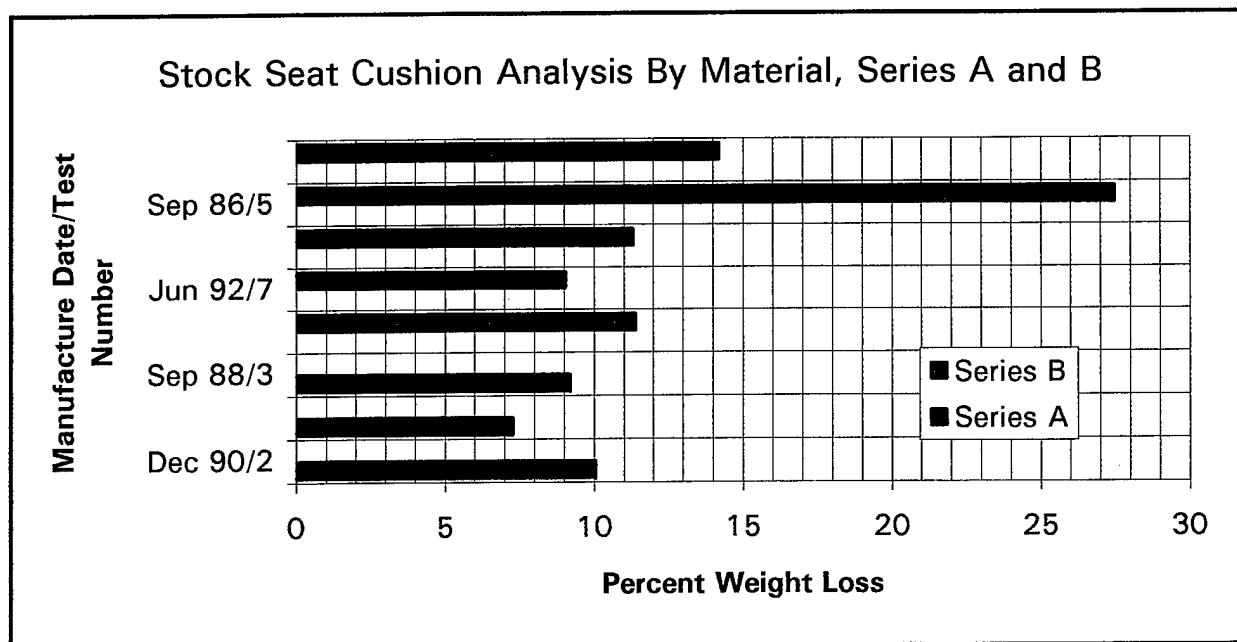
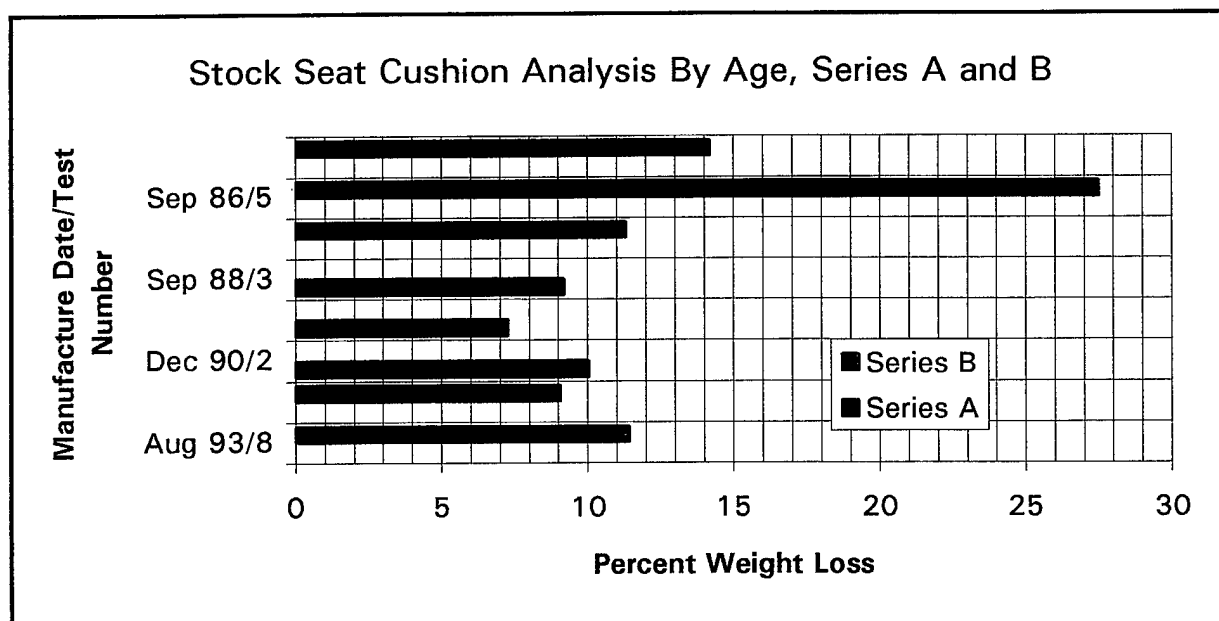
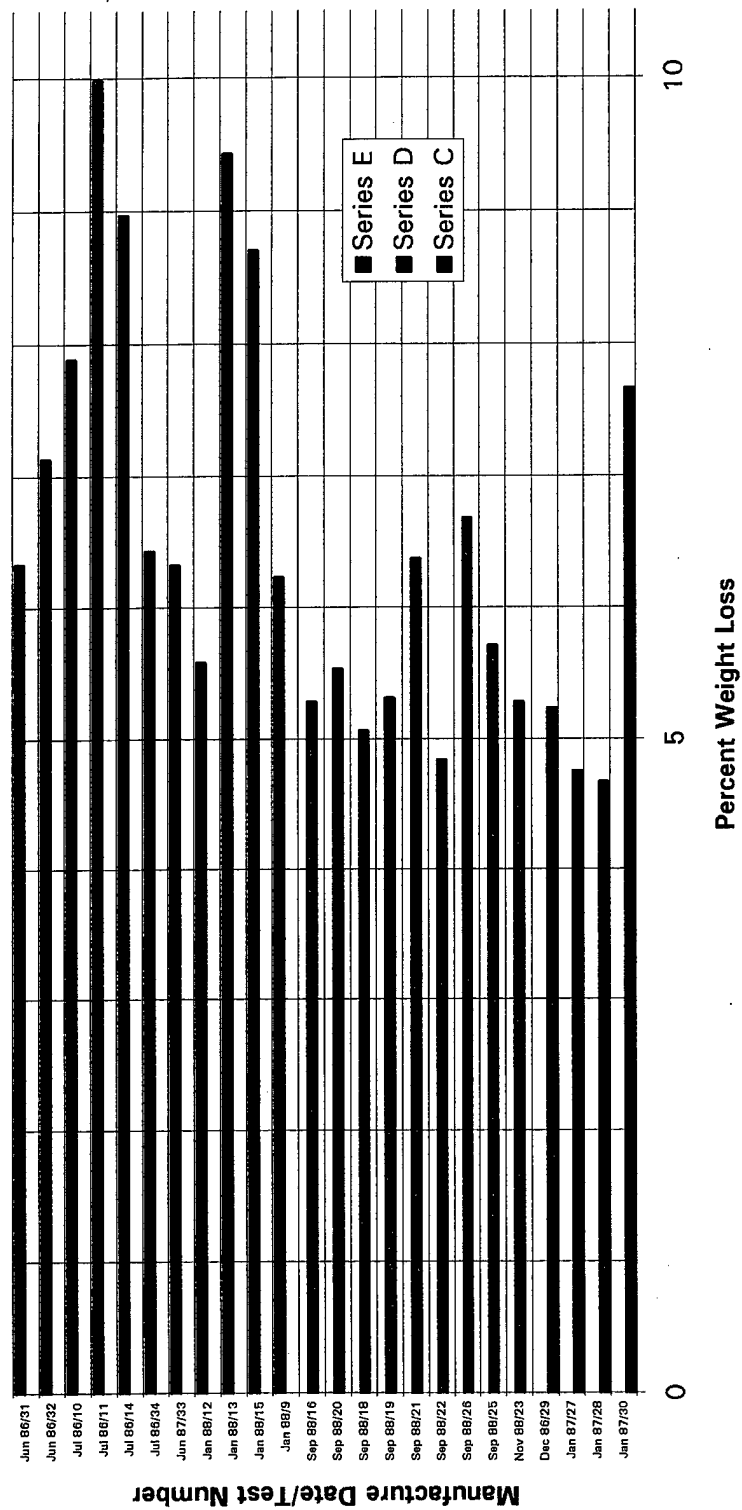
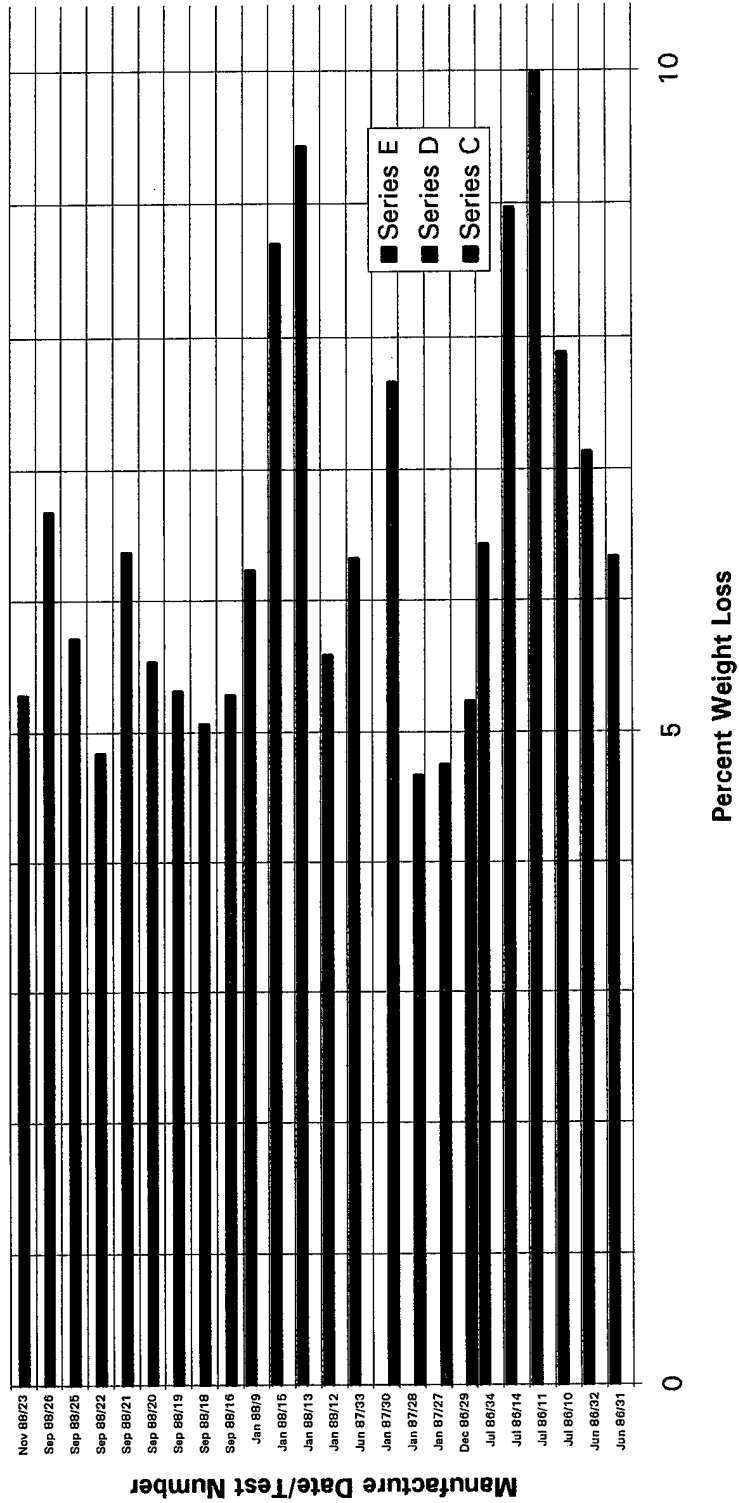
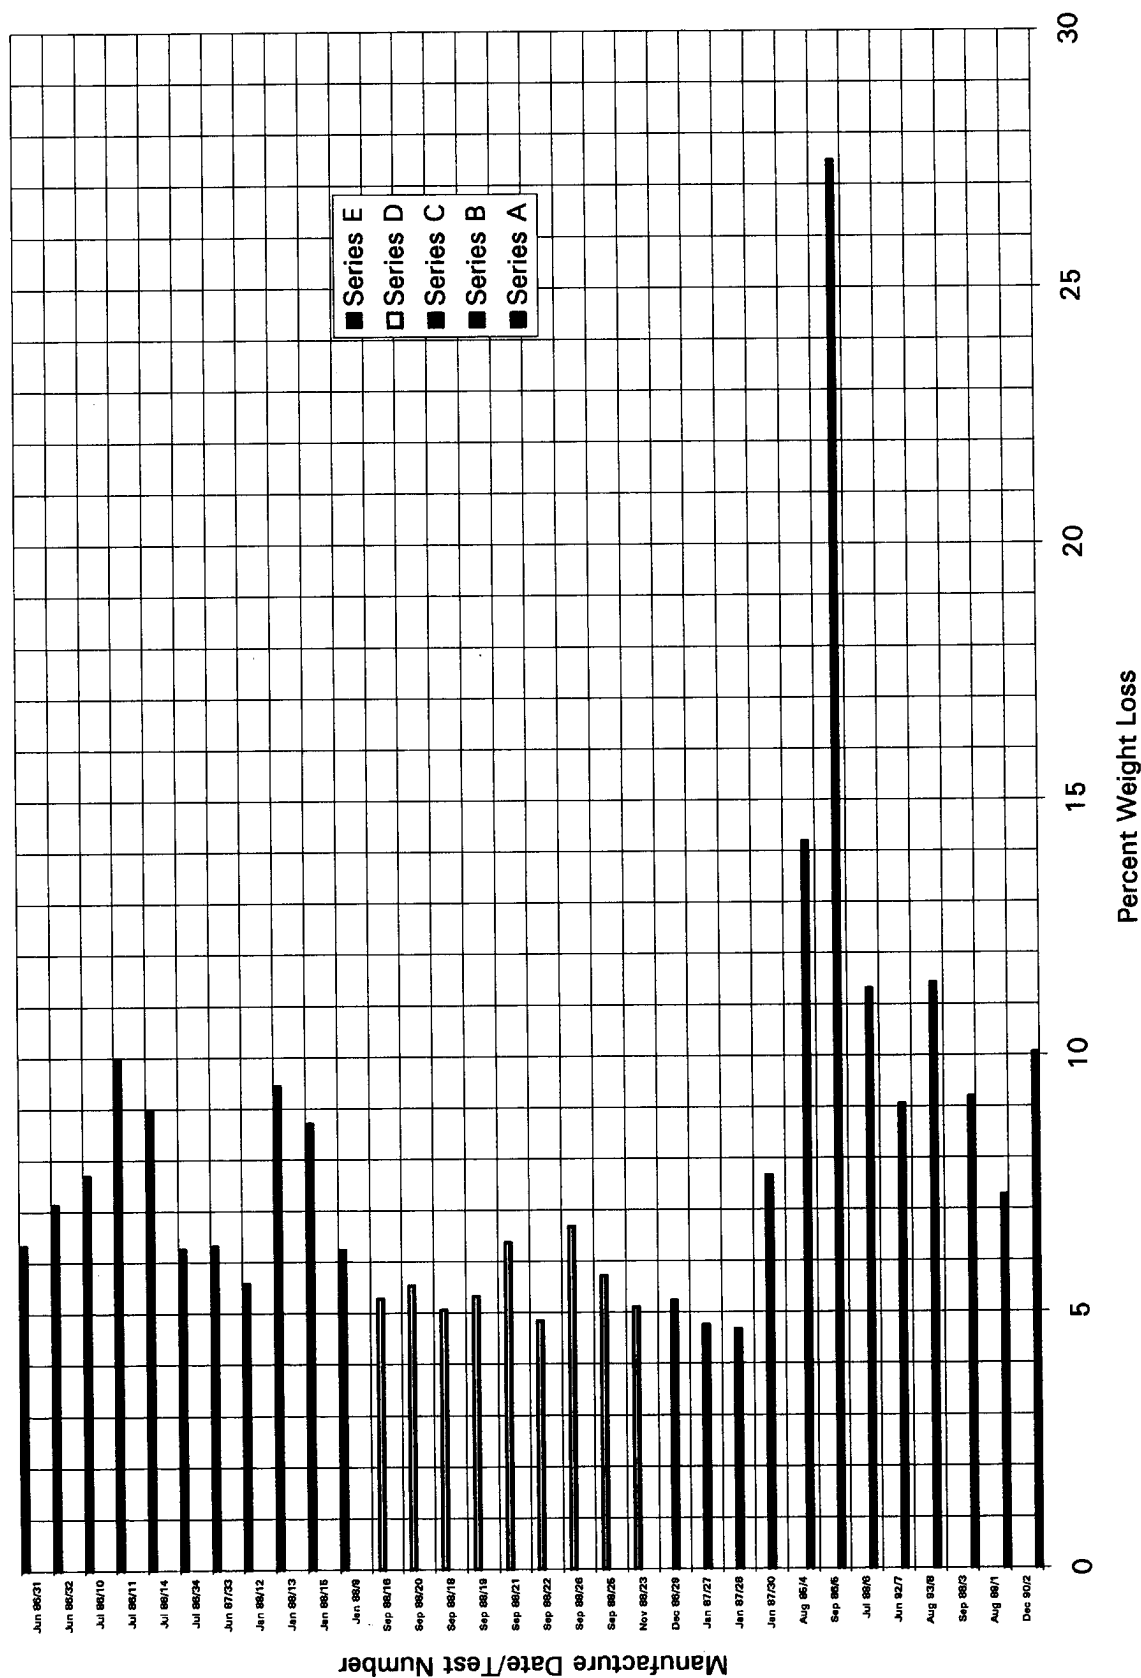
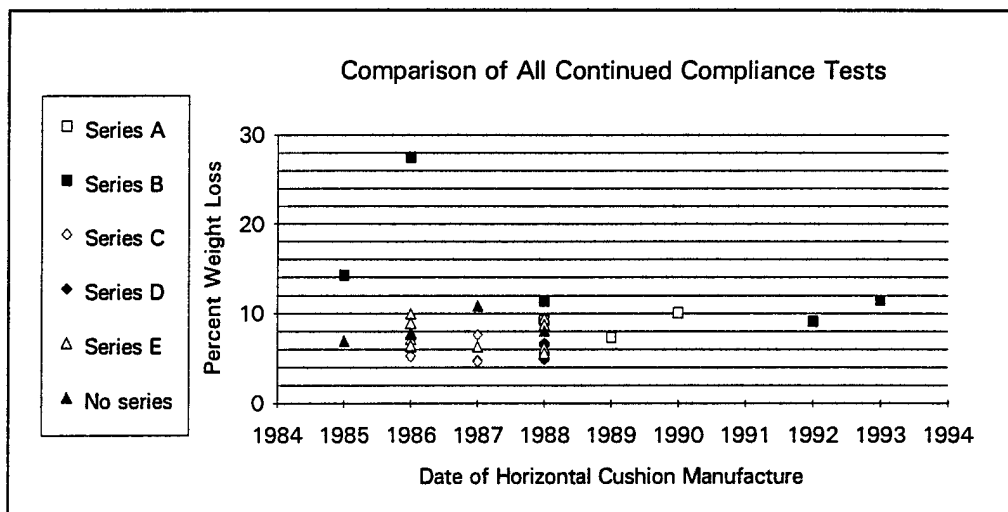
Overall Test Results Comparison. The overall breakdown of all tests based on percent weight loss is given in table 6. Figures 10 through 15 illustrate the test results comparatively.

1. The donated seat cushions used for testing were comparable to the in-service material examined in active transport category aircraft when considering deterioration. This determination was based on inspections of the donated and in-service cushions.
2. The modified cushion test results, as seen in table 4 and figures 14 and 15, show that the worn fire-blocking layers maintained fire endurance with respect to Part 25, Appendix F, Part II.
3. Penetrations in fire-blocking layers may or may not have an effect on the fire endurance of the seat cushions. There is a threshold phenomena, not evaluated during this work, which determines the success or failure of seat cushion combustion.
