**ENERGY SURVEY OF  
EISENHOWER ARMY MEDICAL CENTER  
FORT GORDON**

**AUGUSTA, GEORGIA**

**NARRATIVE REPORT**

**DECEMBER 23, 1996**

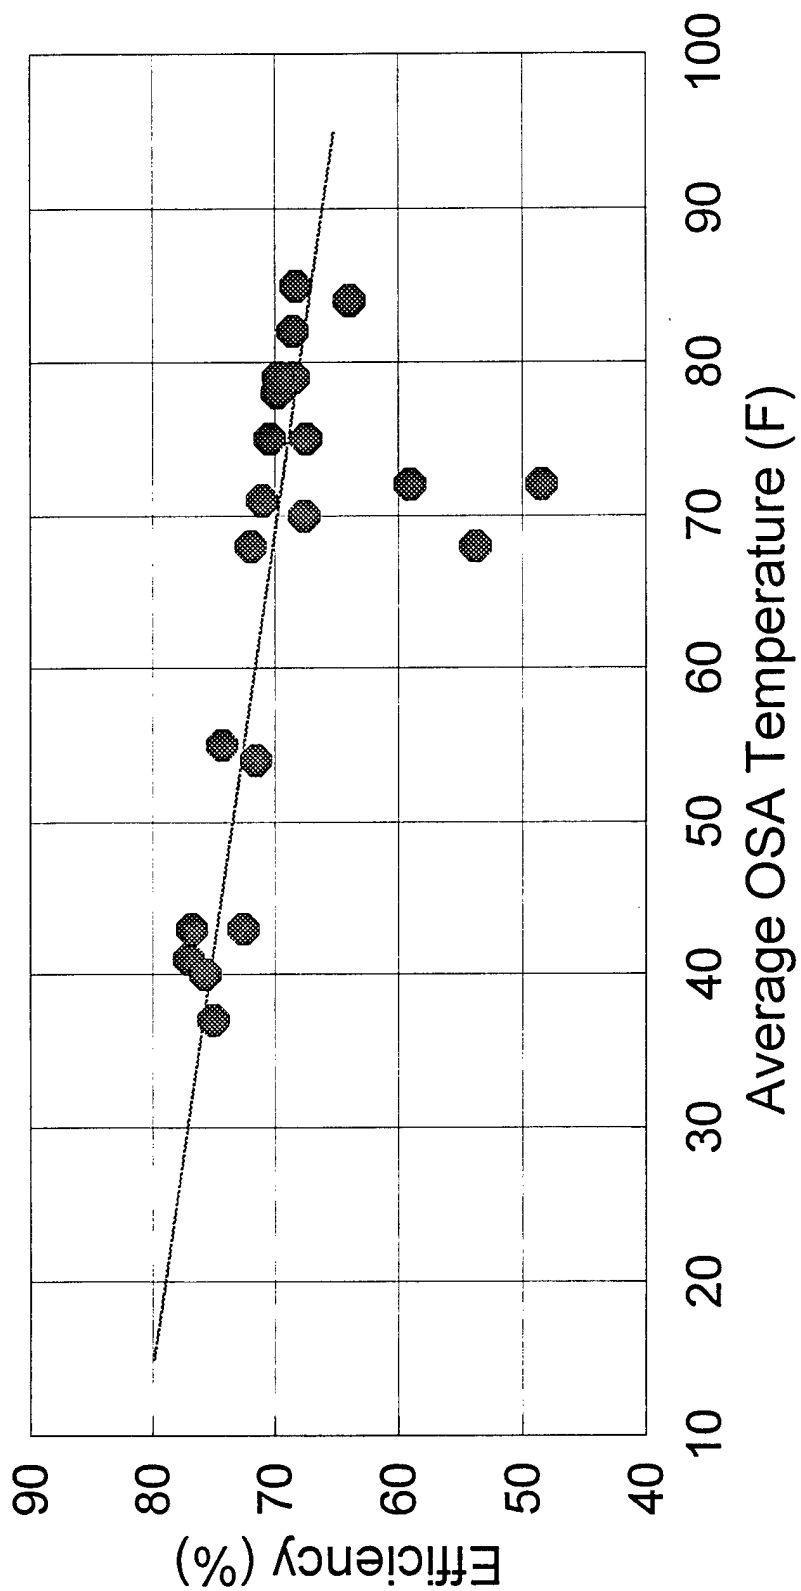
Stack gas measurements taken during a typical drum level swing showed that the excess O<sub>2</sub> levels varied from 2.1 percent to 14 percent. This equates to variations in efficiency from 78.3 percent to 58.7 percent. An average value is 68.5 percent. This compares favorably to boiler log recordings. Figure 2.2-5 was developed using steam flow and natural gas logs from the boiler plant for several months of the year. Boiler efficiencies range from 65 percent to 75 percent.

Boiler total solids is very low indicating that the boiler blowdown is too high. The operators report that they blow down for only ten seconds. A ten second blow may require ten seconds to open the valve, ten seconds to blow and ten seconds to close the valve or thirty seconds total valve open time. This is about as fast as it can be done and still blowdown effectively. The only other option to reduce blow down is to decrease the frequency. This is discussed in Section 4.3.

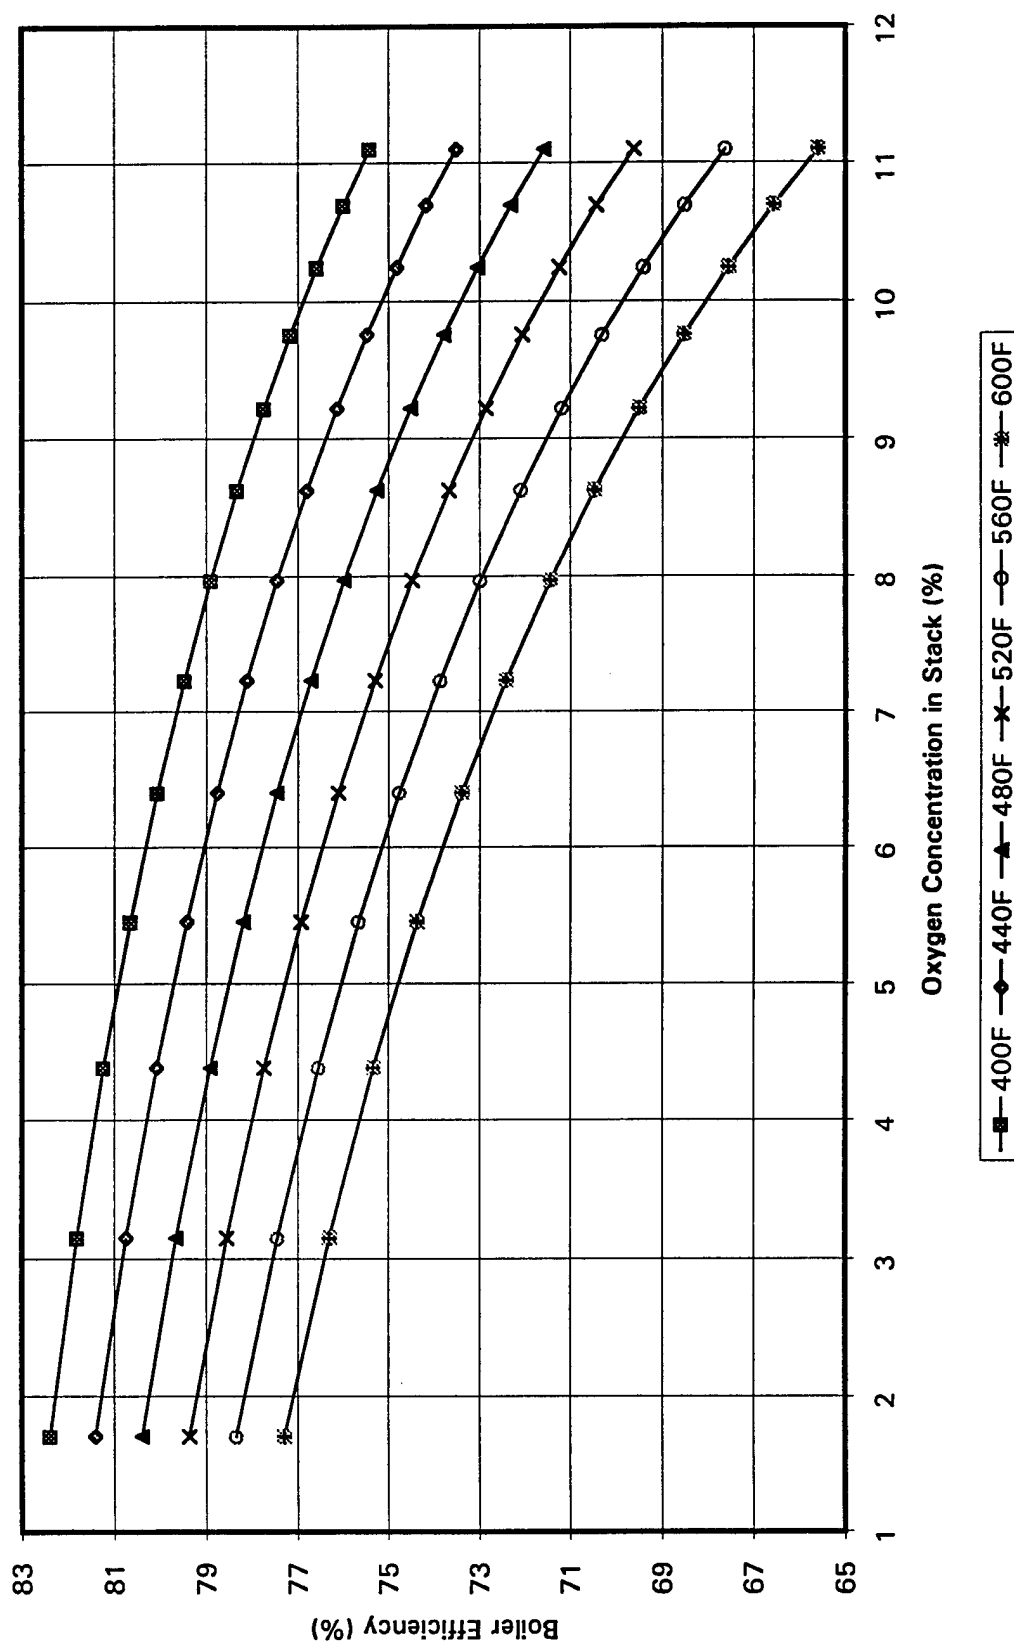
Figure 4.3-1

Between half and full load, the boiler should be able to operate comfortably at ten to 15 percent excess air. Below 50 percent load the excess air should be increased as necessary to maintain safe furnace conditions. Safe furnace conditions below 50 percent load will have to be field determined using a combination of visual flame observations, stack  $\text{O}_2$  measurements, burner air spinner vane adjustments and prudent operating practice.
