TRI-SERVICE CONFERENCE ON CORROSION

21-23 JUNE 1994

Shipboard Exposure Testing of Aircraft Materials

Edwin S. Tankins*, J. Kozol & E. Lee

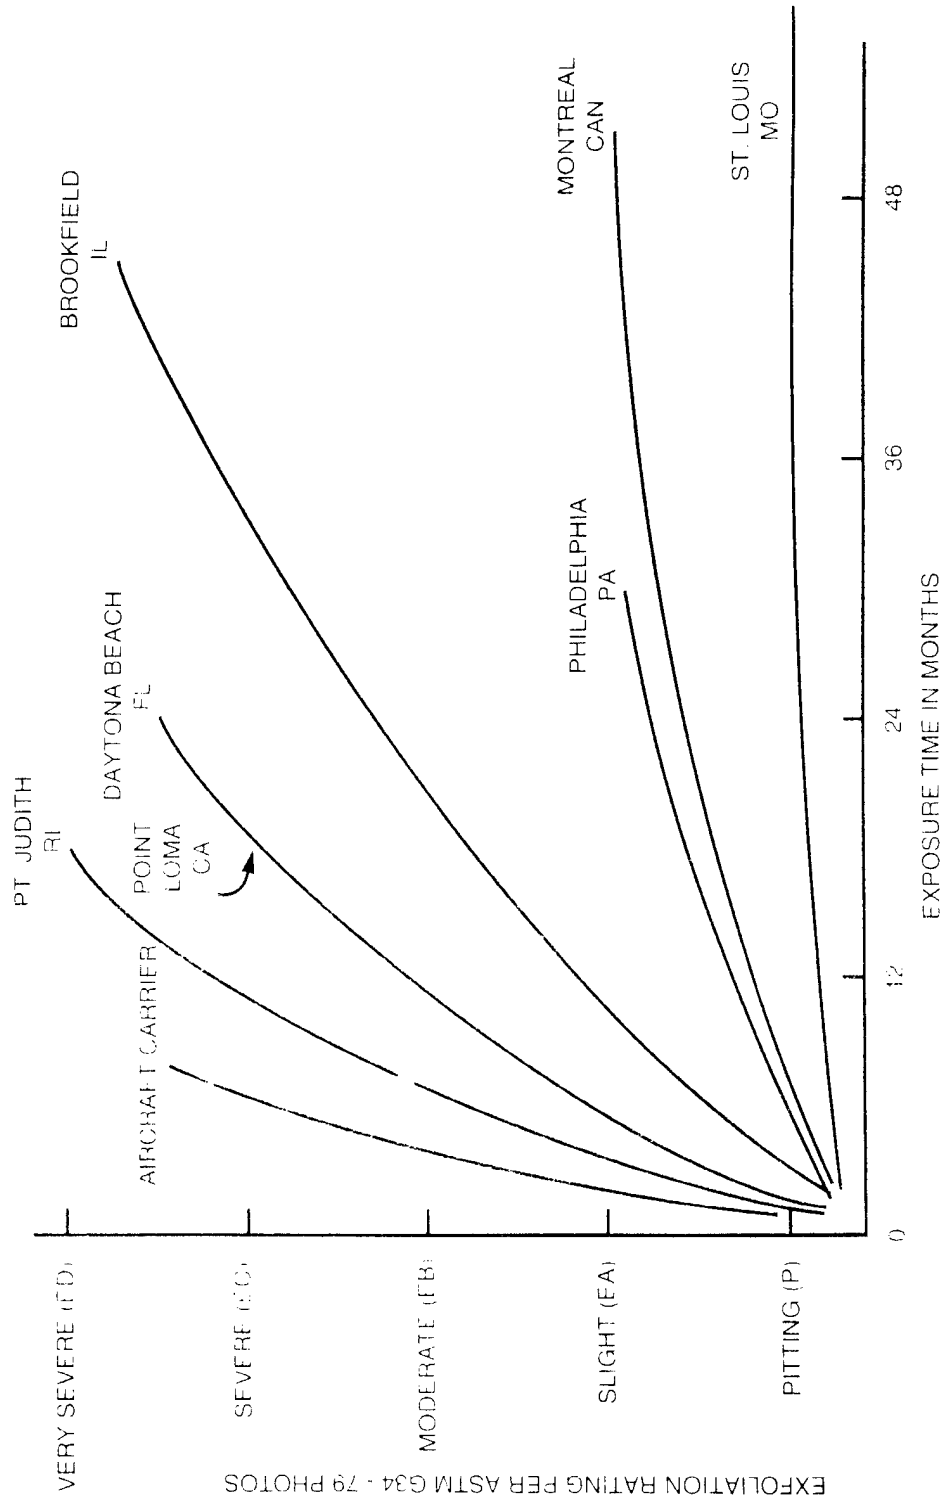
The study of various alloys included exposure aboard aircraft carriers as part of a series of exposures for the last ten years. Figure 1 summarizes the results of previous testing and shows that the carrier environment is more severe than seacoast or industrial environments (2). However, large differences exist between theaters of operations. Environmentally, the Indian Ocean deployment during the monsoon season is far more severe than the Atlantic or Mediterranean Sea deployment from which previous comparisons were made. Susceptible aluminum exposed aboard nuclear powered carriers (no stack gases) exhibited behavior similar to that aboard conventionally powered carriers (stack gases with jet engine

There has been considerable testing performed in various locations. There are pronounced differences in locations and environments. For instance, the Indian Ocean during the monsoon appears to be more severe than the Atlantic or Pacific. The work of Ketchum, et al (2) showed a comparison of the various environments. Figure 1 was first shown in their work (2) and is an excellent comparison.

Fig. 1 - Comparative corrosivity of natural environments
