Access Study to all Pertinent Parts of
Dam Projects During High Reservoir
Conditions

Upper Connecticut Basin New Hampshire and Vermont

JULY 1992

US Army Corps
of Engineers
New England Division

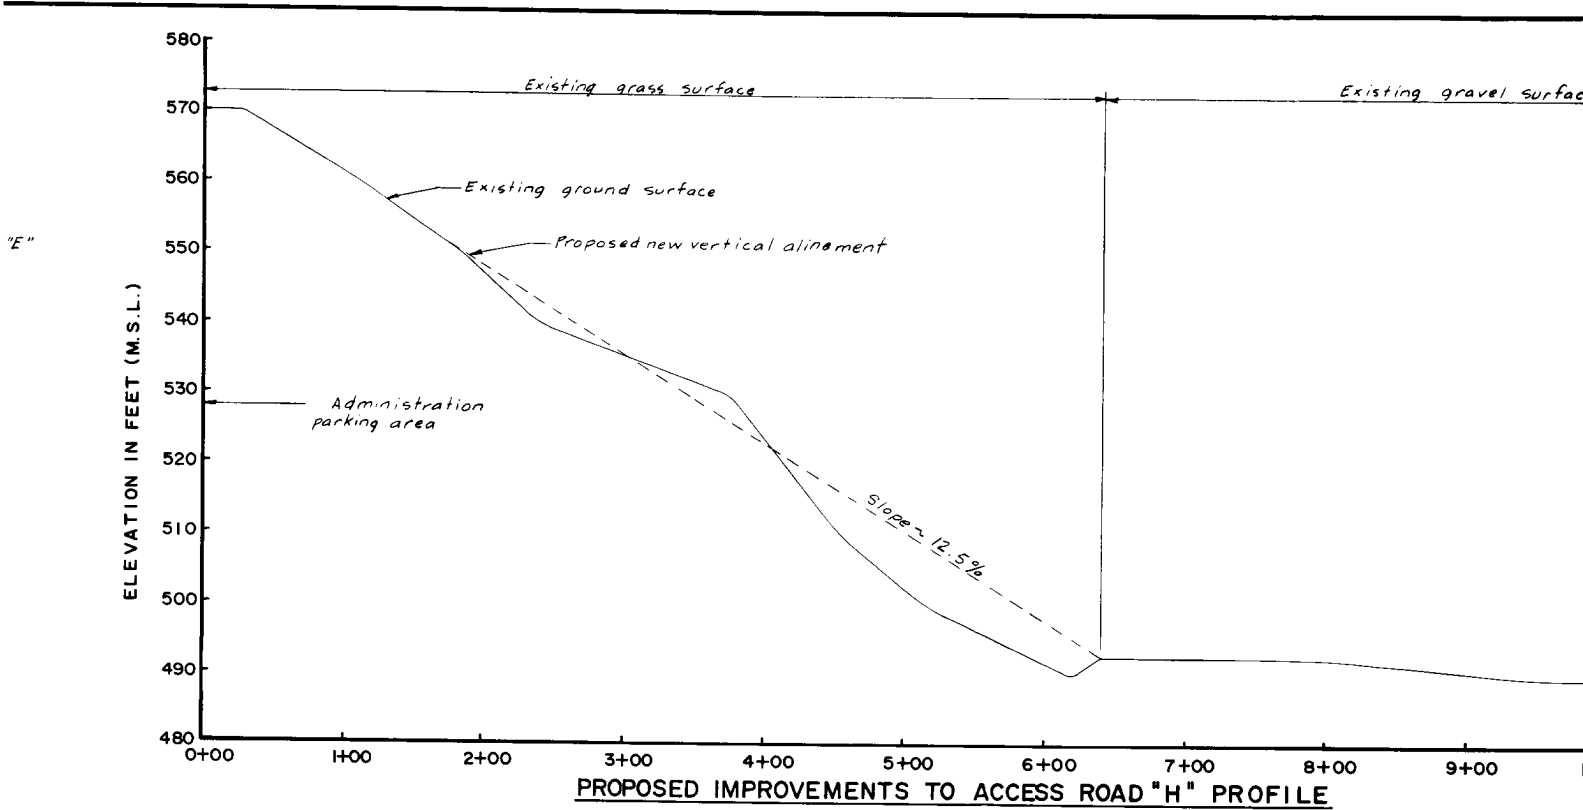
PROPOSED IMPROVEMENTS TO ACCESS ROAD "H" PROFILE
 SCALES: HOR. 1" = 50'
 VERT. 1" = 10'

7. Recommended Improvements. Access Road "I" should be upgraded to allow heavy equipment to operate on it immediately after high water events. It should be extended to meet Access Road "H". The grass on the road (approximately thirty percent of the area) should be removed and grubbed. Soft materials under the grass or along the gravel portions of the road should be removed 12 inches of gravel shall be placed on former grass portions of the road, and six inches of gravel shall be placed on the existing gravel portions of the road. A small amount of gravel may be needed to use Access Roads "J" and "L" after heavy rain and high water events.

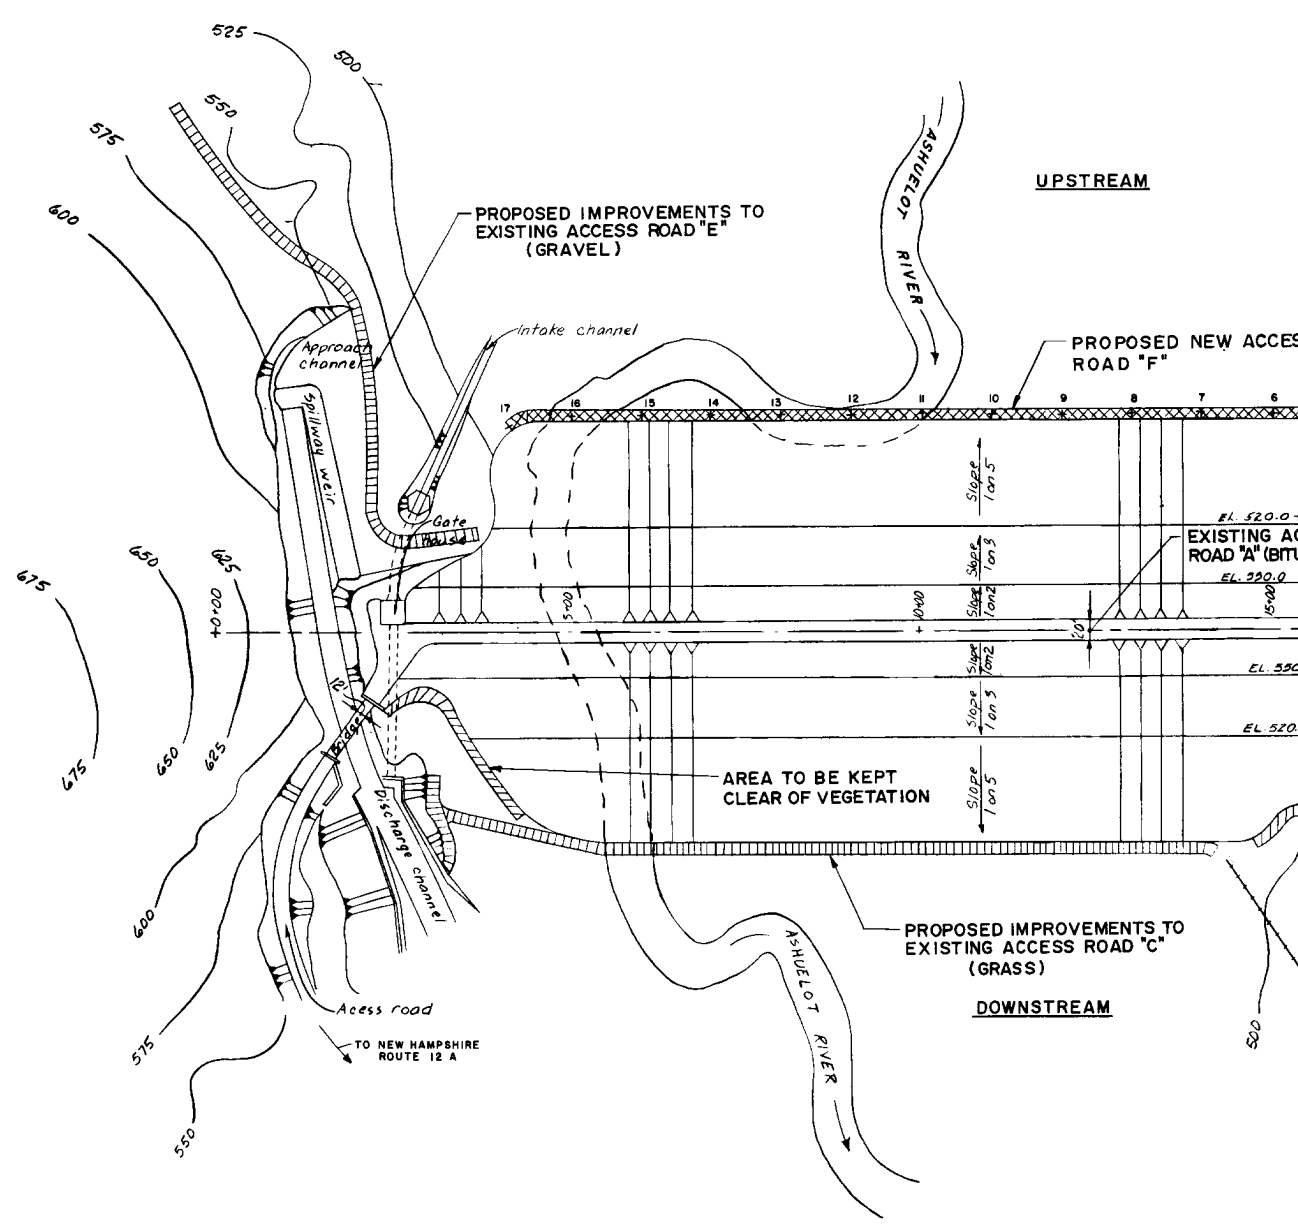
DEPARTMENT OF THE ARMY NEW ENGLAND DIVISION CORPS OF ENGINEERS WALTHAM, MASS.	
DES. BY. _____ DR. BY. _____ CR. BY. _____	EMERGENCY ACCESS STUDY UPPER CONNETTICUT RIVER BASIN SURRY MOUNTAIN LAKE GENERAL PLAN
GEO TECH. ENG. DIV.	SCALE: 1" = 100'
PLATE F-1	DATE: AUG. 1990

6. Adequacy of Access. Access to the crest of Surry Mountain Dam is adequate. The upstream toe of the dam can only be reached by foot or boat.
7. Recommended Improvements. Access Road "F" as shown on Plate F-1 and F-2 is recommended to improve access to the upstream toe of Surry Mountain Dam. It would be a rock fill road which would provide upstream toe access during

9. Adequacy of Access. Access Road "E" is adequate to access the inlet channel and structure until the pool reaches an elevation five feet below spillway discharge (545 feet NGVD). Access Road "C" is inadequate during spillway discharge because it is inundated by four to five feet of water.

normal pool conditions. The surface of Access Road "D" should be surfaced with six inches of gravel so that heavy equipment can easily reach Access Road "F" from Access Road "A".

10. Recommended Improvements. Clearing and placement of a small amount of gravel (approximately 100 cubic yards) should be done along Access Road "E" so that heavy equipment can use it easier. Access Road "C" should be improved as discussed in paragraph 4.

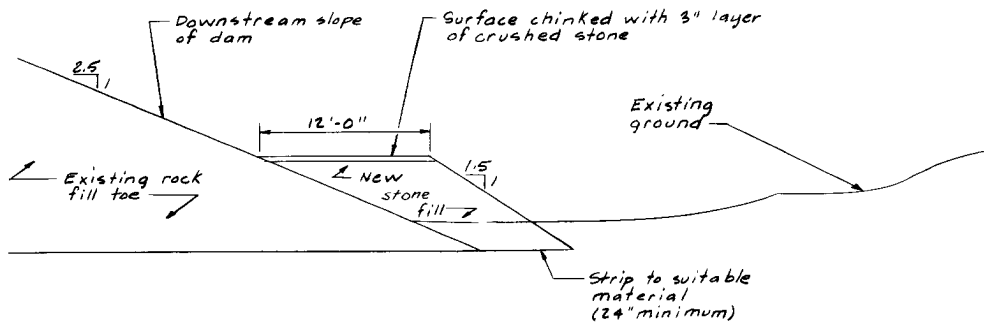
TYPICAL ROCK FILL SECTION FOR PROPOSED ACCESS ROADS "C" AND "F"

3. Adequacy of Access. The downstream toe of Surry Mountain Dam can not be traversed when spillway discharge occurs.
4. Recommended Improvements. The surface of Access Road "C" should be raised above the elevation of water which inundates the area during spillway discharge. It is recommended that an approximately seven foot high stone berm be constructed adjacent to the dam embankment as shown on Plates F-1 and F-2. Three inches of crushed stone should be placed on the stone berm so that maintenance vehicles can travel on top of it.
