Report No. CG-D-02-98

## IMPROVED INSPECTION OF WOODEN VESSEL FASTENERS

**Kurt A. Hansen**

Final Report  
August 1997

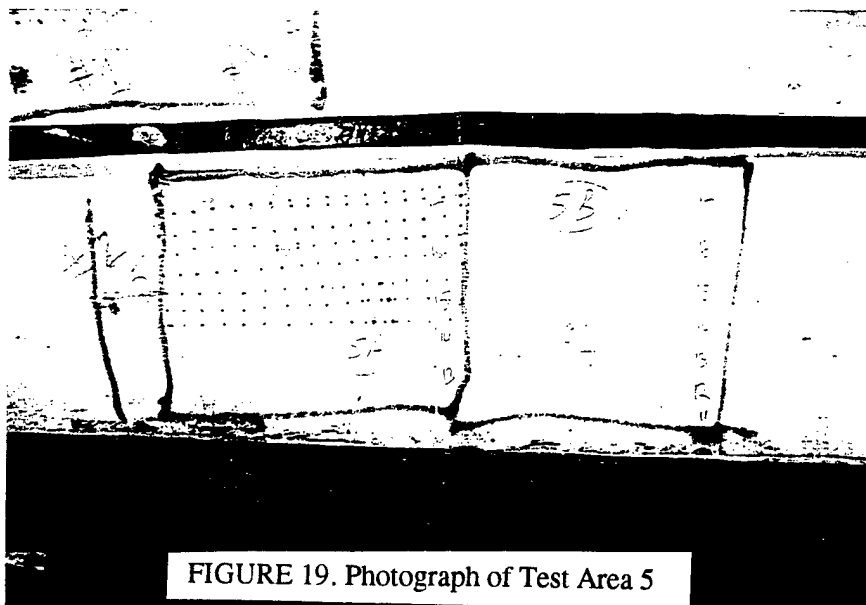
FIGURE 19. Photograph of Test Area 5

| <u>Area</u> | <u>Description</u> |
|---|---|
| 5. | A generally good area above the water line but below the middle rub rail. Area is about 3 feet by 3 feet. (Figure 19) |

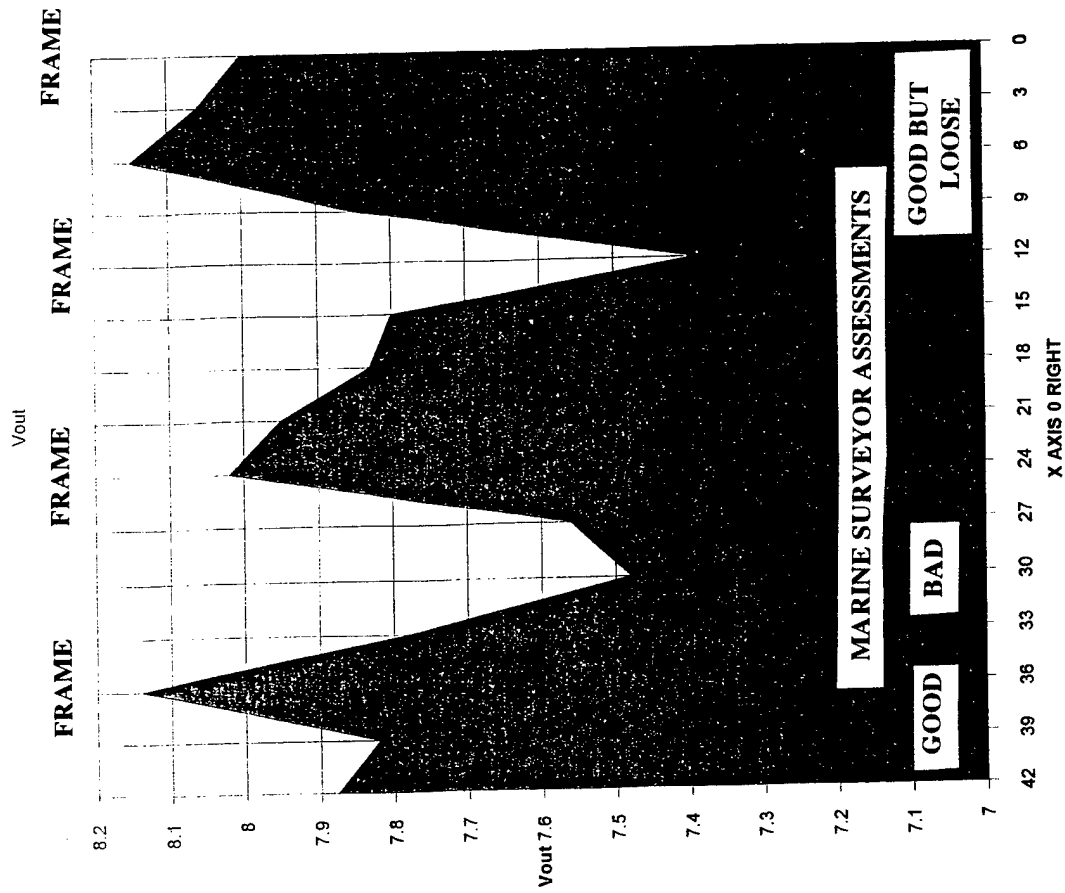
FIGURE 27. Capaciflector Results (Area 1)

Locations above the waterline were tested in Areas 1 and 5. In Area 1, dips in the readings were seen at two areas where the marine surveyors had indicated problems. (See Figure 27) In fact, it was marked right on the wood. But the dip at the 12 inch area is not consistent, especially since it is at a frame where the oak and fasteners should increase the readings. Area 5 was expected to be good and the data generally agreed except for a couple of areas on the left and top of the area (see Figure 28). Again, the data did not match the vessel frames as expected.

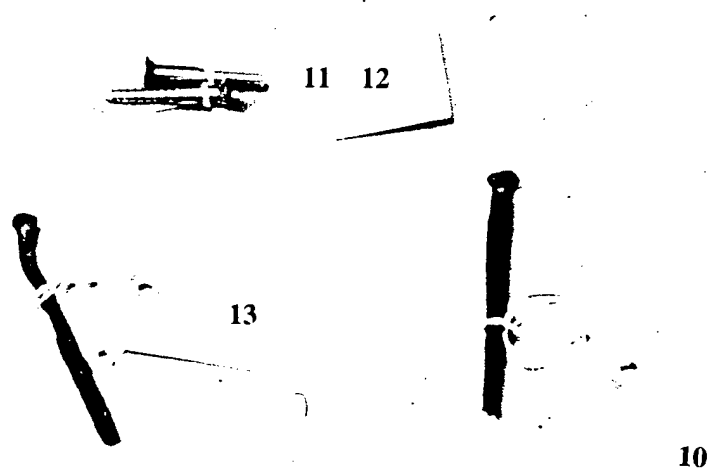
FIGURE 42. Photograph of Fasteners 10, 11, 12 and 13 in Area 3

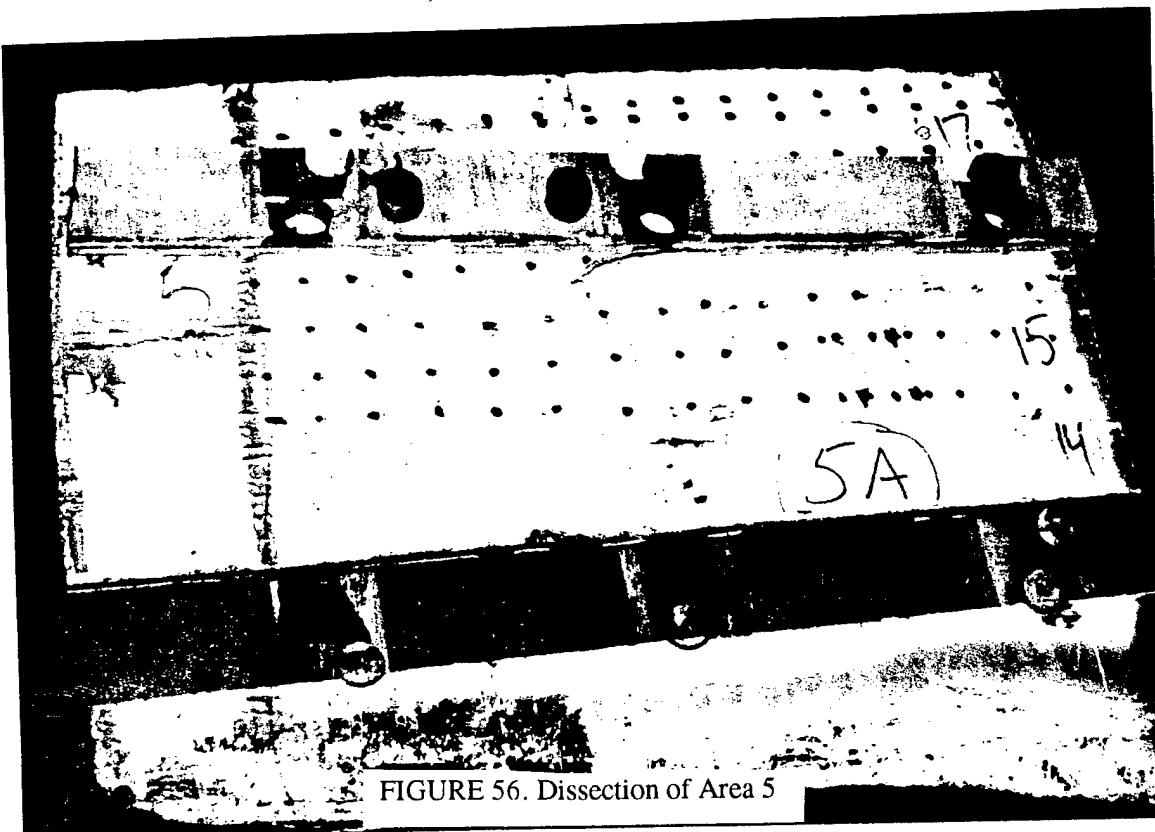
There were x-rays taken of other parts of the vessel, but conventional and real time shots were not taken in the same place. Real time shots were taken of Area 5 because the equipment was portable enough to be moved to that area. (Figure 55) The plank and the ceiling fasteners can both be seen. As expected, the fasteners in this area are in good shape and this was confirmed when taken apart (See Figure 56) Holes can be seen where the fasteners were removed.

FIGURE 56. Dissection of Area 5

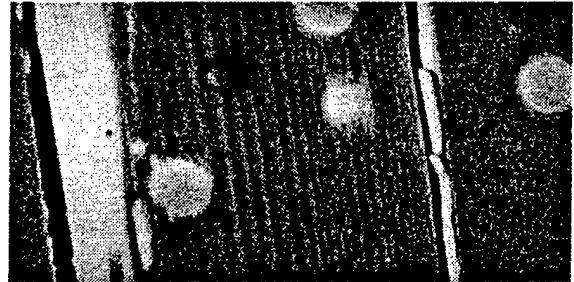
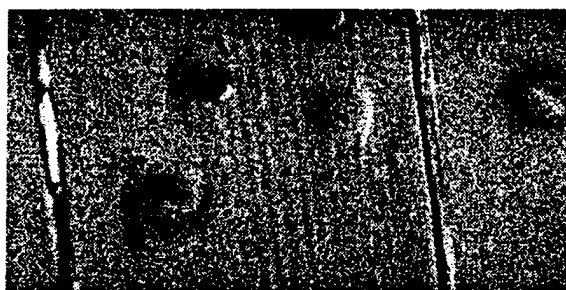
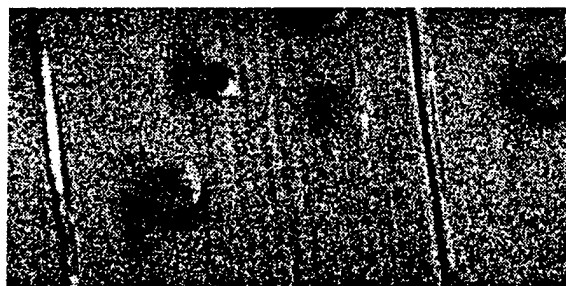
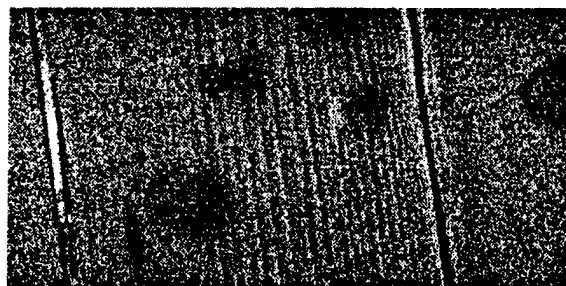
FIGURE 81. Backscatter X-ray Results

An x-ray backscatter method was attempted using a system developed by the Naval Research Laboratory. A set of images is seen in Figure 81. Each image represents a 50 mm by 100 mm (about 2 inches by 5 inches) slice about 0.5 mm thick. It is easy to identify caulk, screw hole filler, fasteners and changes in wood density. The hole filler material is seen up to about level 11 or 12 where the heads of the screws appear. The shadow of the heads continues on the images as deeper shots are taken.

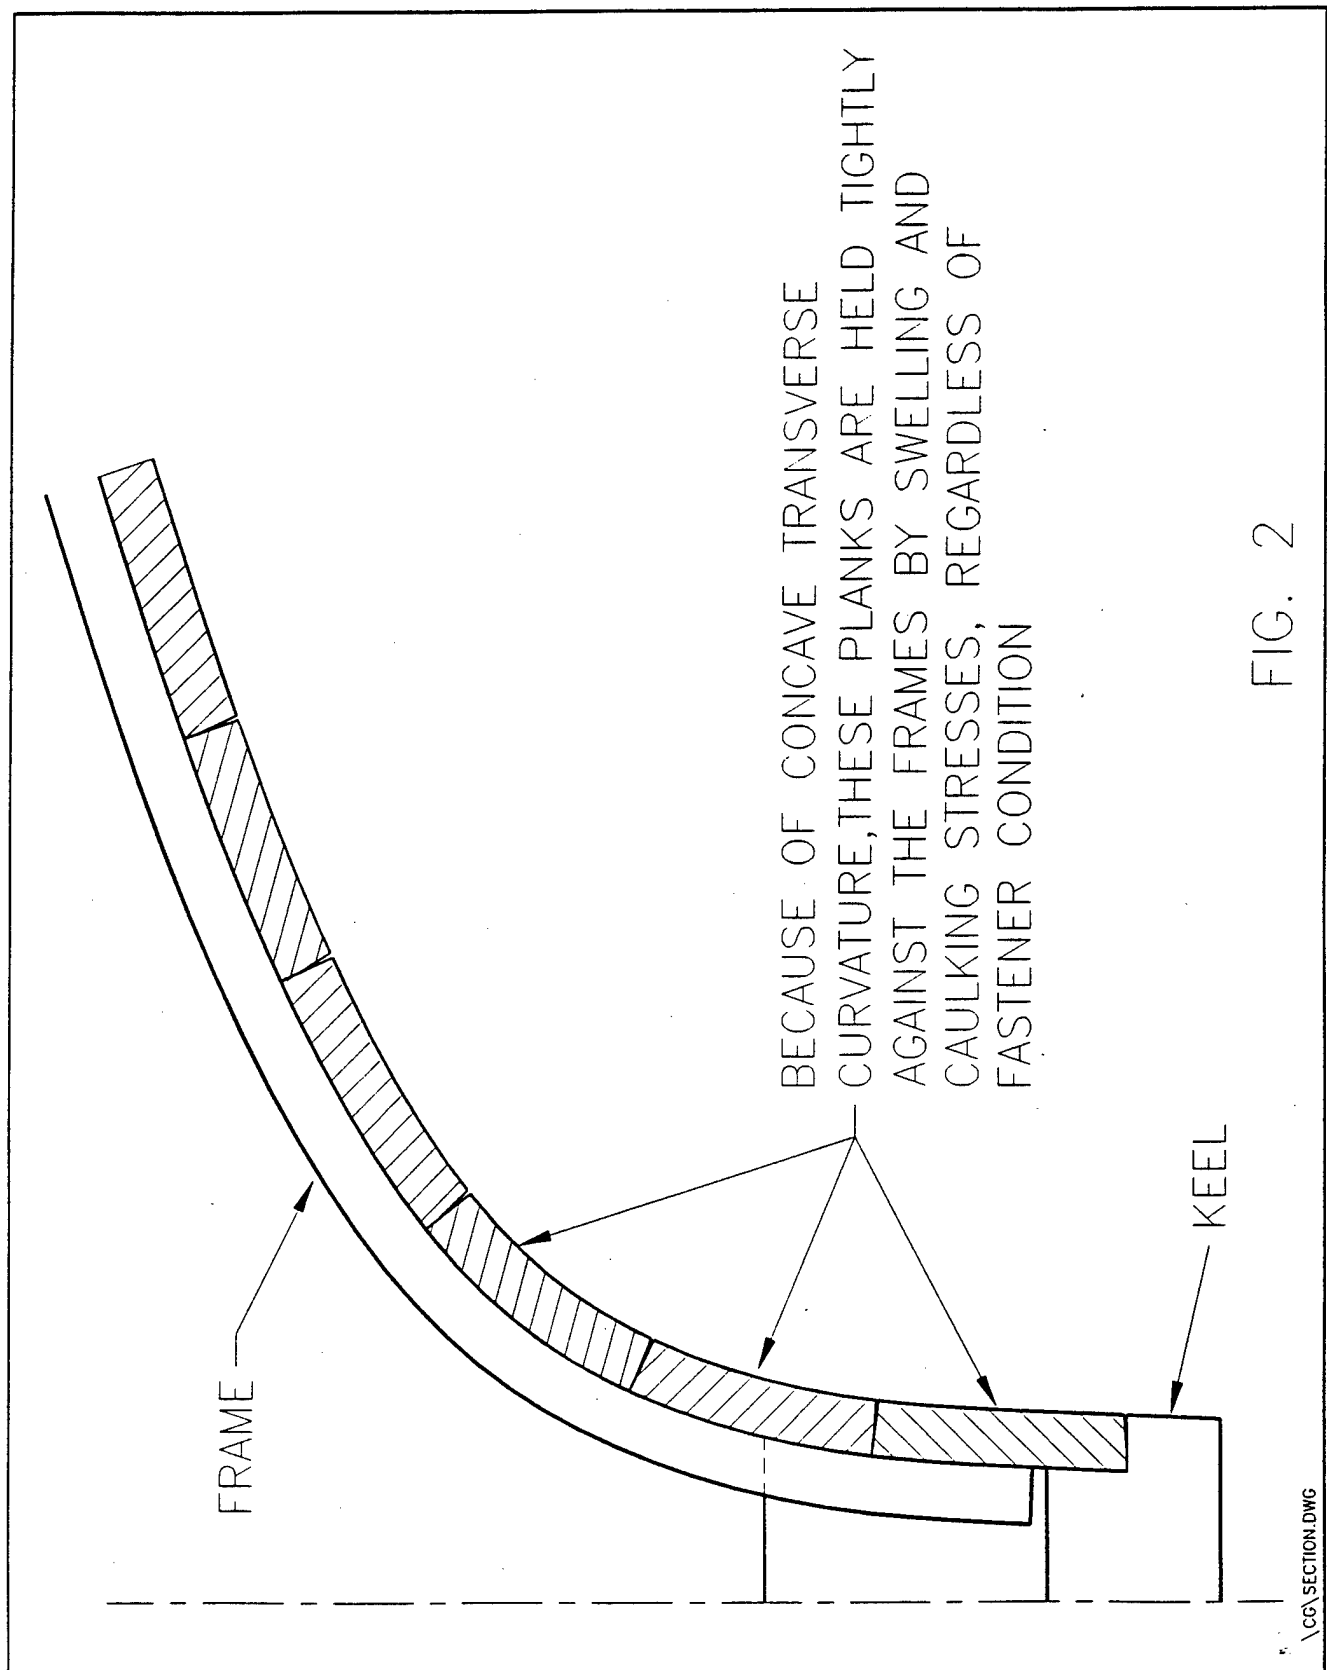
FIG. 2

In the case of these butts, the first type of geometric restraint (shown in Fig. 1) does not apply, since there is no fore-and aft structural continuity remaining in the individual planks with the butt fastenings gone. The garboard butts were held in place solely by the reverse curvature of the section (as shown in Fig. 2). This situation was further worsened by the completely deteriorated condition of the nails into the keel rabbett along lower edge of the garboard plank forward and aft of the butt. Despite the condition of these butts, none of us, using traditional survey techniques, had found any cause for great alarm.
