MODIFICATIONS TO THE TUBE-LAUNCHED, OPTICALLY  
TRACKED, WIRE-COMMAND MISSILE LAUNCHER FOR  
THE BRADLEY FIGHTING VEHICLE SYSTEM

Report Number 98-165

June 25, 1998

Office of the Inspector General  
Department of Defense

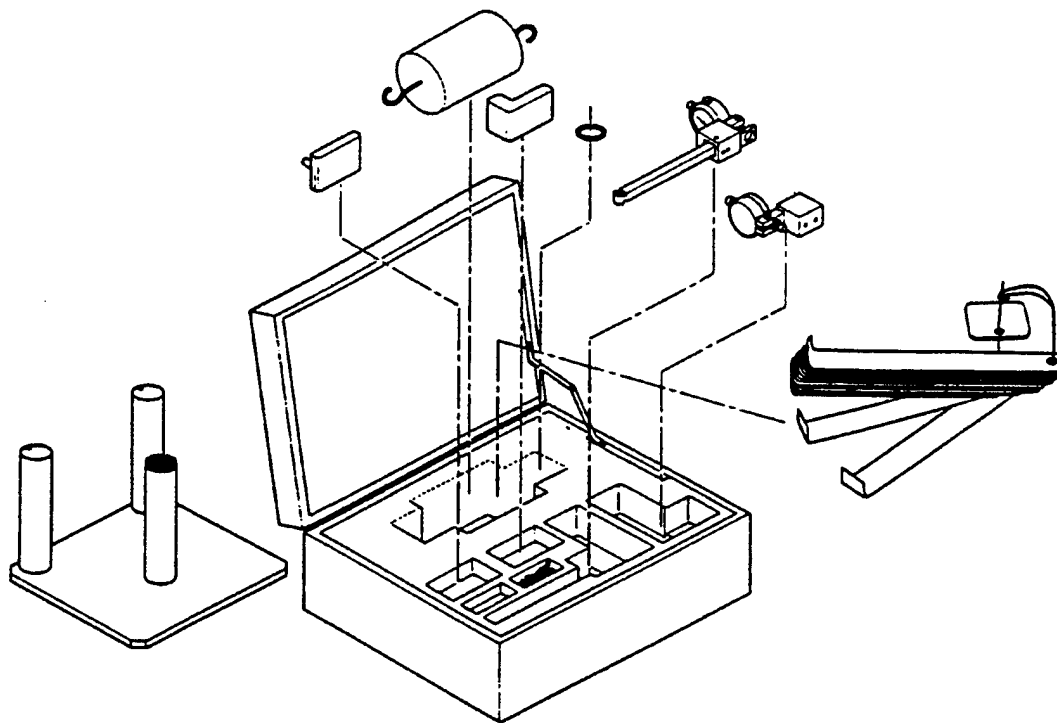
Figure 2. Switch Adjustment Gauge Set

**ACU Final Assembly and Testing.** Final assembly and testing of the ACU requires a switch adjustment gauge set, part 1366078, to ensure proper alignment of the ACU. The gauge set comprises gauge assemblies, tools, and fixtures as shown in Figure 2.

The gauge set is used to align and test umbilical and motor stop switches within the ACU. Those switches must be set to precise tolerances to satisfy design specifications and meet minimum in-process quality assurance inspection points required by the DMWR.

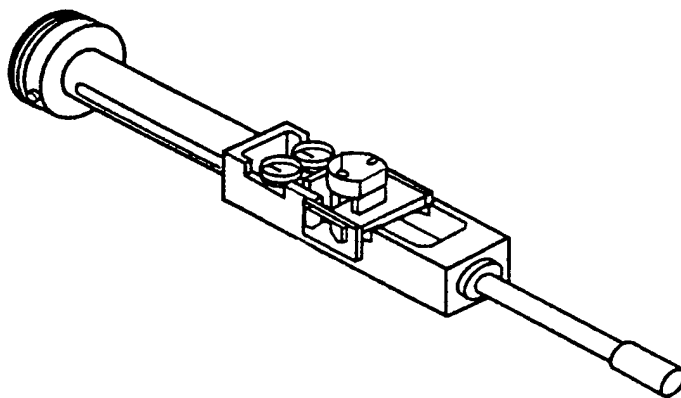
**Figure 5. Setscrew Adjustment Gauge**

**Setscrew and Stop Block Adjustments.** A setscrew adjustment gauge, part 12295912-40101-5 (shown in Figure 5), is required to perform the setscrew

and stop block adjustments to ensure that they meet the design specifications. The setscrew is to be set between -0.0005 inches and 0.0005 inches; and the stop block is to be set between 0.002 inches and 0.001 inches.

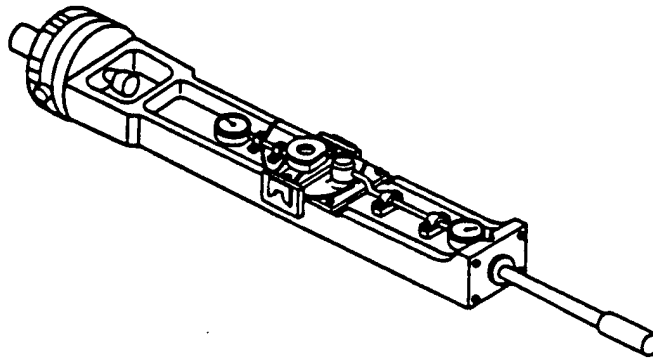
Figure 6. Boresight Alignment Fixture

**Holdback Pin Plunger and Umbilical Connector Distance Tests.** The distance test is performed to ensure that the holdback pin plunger and umbilical connector travels the minimum required distance. The minimum distance for the holdback pin plunger is 0.350 inches, and for the umbilical connector 0.457 inches. The DMWR requires the use of the boresight alignment fixture (shown in Figure 6), part 12295912-40101-6, to perform this test.
