# Structural Analysis of DEW Line Station DYE-2, Greenland

1983-1988

Michael R. Walsh and Herbert T. Ueda

CRREL Report 98-3

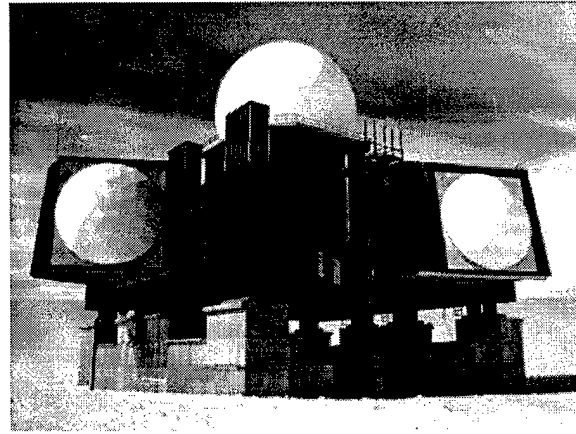
Figure 3. DYE-2: 1977.

During the intervening years, the column foundations had been distorted by differential settlement due to the nature of the supporting snow. The foundation distortions caused secondary stresses to accumulate in the structural frame. In addition, hydrostatic pressure from the surrounding snow became higher as the building was raised and the column length below the snow surface increased. Eventually, the pressure was high enough to begin distorting and crushing the protective wooden enclosures, shown beneath the building in Figure 3.

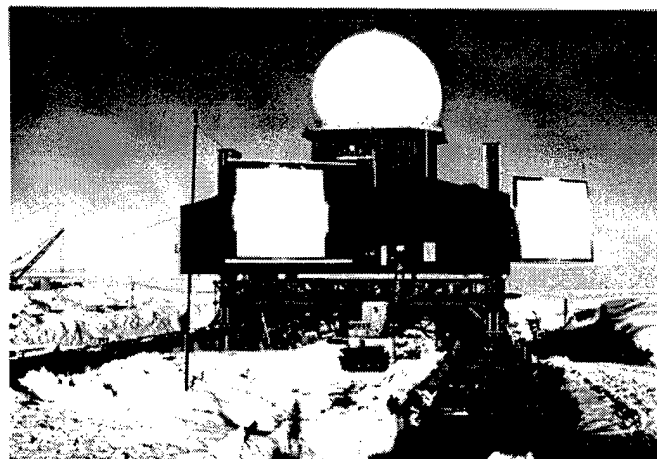
Figure 4. DYE-2 move: 1982.

By the early 1980s, measurements indicated that column stresses were sufficiently high to require drastic remedial action. In 1982, the supporting structure was severed at a new base level, and DYE-2 was moved sideways 64 m onto a new set of footings (Fig. 4). The following year, the building was lifted 8.2 m. Since that time, CRREL personnel monitored building and col-

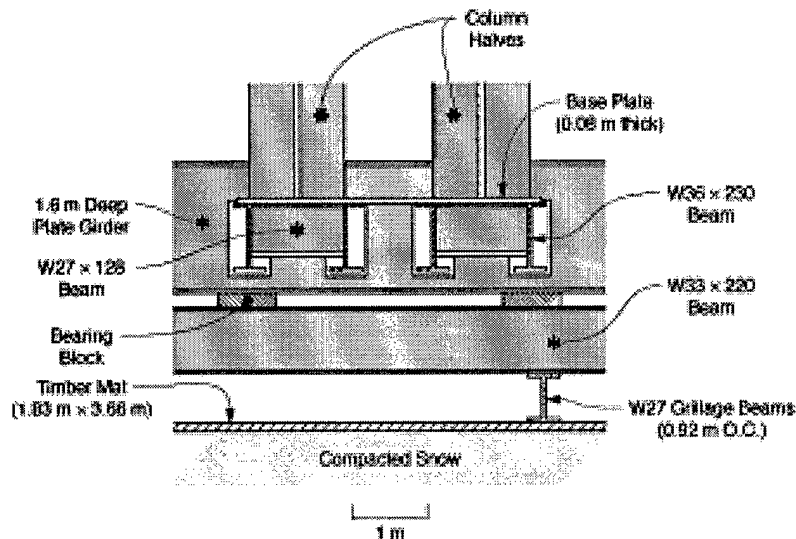
Figure 9. Column footings.

Differential settlement of the column footings is caused by differences in densification rates of the foundation snow beneath each column footing. At DYE-2, the snow was not of uniform consistency because of the presence of ice lenses of various sizes and thicknesses imbedded in the matrix of the snow. These "defects" were formed by snow melting and refreezing during the warm summer months and subsequent burial beneath drifted or fallen snow. Matrix density irregularities cause differences in the densification rate for a given load, and thus settlement irregu-

larities can occur beneath different columns. A column that settles more rapidly on its snow foundation will not support as much load as the adjoining columns, which then must assume a portion of the sunken column's load. Continued settlement will result in structural tilting and a redistribution of stresses. This results in increased stresses in the structure because of uneven loading and tilting.

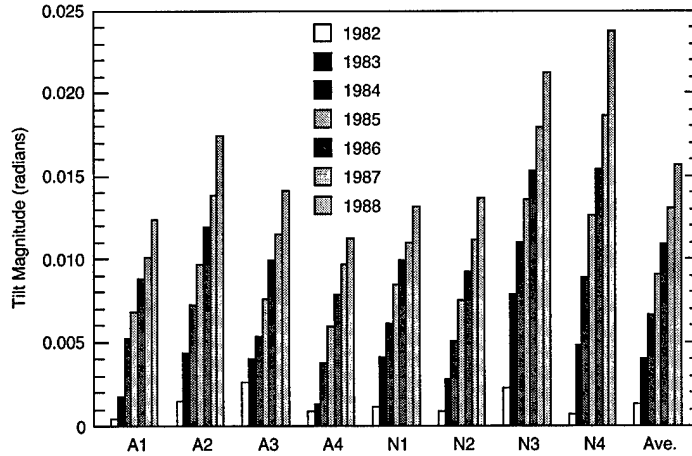
Figure 16. Footing tilts: 1982-1988.

Footing tilts correlated remarkably well with the settlement data at DYE-2. Table 4 contains resultants and directions for the footing tilt data for the years 1982 through 1988 for each column. Also included are the averages for all columns for each year. This is depicted graphically in Figure 16. Comparing Figure 13 to the data in Table 4 and Figure 16 shows that the footings are tilting in almost the same direction with the same magnitude as the columns: in a direction of  $313^\circ$  with a magnitude of approximately 0.015 radians. These values are too close to be coincidental. The rates of change are also very similar, approximately 0.0025 radians per year. Statistical analysis of the resultant averages shows a very high degree of linearity in the tilt progression:  $>0.997$ .

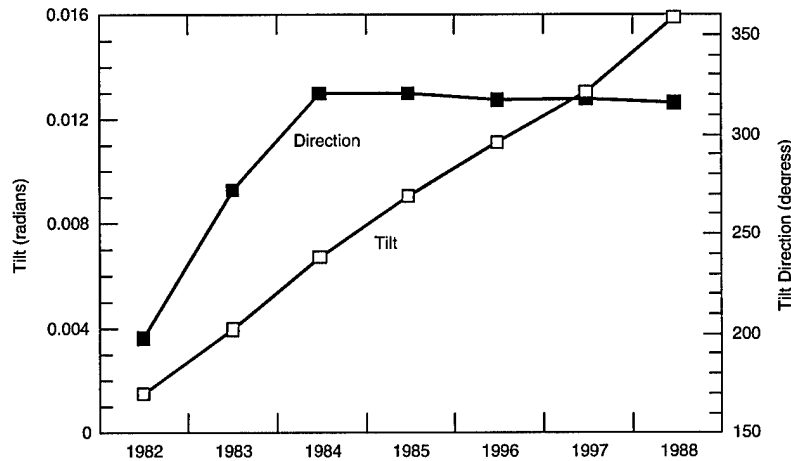
Figure 17. Footing tilt trends.

Figure 17 shows trends for the average tilt and direction for the footings. These should be compared to the footing settlement trends in Figure 14.
