**US Army Corps
of Engineers®**
Cold Regions Research &
Engineering Laboratory

Moisture in the Roofs of Cold Storage Buildings

Wayne Tobiasson and Alan Greatorex

SPECIAL REPORT

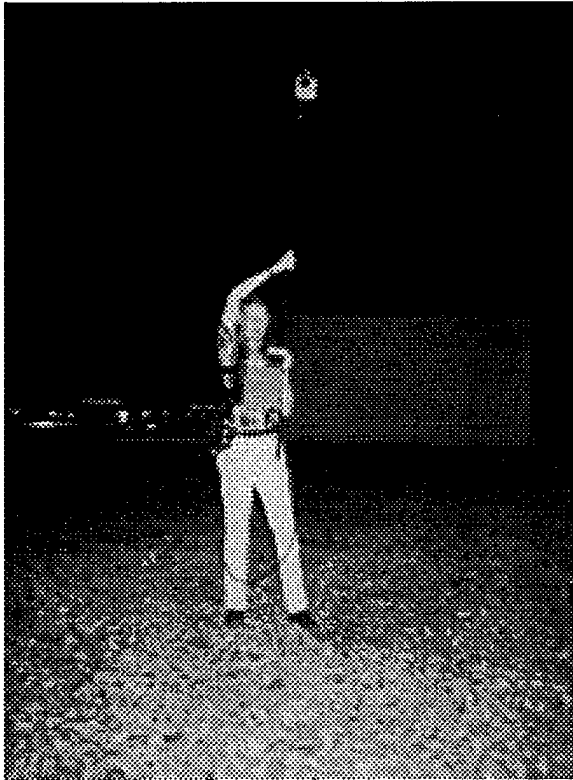
Figure 1. Conducting nighttime on-the-roof infrared roof moisture surveys. We found it quite valuable to observe the roof from as high a vantage point as possible.

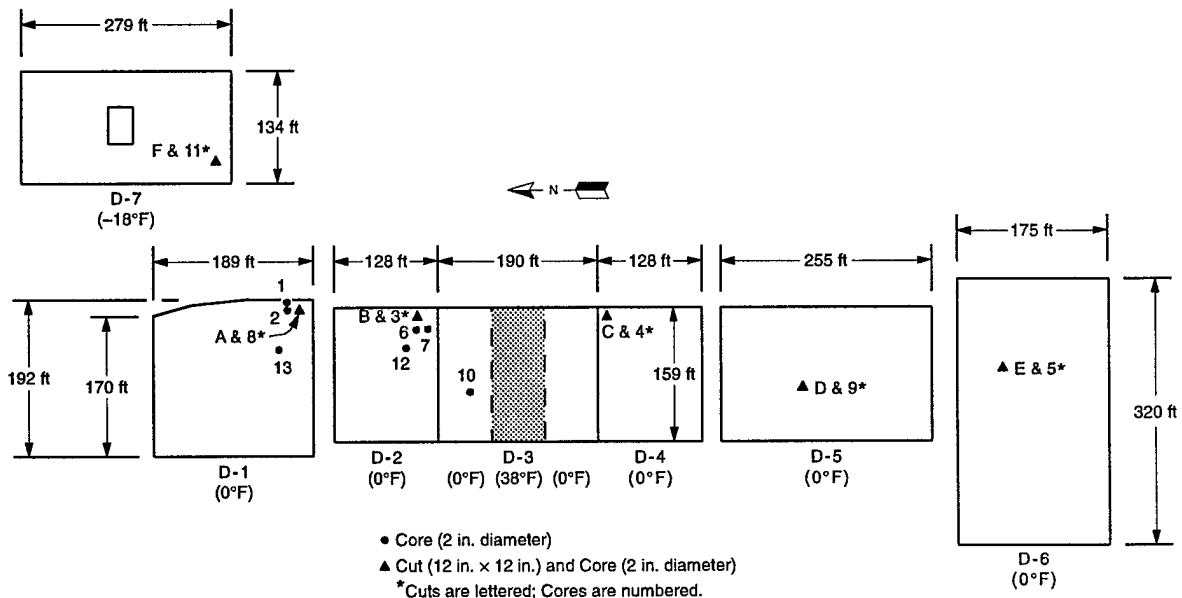
Figure 2. Plan view of the seven roofs examined in Dallas, Texas.

Bright areas were also detected by the infrared scanner in the southeast corner of this roof. Core samples 1, 2, and 8 and roof cut A were taken in this area (Fig. 2). Table 1 presents all core sample findings for this roof. The bottom 1 to 3 in. (2.5 to 7.6 cm) of fibrous glass insulation in this area was frozen "solid" (i.e., it was full of ice). Figure 8 shows the two areas of cleaned membrane where

Figure 2 shows where 12- × 12-in. roof cut A was made. Results of tests run on the components of that cut are presented in Table 2. Core 8 was taken at the same place as cut A. Both found the expanded polystyrene insulation and the upper layer of fibrous glass insulation to be dry. However, the lower layer of fibrous glass obtained in cut A contained considerably more moisture than the similar layer in core 8 (14.8% vs. 1% by weight). In all likelihood, some of the wet fibrous glass below was collected in the cut while it was all left behind in the core. Prior CRREL studies (Tobiasson et al. 1991) indicate that fibrous glass with a moisture content of 14.8% by weight would have about 93% of its dry insulating ability (i.e., it would have a Thermal Resistance Ratio [TRR] of 93%). However, the TRR obtained by measuring the insulating ability of these fibrous glass specimens before and after drying them was only 36%. Differing test

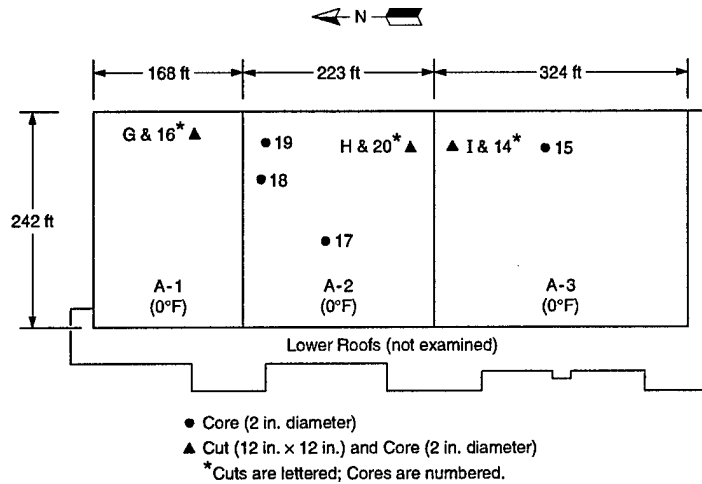
Figure 3. Plan view of the three roofs examined in Arlington, Texas.

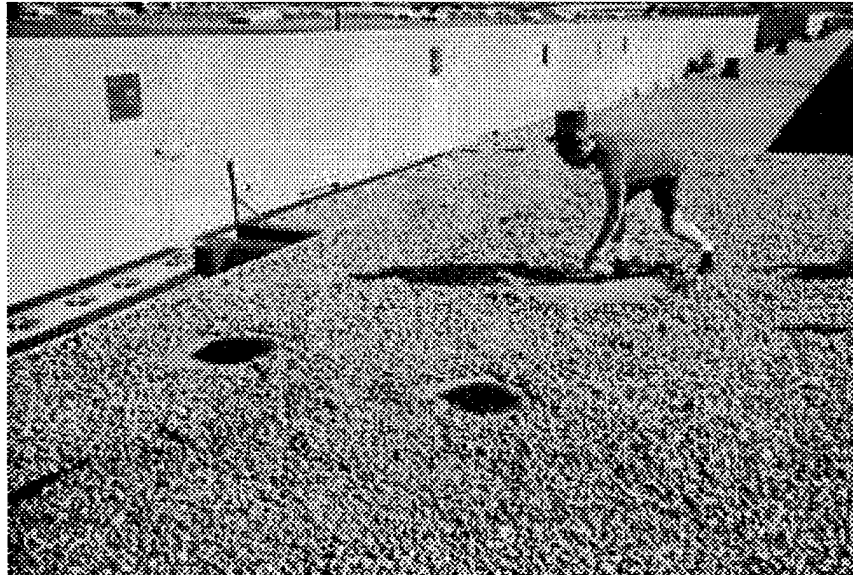
Figure 8. Southeast corner of roof D1 showing areas cleaned for cores 1 and 2 and a larger area being prepared for core 8 and cut A, looking SE.

cores 1 and 2 were subsequently taken. The individual is marking the area where core 8 and cut A were taken. Core 13, taken nearby where shown in Figure 2, was outside this bright (wet) area. All insulation was dry where core 13 was taken. Thus it appears that only a small area of wet (frozen) fibrous glass insulation is present in the southeast corner of this roof. No obvious flaw was uncovered that could be held responsible for this problem. It is likely that the flaw was in the old membrane, and the wetness has been present since the old bituminous built-up membrane was overlaid with additional insulation and a ballasted EPDM membrane. Because this moisture is located deep in the roof, not near its top, the thermal anomaly should have been dark not bright. Since it was bright, something else is happening here. One possibility is that moist, warm air is infiltrating into this portion of the roof below the old membrane.

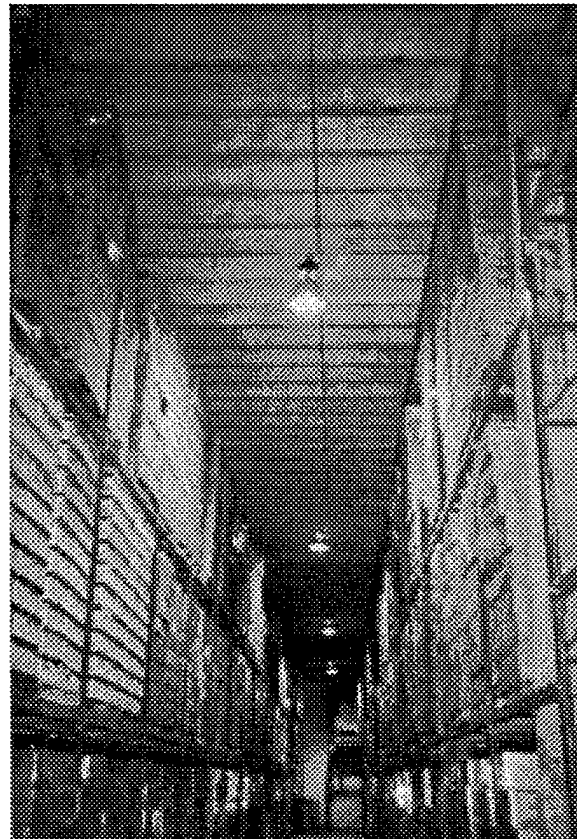
Figure 9. Interior view of the freezer below roof D1, which has a precast concrete deck.

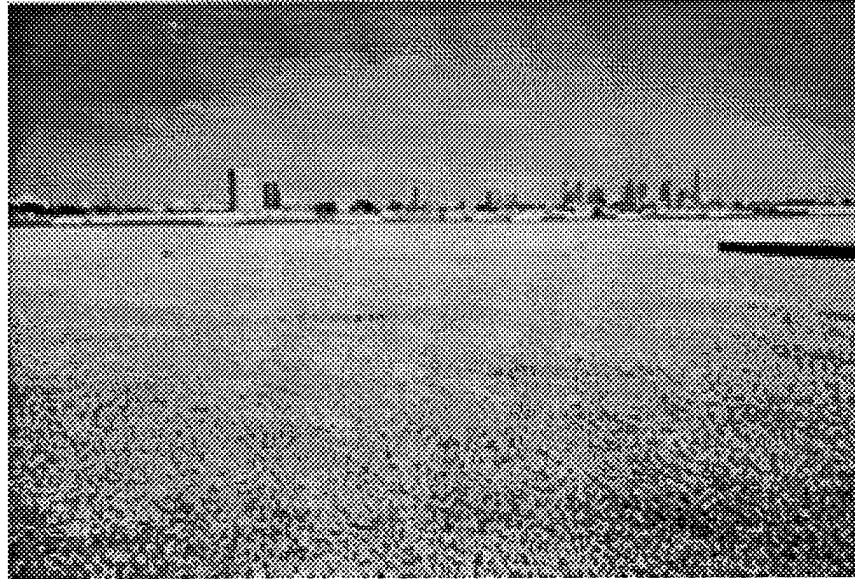
Figure 17. General view of roof D4 looking towards downtown Dallas (i.e., about southeast).

This roof consists of a ballasted EPDM membrane, expanded polystyrene insulation (2 in.), an old bituminous built-up membrane, fibrous glass insulation (7 in.), and a concrete deck. The temperature of the freezer below this roof was 0°F. A general view of this roof is shown in Figure 17. There were no bright or dark thermal anomalies on it. However, the infrared survey done within the freezer revealed extra brightness within a few feet (about a meter) of the northeast corner of this roof. That brightness was similar to that shown for roof D1 in Figure 11. We expect that it was caused by air infiltration not wet insulation. Core 4 and cut C were taken in this area to verify our suspicions. Core 4 findings are presented in Table 6 and cut C findings in Table 7. At core 4, a thin

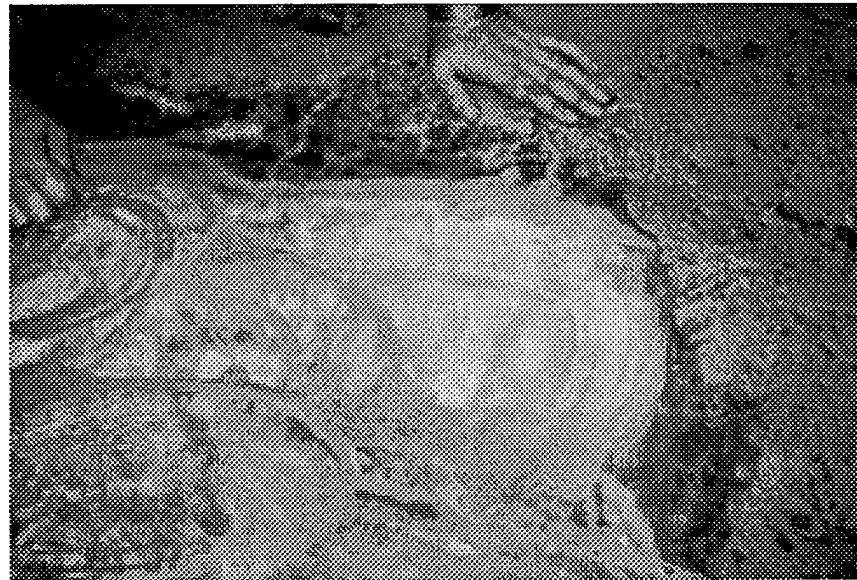
Figure 20. Cleaning the roof D5 Hypalon membrane before making cut D.

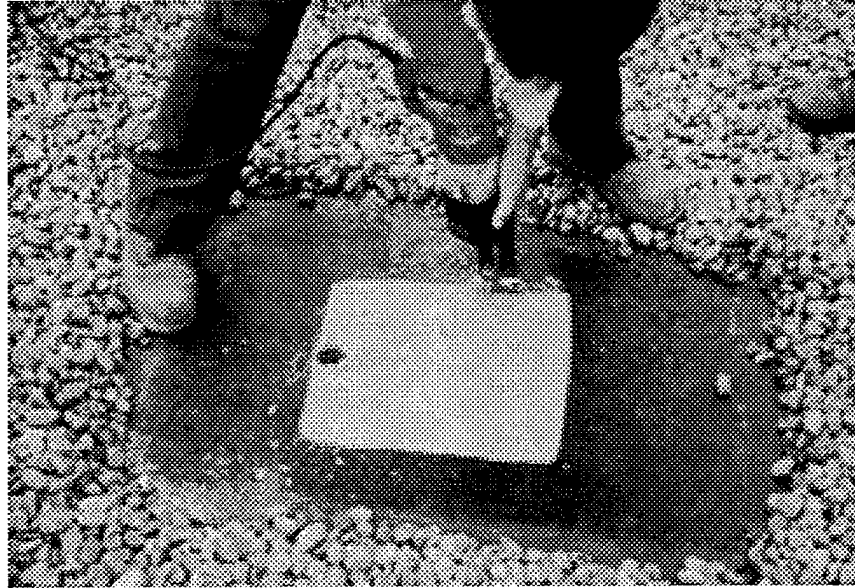
Figure 22. Hole where core 5 was taken and where cut E is being taken on roof D6.

No signs of entrapped moisture were detected during the infrared surveys of this roof. During the visual inspection, no membrane or flashing defects were noticed. Core 5 and cut E were taken where shown in Figure 2. Figure 22 shows cut E being taken where core 5 had been taken. Figure 23 shows the wall of the cut E hole. Table 10 presents findings for core 5 and Table 11 presents findings for cut E. All three types of insulation at this location were dry.

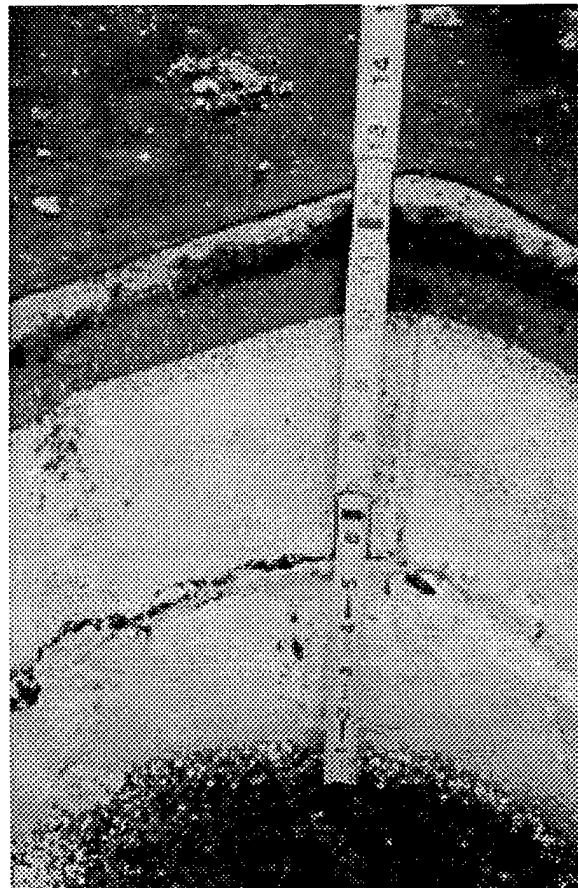
Figure 23. Cut E on roof D6 showing layers of wood fiber, perlite, and expanded polystyrene insulation.

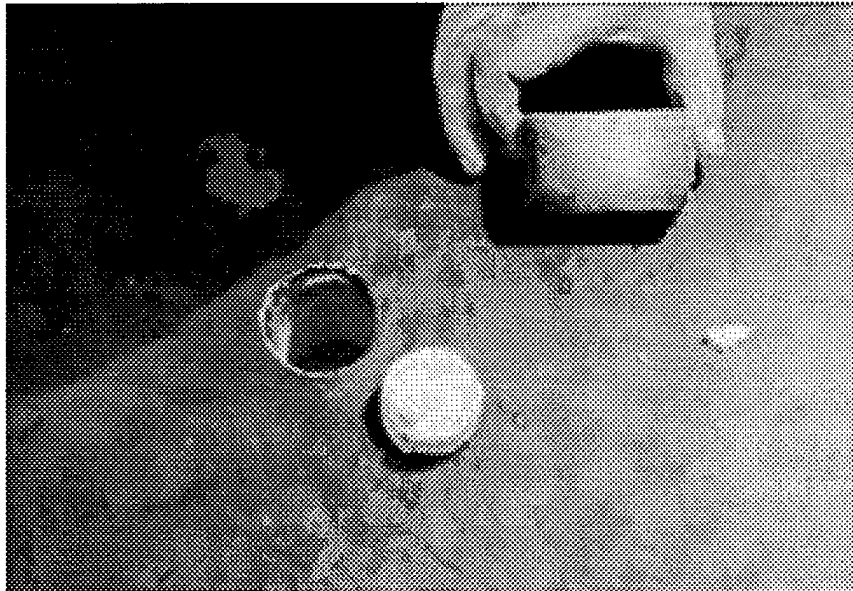
Figure 30. Upper layer of phenolic insulation at core 18.
