**AFRL-ML-WP-TR-1998-4191**

**CUT PROGRESSION DURING DYNAMOMETER  
TESTING OF FOREIGN OBJECT DAMAGED TYPE  
VII EXTRA HIGH PRESSURE AIRCRAFT TIRES  
SAE PAPER 912155**

**SEPTEMBER 1991**

**FINAL REPORT FOR 03/15/1984 – 06/15/1991**

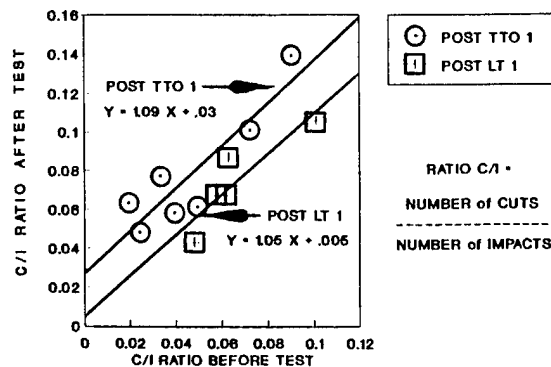
FIGURE 14: PERCENTAGE INCREASE in CUTS  
Recapped Tires

On return from NAEC, a ratio, of the number of cuts to the number of the objects impacted, ranged from 1.3 to 15%. After TTO 1, the range narrowed to 4.8 to 13.9%; some of the tires were not remapped after TTO 1. After LT 1, the range was 4.4 to 10.6%. The numerical data from Figure 13 is presented as this ratio, in Figure 14. The curves show positive slope and intercept again. The TTO 1 curve is above the LT 1 curve.

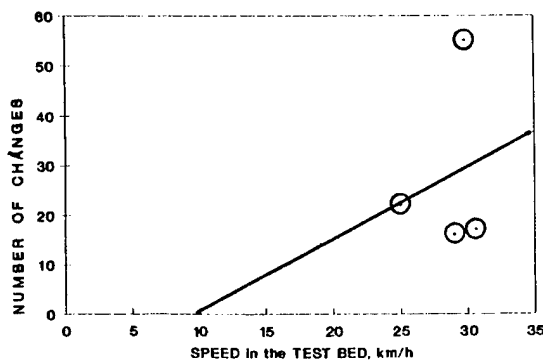
FIGURE 26: SPEED vs NUMBER of CUTS  
Radial Tires

The number of primary cuts produced is presented in Figure 26, as a function of speed in the test bed at NAEC. The "newer" design H-1, 2, and 3 produced 2/3's fewer cuts than the "earlier" design H-4. Of the 110 primary cuts on all four tires POST NAEC, one half of the cuts were on H-4. Because of the small number of tires, run in a small speed range, there is not enough data to draw a useful conclusion.

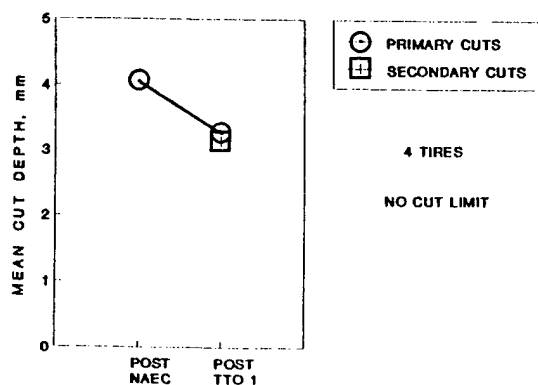
FIGURE 30: MEAN CUT DEPTH  
Radial Tires

The mean depth of primary and secondary cuts of all tires is presented in Figure 30. The data population is very small, and no useful conclusions may be drawn.
