# Repair of Damage to Marine Sandwich Structures: Part I – Static Testing

Rodney Thomson, Raoul Luescher and  
Ivan Grabovac

DSTO-TR-0736

*October 1998*

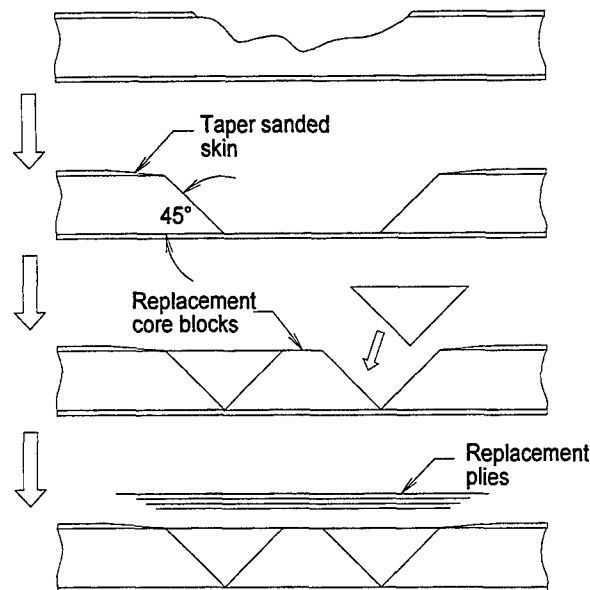
Figure 5: RAN method for the repair of Type B damage to GRP/foam sandwich panels.

Several features of the repair technique were difficult to perform. These related to the 45° bevel on the edge of the existing foam which needed to be accurate to ensure good fit of the replacement core and an even bondline thickness. It was found that the angle was difficult to maintain accurately on both the edge of the repair area and on the replacement foam. This difficulty would increase significantly under field conditions using hand held tools and on a repair with a curved profile.

1. *Remove Damaged Material.*
  - a) Remove the damaged skin, working from the centre of the damaged region outwards until sound material is encountered.
  - b) Remove the exposed damaged core leaving the other skin intact.
2. *Prepare the area for repair.*
  - a) Prepare the foam core to an angle of 45°.
  - b) Sand the edge of the laminate to a taper of 20 mm per layer. This provides a scarf angle of approximately 6°.

3. *Install the replacement foam.*
  - a) Use a paste adhesive designed to bond PVC foam.
  - b) Use the appropriate grade of foam.
  - c) Use the minimum amount of adhesive (bondline thickness 3 mm maximum).
  - d) No voids should exist between the undamaged skin and the replacement foam.
4. *Replace the skin.*
  - a) Use the same number of layers as the original skin.
  - b) Each successive layer is to be 40 mm longer and wider than the previous layer.
  - c) Apply one extra layer of GRP extending 100 mm beyond the extent of all damage.

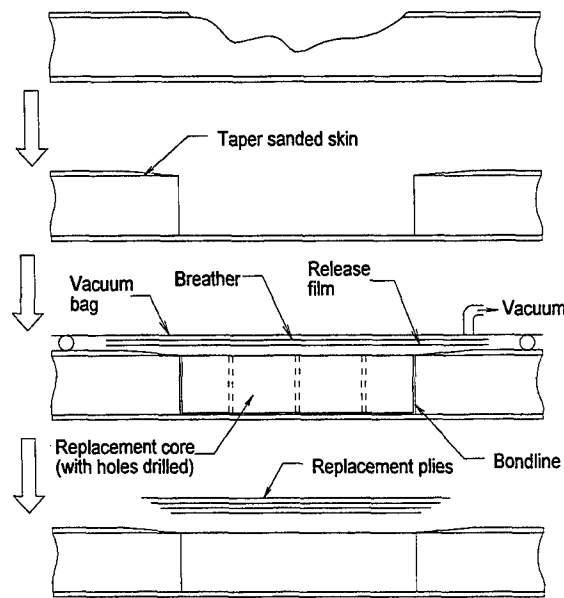
Figure 6: Modified method for the repair of Type B damage to GRP/foam sandwich panels.

5. *Replace the skin.*

- a) Use the same number of layers as the original skin.
- b) Each successive layer is to 40 mm longer and wider than the previous layer.
- c) Apply one extra layer of GRP extending 100 mm beyond the extent of all damage.

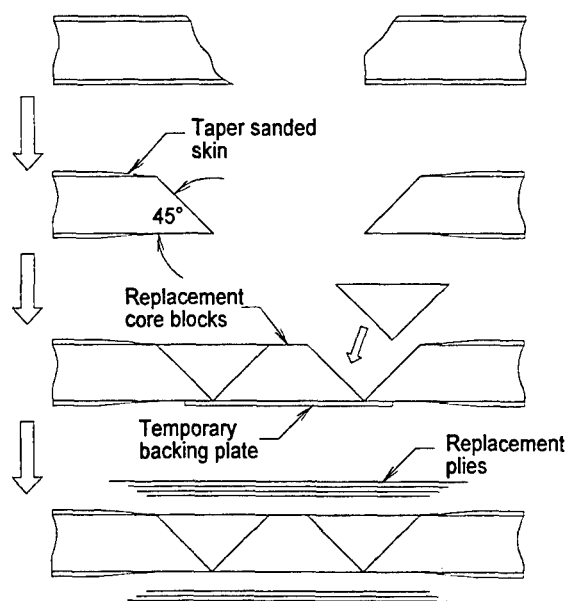
Figure 7: RAN method for the repair of Type C damage to GRP/foam sandwich panels.

In preparing the Type C repair test specimens, it was observed that the RAN technique was more time consuming and demanding to prepare. A real repair which could be elliptical in shape would be very difficult because of the 45° joins in the core. On the other hand, the modified technique was very straightforward to perform. A comparison of the strengths of the two Type C repair techniques is shown in Table 3 and Figure 23 for the 400 mm span tests. It is apparent that in general, both repair techniques effectively restored the strength of the specimens and, with respect to the effectiveness of the repairs from a strength perspective, little separates the two methods. However, the modified method proved to be superior from a processing viewpoint.

4. *Replace the skins.*

- a) Use the same number of layers as the original skin.
- b) Each successive layer is to be 40 mm longer and wider than the previous layer.
- c) Apply one extra layer of GRP extending 100 mm beyond the extent of all damage.

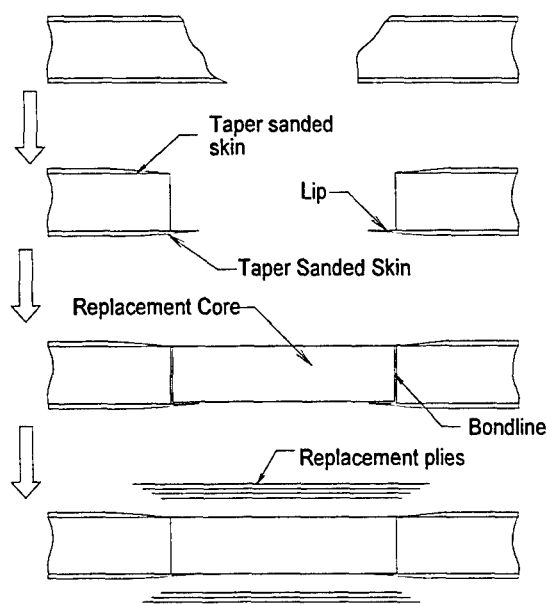
Figure 9: Modified method for the repair of Type C damage to GRP/foam sandwich panels.

- b) Use the appropriate grade of foam.
  - c) Cut a piece of foam, allowing 1 mm all round for the bondline.
  - d) Drill 3 mm diameter holes through the core into the bondline gap, as shown in Figure 8. The spacing of the holes should be twice the core thickness.

4. *Replace the skins.*

- a) Use the same number of layers as the original skins.
- b) Each successive layer is to be 40 mm longer and wider than the previous layer.
- c) Apply one extra layer of GRP extending 100 mm beyond the extent of all damage.

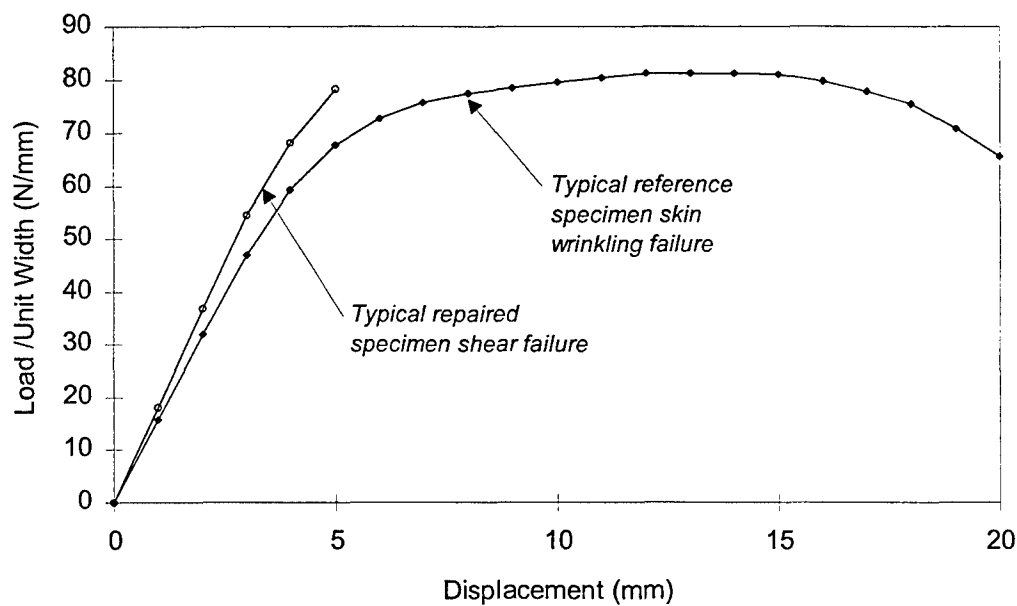
Figure 13: Typical load-displacement curves for reference and repaired specimens. (Displacement is the relative displacement between the loading and support points of the four-point bending fixture.)

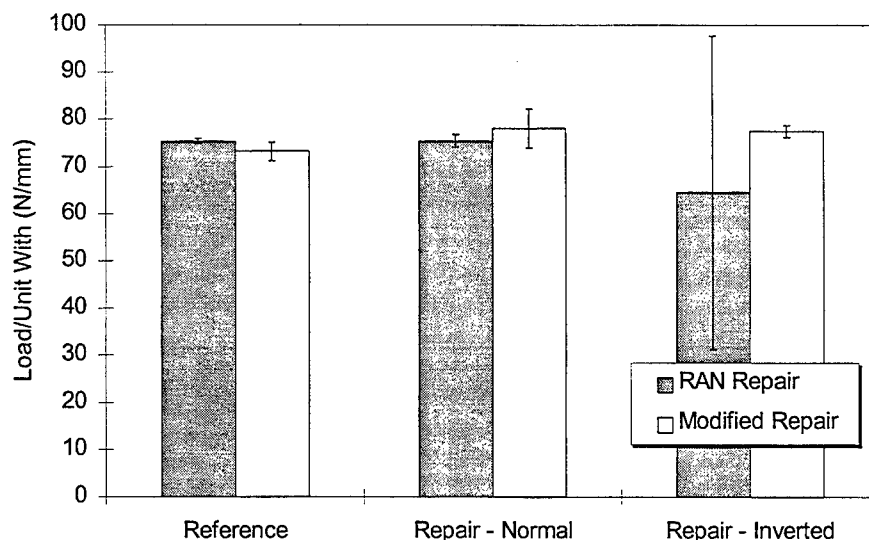
The strengths of specimens repaired using the modified Type B technique were generally greater than the reference specimens. The average strength of specimens tested in both positions was up to 10% greater than the reference standards. The scatter in the results was also very low. This indicates that the bond strength of the repair was adequate while the extra ply used in the repair added to the strength.

The stiffness of the repair was also of importance since an overly stiff repair could lead to load redistribution and the potential for failure at the edge of the repair. The stiffness of the RAN Type B repair technique under four-point bending was approximately 10% and 20% greater than the reference specimens when tested in the normal and inverted positions, respectively. The modified Type B repair technique was approximately 8% stiffer than the reference specimens in both positions. In the RAN technique, the 45° bondline increased the shear stiffness of the core by a small amount. However, the most significant increase in stiffness was due to the extra thickness of the repaired skin, which was identical for both repair techniques. The additional skin thickness reduced local indentation under the loading and support points during four-point bending. The scarf repair on the skin in the RAN repair extended further than in the modified technique and, in the inverted case, extended under the support rollers reducing the amount of indentation. It was therefore concluded that the stiffness under bending of the two repair techniques was very similar.

Figure 18: Bar graphs showing the average strength and standard deviation for Type B repaired four-point-bend specimens.

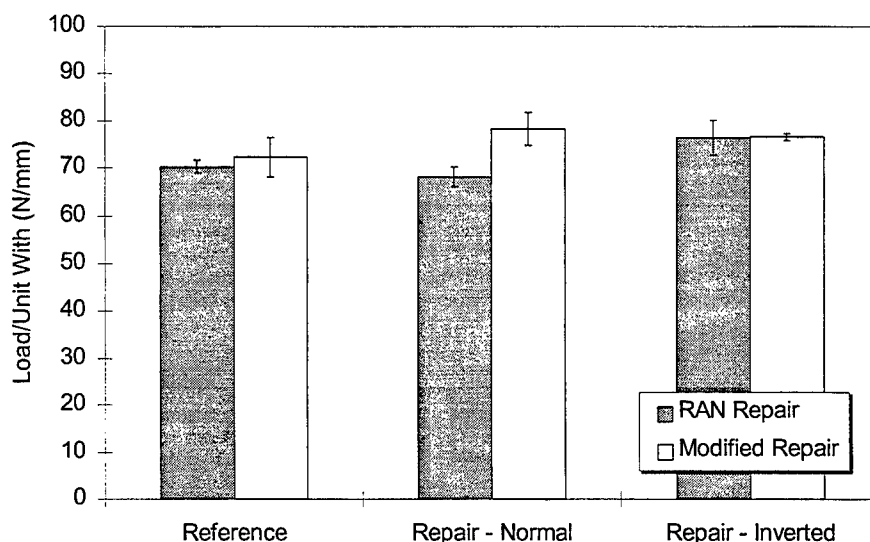
Figure 23: Bar graphs showing the average strength and standard deviation for Type C repaired four-point-bend specimens.

The strengths of the RAN repair technique for Type C damage were generally similar to, and in most cases greater than, reference standards. The reduced strength of some specimens was attributed to interface failure along the 45° bondline under compression. This indicated that the bondline between the existing and replacement core was the weak link in this repair. The standard deviation for the strengths was less than 5% in all cases indicating consistent repair quality.
