AFRL-PR-WP-TR-1998-2119

Investigation of TESCOM Driveshaft Assembly
Failure

James A. Kenyon

October 1998

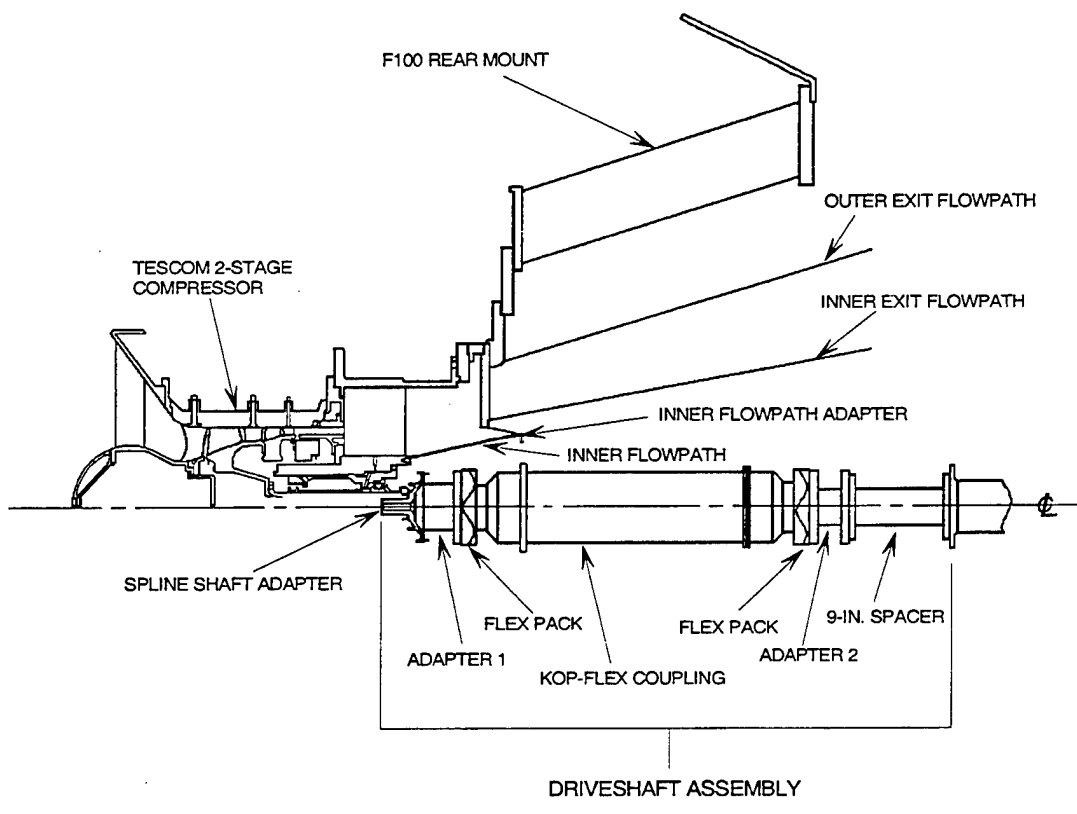
Figure 1.5. TESCOM driveshaft assembly.

The compressor drive system consists of the driveshaft assembly and the balance piston. The compressor drive system is shown in more detail in Figure 1.5. Several new drive system components were required to adapt the test compressor to the CRF drive system. These new components included adapter 1, between the spline shaft adapter and the forward flex-pack, as well as the Kop-Flex coupling spacer between the flex-packs. Upon assembly of the rig in the chamber, it was determined that the compressor driveshaft assembly was 9 inches too short to connect to the CRF main driveshaft. To

alleviate this disparity, a 9-inch spacer was fabricated and installed between adapter 2 and the CRF jackshaft. The effect of this additional spacer on drive system dynamics was not determined prior to testing.

The driveshaft assembly also serves as the wireway for lead wires to blade-mounted instrumentation on the test compressor. For TESCOM, this consisted of strain gages on rotor 2 blades. The lead wires from the strain gage were passed through the hollow center of the driveshaft assembly. A foam filler was sprayed into the hollow areas of the driveshaft assembly to hold the strain gage leads in place along the centerline of the assembly.
