**US Army Corps  
of Engineers**

USACERL Technical Report 99/28  
February 1999

# **Engineering Life-Cycle Cost Comparison Study of Barrier Fencing Systems**

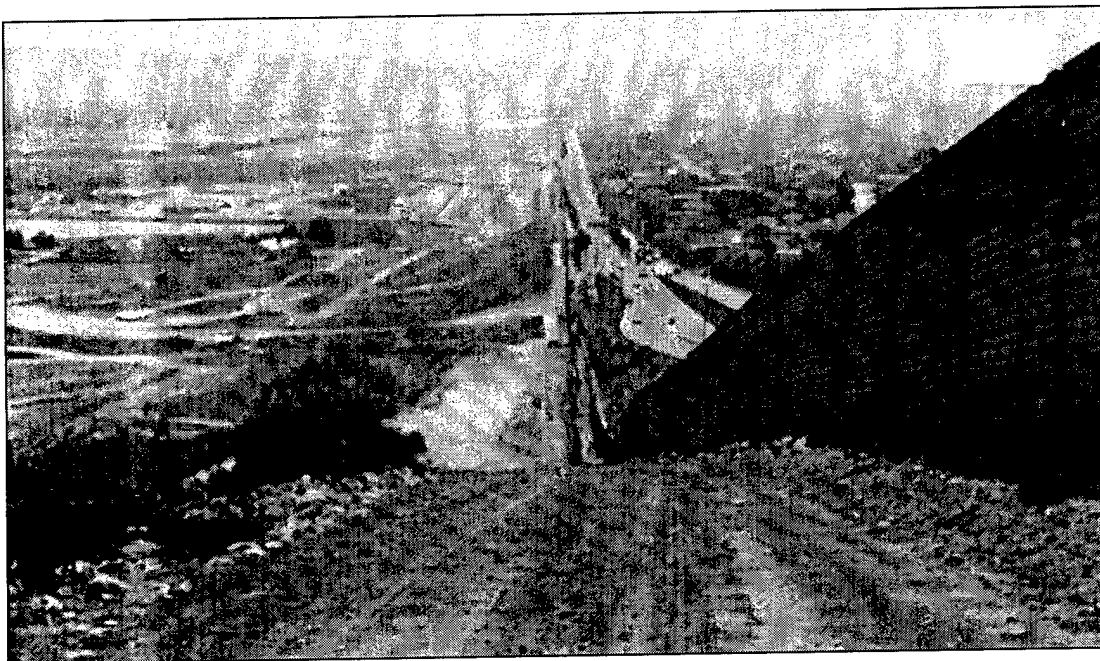
Figure B.14 shows the flat region between the San Ysidro border entry and the hills. The United States is to the left of the fence, and a sewage treatment plant is visible in the distance. The secondary bollard fence will be installed on the lower terrain 100-ft north and at a 30-degree angle to the primary fence. The closeness of the Mexican highway and buildings to the fence is apparent. The flat ground and proximity to San Diego's southern suburbs make this a high traffic area for illegal immigration. The ground shown in Figure B.15 will become a retention pond. North of the sewage treatment plant is the maintenance base camp. The fence continues to the Tijuana levee.

Figure B.14. View of the flat ground west of the San Ysidro border entry point.

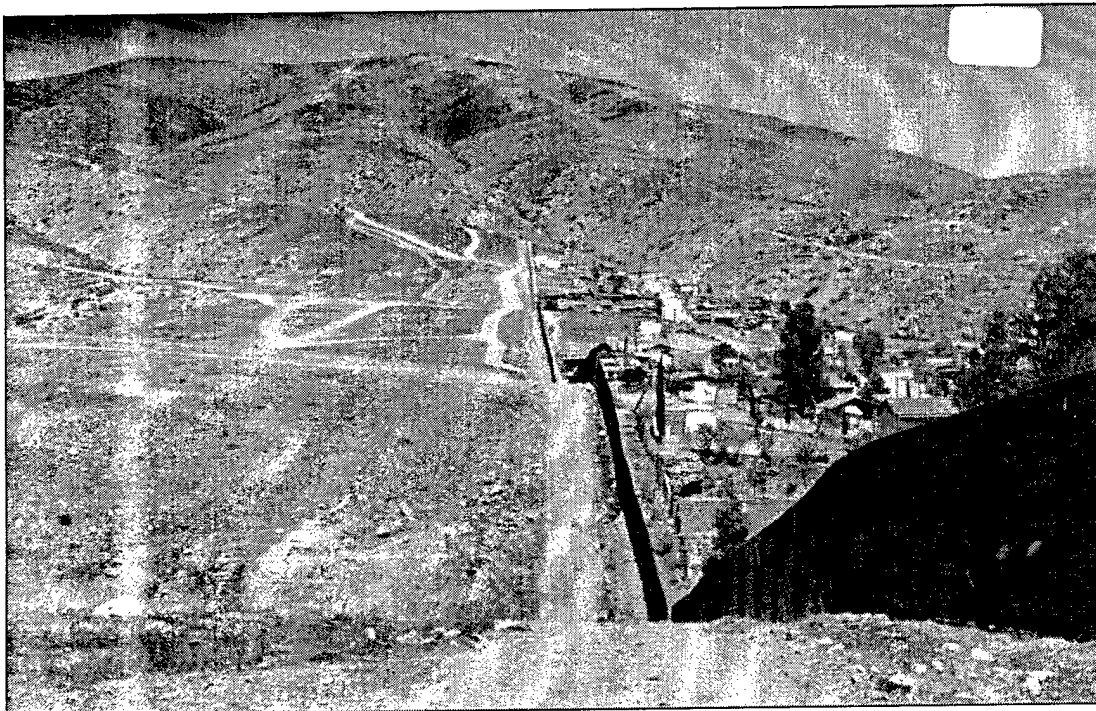
**Figure B.26. The last mile of fence in the Otay hills.**

The final mile of fence running to the Otay hills is shown in Figure B.26. The hilly terrain makes fence construction difficult. Gaps at the base of the fence (seen in Figure B.27) show the ease with which fence penetration can occur by burrowing under. The loose soil erodes easily from the fence footings. A break between sections is also seen at the bottom of the hill. Figure B.28 shows the end of the fence looking into Mexico. Pathways worn by walking and driving around the fence (at the left of the picture) are visible to onsite inspectors. The inland expansion of Tijuana is shown in the distance.
