Technical Report ARWEC-TR-99002

**METALLURGICAL FAILURE ANALYSIS OF THE M230
MACHINE GUN BARREL – MIF-A-001-1999-I**

June 1999

U.S. ARMY ARMAMENT RESEARCH, DEVELOPMENT AND
ENGINEERING CENTER

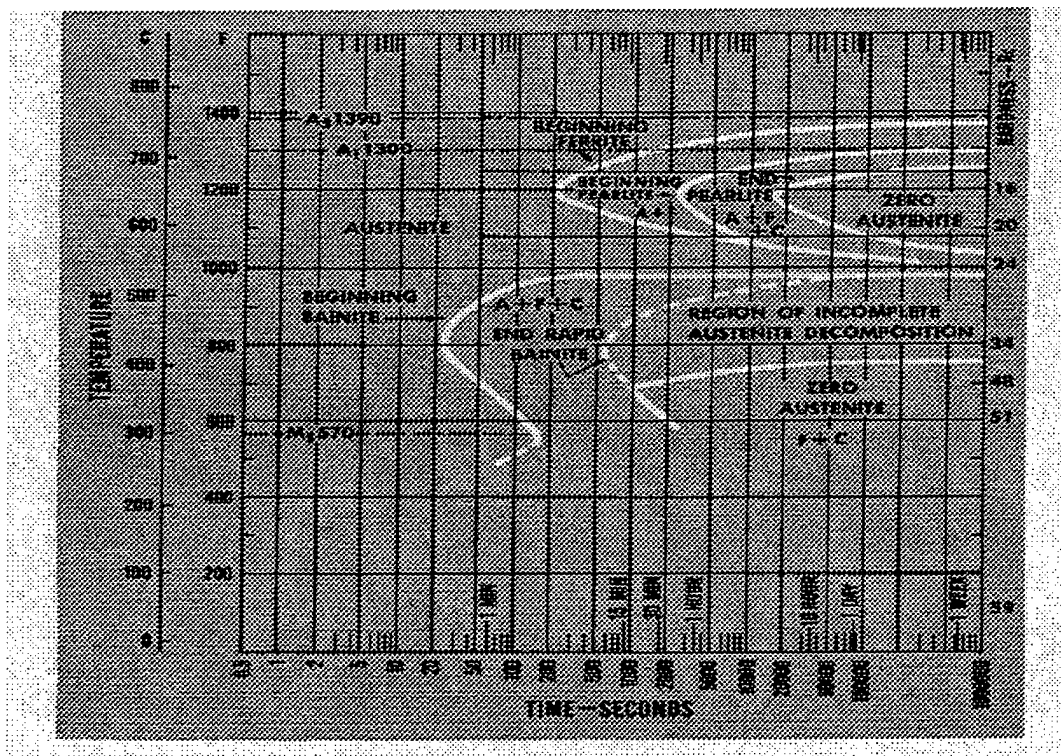
Figure 9
Transformation temperature versus time for medium carbon alloy steels^a

The change in the microstructures from tempered martensite to bainite and untempered martensite coupled with the increase in hardness values seen at the holes where the projectiles exited, supports the theory that the gun barrel steel exceeded the austenitizing temperature and then air cooled. A transformation temperature versus time (TTT) diagram is shown in figure 9. This diagram shows that the austenitizing temperature is 1390°F. The barrel may have gotten hotter than 1390°F, but with the various temperatures throughout the barrel and the subsequent variable quenching rates, it is difficult to pin down exactly how hot the barrel got in different areas.

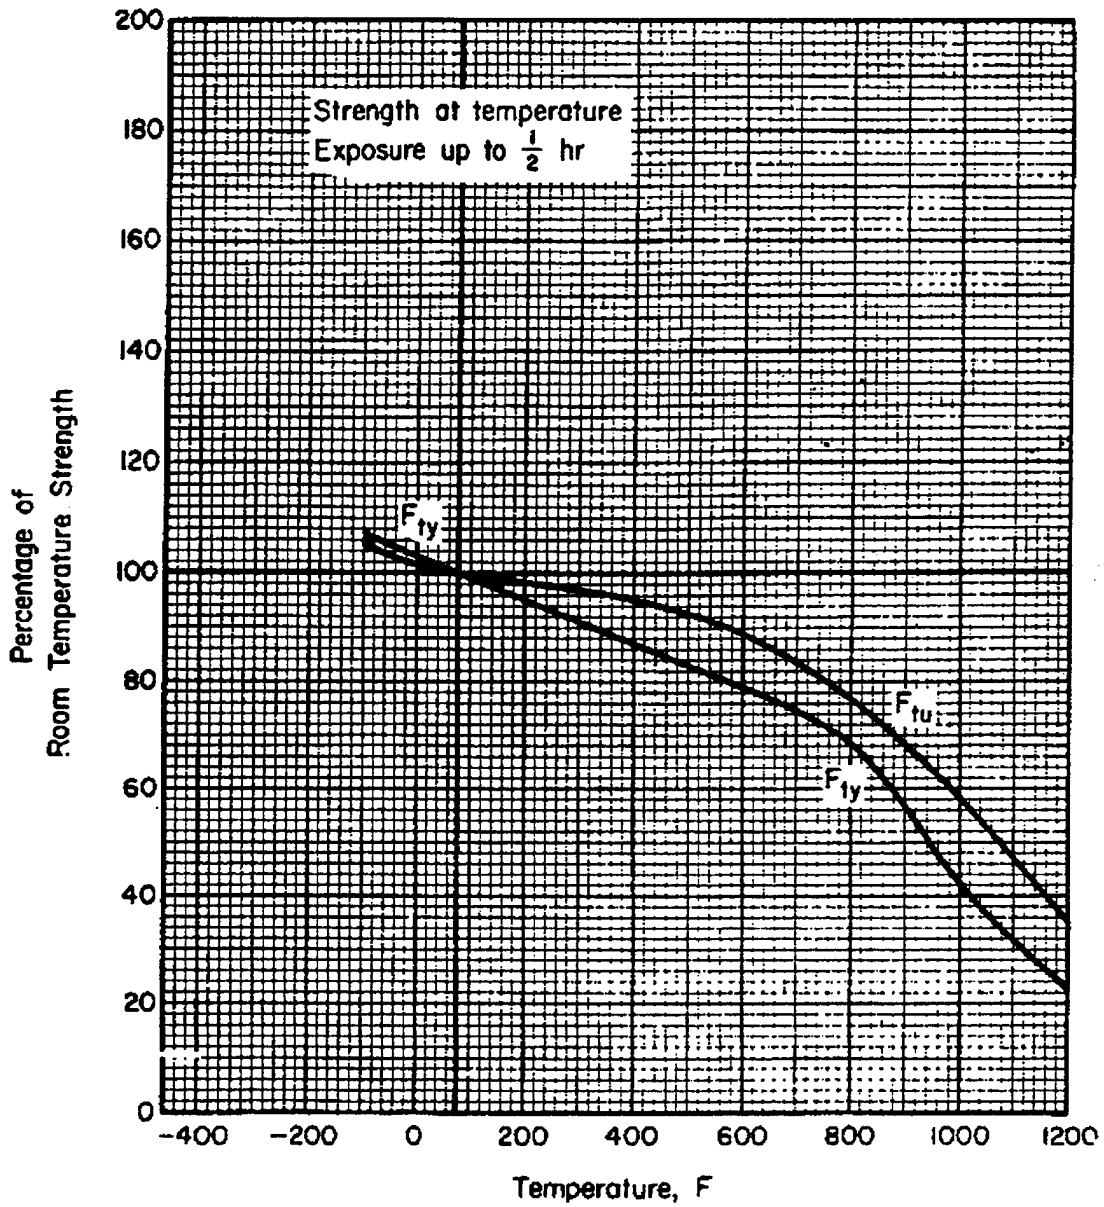
Figure 10
Effect of temperature on the tensile ultimate strength (F_{tu}) and tensile yield Strength (F_{ty}) of AISI low-alloy steels (all products)

Once the barrel steel exceeds the austenitizing temperature, the hot tensile strength plummets (fig. 10). This diagram shows that at 1200°F, the barrel steel has only 35% of the room temperature ultimate tensile strength. Room temperature strength values are given in table 1. Thus, at 1,200°F the yield strength of the steel is 40 ksi maximum with the chances being that the yield strength is actually far lower than that at the austenitizing temperature of 1,390°F.
