---TECHNICAL REPORT---

No. 13755

Test and Evaluation of the
LMTV Driveline
1998

U.S. Army Tank-Automotive Research,
Development, and Engineering Center
Detroit Arsenal
Warren, Michigan 48397-5000

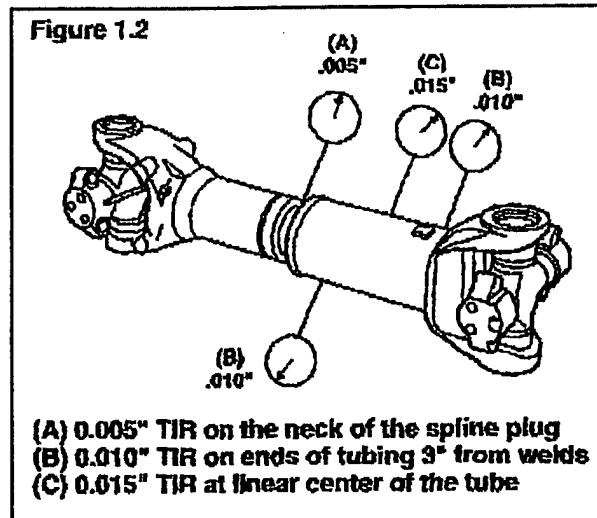
Figure 1 - Driveshaft Runout Specifications

When checking with the PM's office regarding this finding, it was revealed that the shaft did meet the specifications for balance as provided by the manufacturer, Meritor, but did not meet the specification for runout. The Meritor specifications stated for balance that a value of 2.06 inch-ounces is the maximum on the slip end and 1.49 inch-ounces is the maximum on the weld yoke end. Runout values that should not be exceeded are 0.005 inches on the spline plug, 0.015 inches in the center and 0.010 inches on the weld side. Refer to figure 1 for the visual locations of these values as specified by the manufacturer.

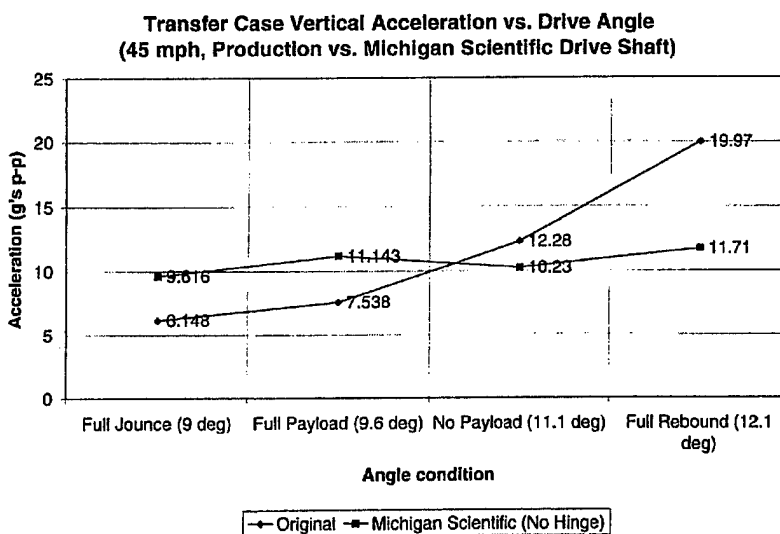
Figure 11 - Comparison of Vertical Accelerations in Resonant Range

The data for both the MSC driveshaft and the production driveshaft indicated marked increase in acceleration levels as the driveline angle increased. The MSC driveshaft, with the elimination of the hinging effect, proved more effective than the production driveshaft with nylon thrust washers in the resonant frequency range at the high angles. Outside of the resonant range and high angles, no particular driveshaft had an advantage all the time. Figure 11 shows a visual representation of the performance of these two shafts within a resonant frequency range measuring g-loads from peak to peak.

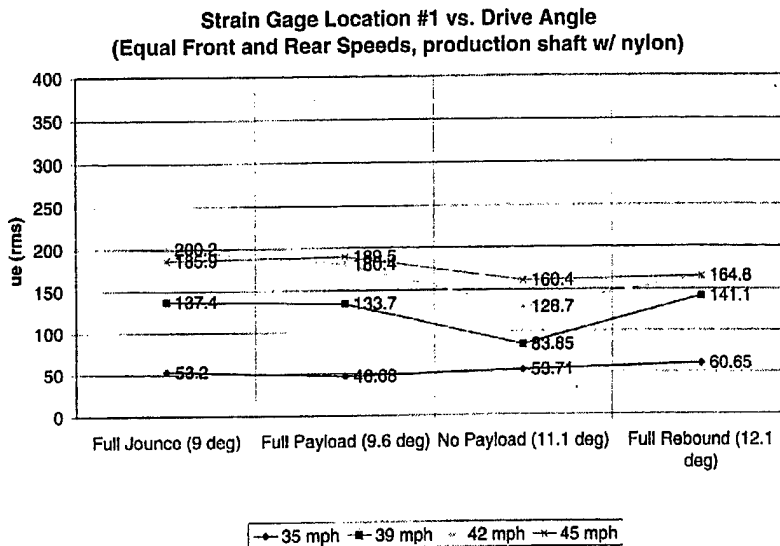
Figure 12 - Production Flywheel Housing strain versus speed and angle

The flywheel housing strain, measured at strain gauge one, does not appear to be effected by drivetrain angle. What does affect the flywheel housing strain appears to be the speed at which the vehicle is moving. From figure 12, it is visible that this type of relationship exists.

Reduced speed then is the key issue behind keeping the strain levels down on the flywheel housing while a reduced driveline angle is the key to keeping the accelerations down at the transfer case universal joint.
