**F-111 Bonded Panel Repair
Status**

DSTO-TR-0803

**Maritime Platforms Division
Aeronautical and Maritime Research Laboratory**

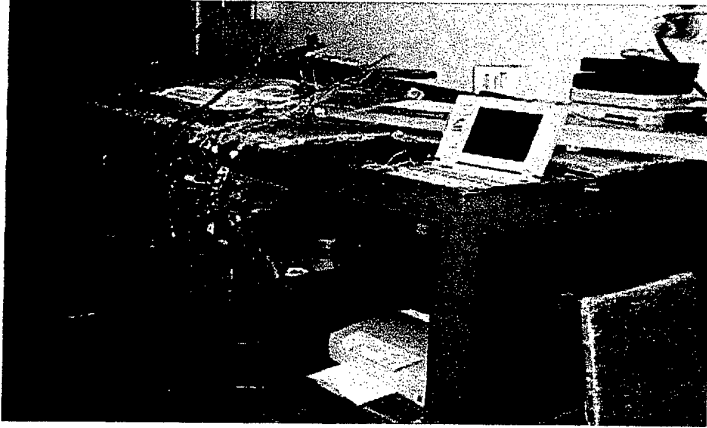
The routed area then has a moisture evacuation performed at 85°C and -75kPa with 6 thermocouples and a heater blanket either side of the repair area, refer figure A-2.0.

Figure A-2 Moisture evacuation of the repair area using the vacuum bag, heater blanket arrangement, using a hot-bonder unit HBC-43 from Novatech®.

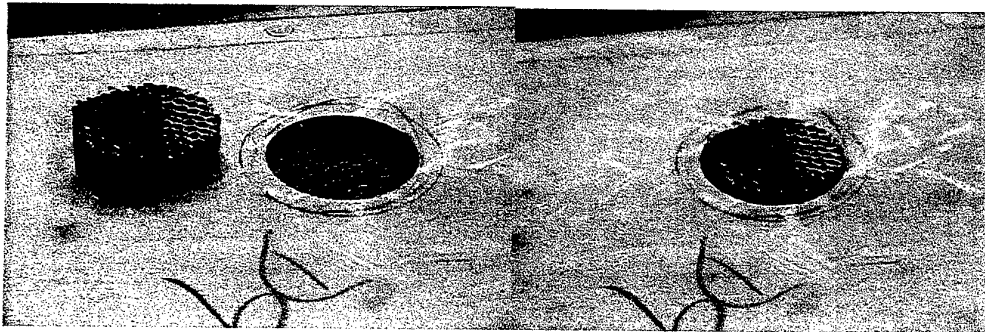
Before moisture evacuation a piece of honeycomb plug is carefully cut to shape which is 10mm thicker than the skin level, as indicated in figure A-3.0.

Figure A-3 The core plug insert used to repair the routed core

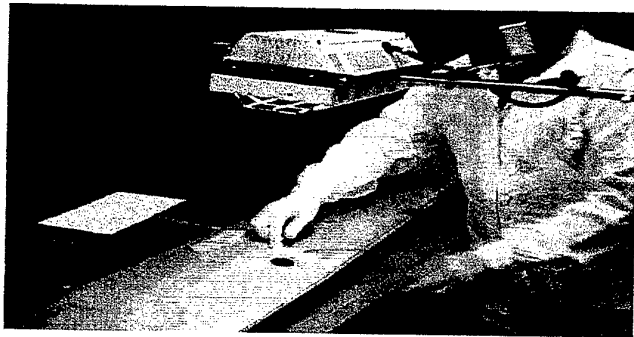
The core plug is then flushed with methyl ethyl ketone (MEK), analytical reagent and dried at 110°C for 2 hours using an oven. The routed area of core on the panel is also flushed with MEK and an infrared lamp is used to dry the repair area at 110°C for 2 hours.

Figure A-4 Infrared heating of core after MEK flush.

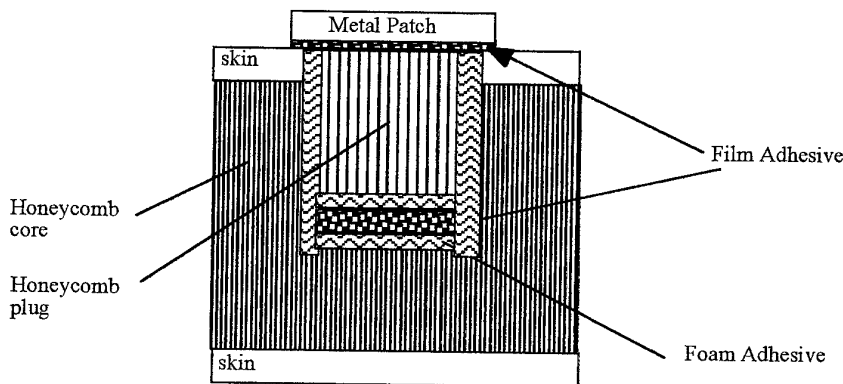
After the drying of the plug insert, pre-thawed foaming and film adhesive are cut to shape and applied to the plug insert as shown in figure A-5.0. Once the core area on the panel is dried, the plug and adhesive are applied to the routed core area. The plug insert is cured initially, as shown in figure A-6.0, and the metallic patch is applied as the final step of the repair, figure A-7.0.

Figure A-5 Diagram indicating the details of the plug adhesion process. Step 1 involves curing the plug in place. Step 2 involves application of the metallic patch.

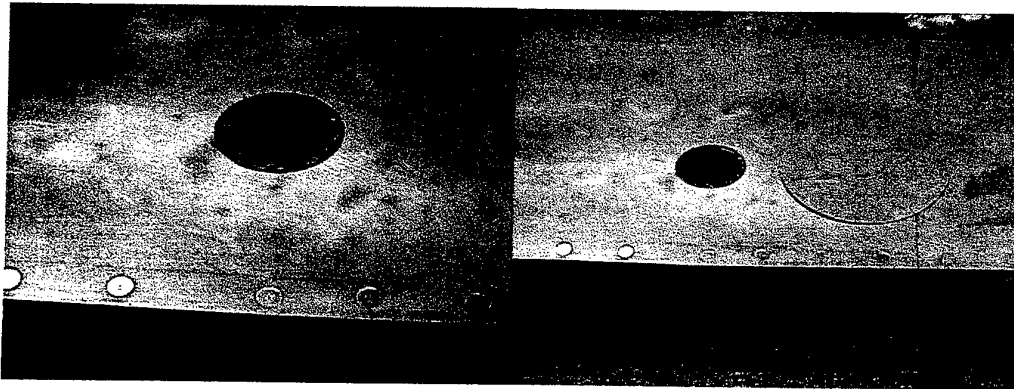
Figure A-7 The plug is sanded back to flush with the skin level and a metallic patch is applied using FM-300 film adhesive.

The skin surface and metallic patch are pre-treated with the standard grit-blast silane process and dried at 110°C for two hours. FM-300 film adhesive is then cured at 160°C for 1 and ¾ hours using the standard vacuum bag procedure.
