| <div style="border-bottom: 1px solid black; display: inline-block; margin-bottom: 5px;">DEC 93-12</div> DOCUMENT IDENTIFICATION<br>DEC 93 | | DISTRIBUTION STATEMENT A<br>Approved for Public Release<br>Distribution Unlimited | | | | | | | | | | | | | | | | | | | | | | | | | | | | | | | | | | | | | | | | | |

- UH-1
- H-60
- AH-1
- AH-64
- H-47D/E
- OH-58A/C
- OH-58D
- Fixed Wing

This report is in nine sections. Section I describes overall Army aviation experience. Sections II through IX provide overviews of the accident experience of each aircraft system, along with synopses of selected accidents and accident-prevention measures. Note that these synopses do not necessarily reflect all factors contributing to the accident; they concentrate on the primary cause or risk management failure.

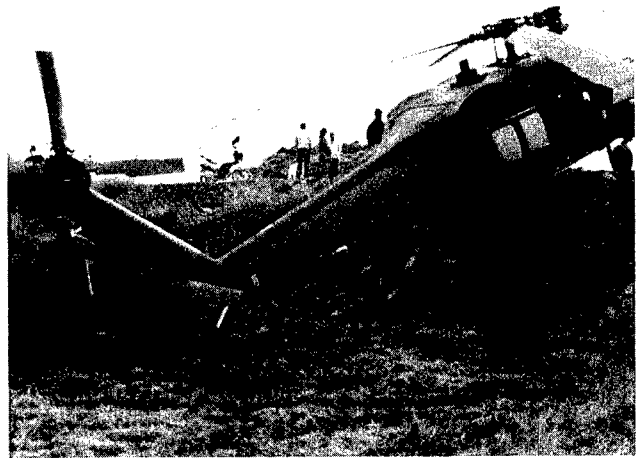
■ **Result:** Damage cost of \$295,004.

■ **Cause:** Crew failed to anticipate and correctly identify an in-flight hazard.

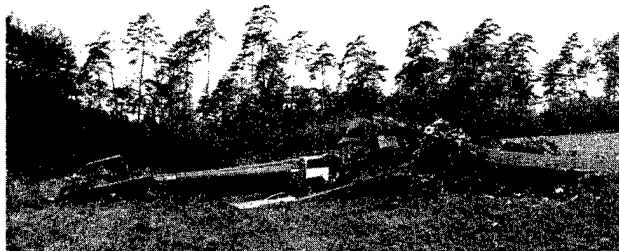
**Scenario 1.** Following a night low-level, deep-attack training mission using night vision systems, Chalk 4 in a flight of four struck a 3/4-inch multistrand cable on the return route from the battle position. The aircraft crashed in a 36-degree nose-low, 34-degree right-roll attitude onto the top of a berm.

- **Result:** Two fatalities, a destroyed aircraft, and a cost of \$12,500,000.

- **Cause:** Failure to adequately search the field of view for hazards.

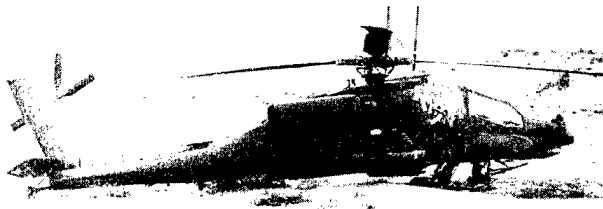
- **Result:** Damage cost of \$975,893.

- **Cause:** Inadequate attention as to their

position off the lead aircraft and the terrain over which they were operating. The aircraft descended below the minimum altitude required by the unit tactical standing operating procedures, which would have kept them clear of the wires.

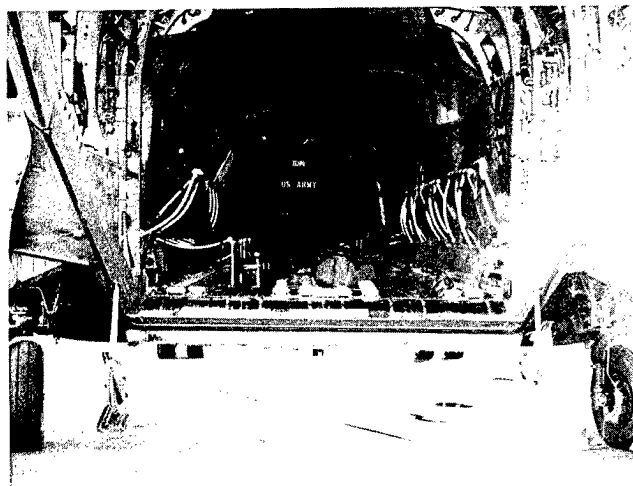
**Scenario 2.** The aircraft was on a low-altitude and low airspeed night aided approach to the water for a helocast operation. The ramp, with a Zodiac water craft attached, was lowered for the drop. At

approximately 10 feet, the PI attempted to slow the aircraft to the drop speed of 10 knots. An aft drift was detected by the crew, and as the IP initiated corrective action, the ramp entered the water. On impact, a significant amount of water entered the aft cabin section. As the aircraft came out of the water, the ramp broke away taking the Zodiac with it. Appropriate emergency procedures were accomplished, the Zodiac was recovered, and the aircraft returned to home station.

■ **Result:** Damage cost of \$287,627.

■ **Cause:** The IP and the PI lacked adequate training, and the IP failed to maintain the desired speed and height over the water. None of the crewmembers had ever attempted to perform a helocast/soft-duck operation in open water while under NVGs. The mission was part of the battalion's METL, but a special mission task had not been developed to facilitate implementation of training and enforcement of standards of performance to be met before crewmembers could be certified for the various duty positions on this mission.

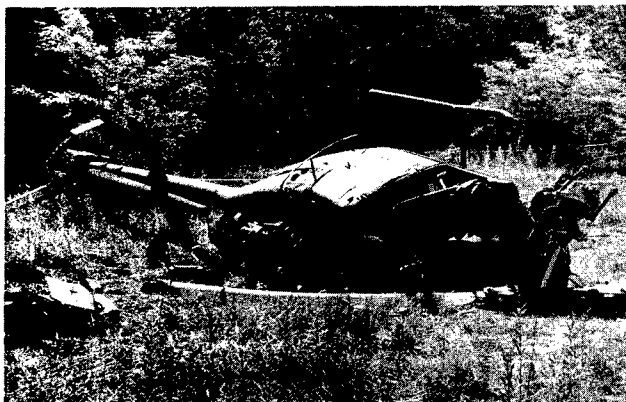
**Scenario 1.** While attempting a takeoff to a hover from level terrain at a field site, the IP did not properly coordinate his flight controls to establish a vertical ascent as required by TC 1-215, Task 1017. He failed to adjust cyclic input to establish a vertical ascent with the aircraft, which he knew was right-side heavy, and then did not reduce the collective pitch control in time to correct for the developing dynamic rollover condition. As a result, the right roll progressed beyond the aircraft's critical rollover angle and the main rotor blades made ground contact with a 2-foot embankment on the right side of the aircraft.

■ **Result:** A destroyed aircraft and cost of \$92,290.

■ **Cause:** Failure of the IP to adjust cyclic input to establish vertical ascent. The IP's actions resulted from his failure to observe the aircraft roll rate as the left skid left the ground. Contributing to the IP's distraction was his attempt to get the AO to monitor the engine turbine outlet temperature during the takeoff.

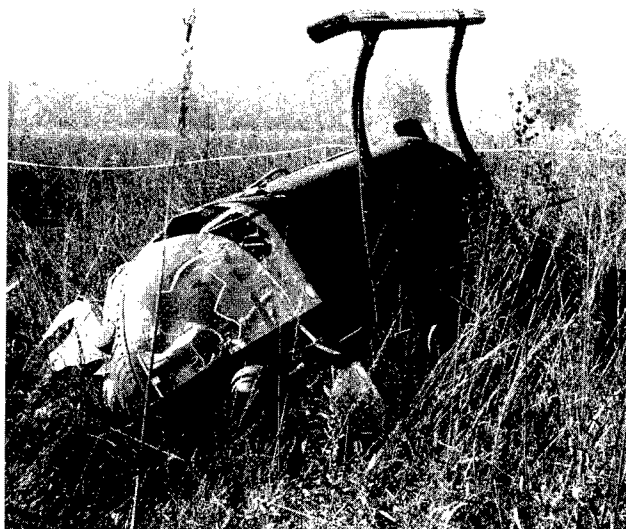
**Scenario 2:** During a night-aided landing in tall grass, the PC became spatially disoriented and misinterpreted the aircraft's actions. The blowing tall grass and the lack of visual cues, in conjunction with a perceived slope, resulted in the PC becoming spatially disoriented. As a result, he permitted the aircraft to roll right to the point the main rotor blades made ground contact.

■ **Result:** A destroyed aircraft and a cost of \$93,335.

■ **Cause:** Spatial disorientation and overconfidence. Due to the repetitive nature of the missions in which he had been involved for the past 10 days, his more than 100 hours of experience with NVGs, and his awareness of the successful landing of an aircraft in the same area a short time earlier, the PC was lulled into a complacent state of well-being. This business-as-usual attitude contributed to his misinterpretation of what the aircraft was doing as well as a breakdown in crew coordination.

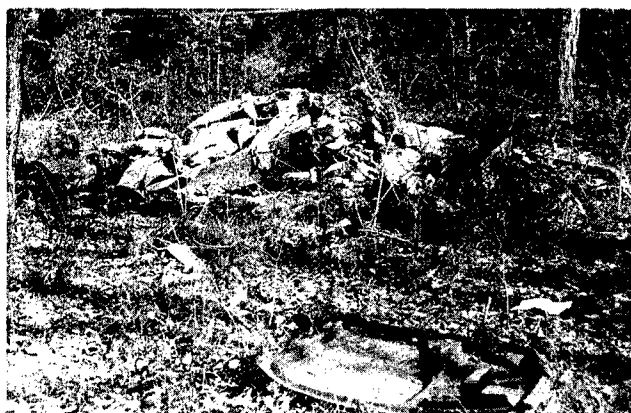
**Scenario 1.** While flying at between 600 and 800 feet above ground level and at 110 to 115 knots, the PC willfully violated AR 95-1: Flight Regulation, paragraph 2-10 by conducting an unauthorized aerobatics maneuver—a right roll in excess of 90 degrees. As a result, the aircraft rolled inverted and entered a steep dive. The PC was unable to regain control of the aircraft before it impacted trees. The PC had been verbally counseled while at the National Training Center for flying too low and exceeding limitations during turns. The PC had also been observed performing unauthorized maneuvers (steep cyclic climbs with negative "G" dives) 2 days before the accident.

■ **Result:** Two injuries, a destroyed aircraft, and a cost of \$3,891,844.

■ **Cause:** The PC was attempting to perform an unauthorized maneuver.

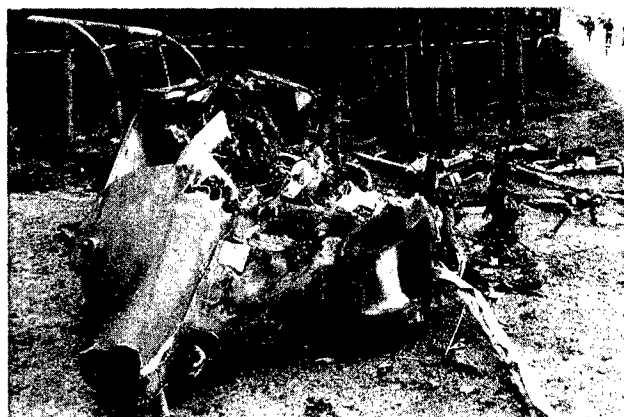
**Scenario 2.** During a night NVG takeoff at 50 feet AGL and 40 to 60 KIAS, the IP, in the left seat, attempted to take control of the aircraft. The IP was unable to control the aircraft and it crashed. The aircraft impacted the ground, right side low, in a near-vertical descent. The wreckage was largely consumed by a postcrash fire.

■ **Result:** Two injuries, a destroyed aircraft, and a cost of \$3,836,056.

■ **Cause:** The IP failed to properly preflight the aircraft in accordance with the operators manual (he failed to ensure the cyclic was engaged for flight). The PI failed to properly transfer the aircraft flight controls to the IP. He did not feel the IP move the flight controls and did not visually confirm positive transfer before releasing the controls. After releasing the controls, the PI observed the IP struggling with both hands on the cyclic control, but he remained clear. There was no communication between the pilots. The IP thought he had a hydraulic problem when in fact the cyclic was in the lockout position. The PI had been briefed that whoever was at the controls would execute the appropriate emergency procedure, and he did not want to interfere with the IP's

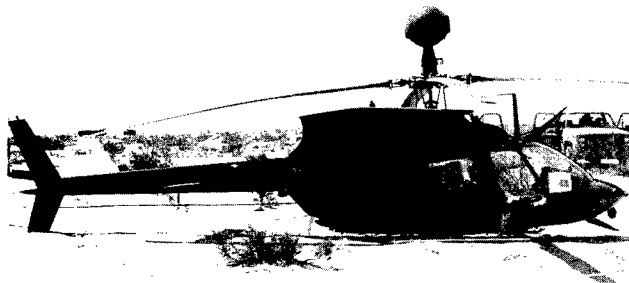
**Scenario 1.** During a VMC flight to a secure area, the fuel boost pump failed. The PC turned the boost pump off in accordance with the operators manual. At 400 feet AGL about 3 to 5 minutes later, the PC was attempting to accelerate from 70 to 100 knots when the low rotor RPM audio sounded and the airframe began to vibrate. The PC confirmed an engine failure and initiated an autorotation. During the descent the rotor warning ceased, indicating there was adequate rotor RPM. The aircraft touched down slightly nose high with the tail skid on the ground. Both skids made ground contact at the same time, and the aircraft began sliding forward. The skids dug into the sand, causing the wire cutter to act as a brake. As the aircraft abruptly slowed, the rotor system flexed down and severed the tail boom. The aircraft continued to slide a short distance before coming to rest on its left side.

■ **Result:** Damage cost of \$3,756,000.

■ **Cause:** The fuel boost impeller assembly and plain seal were worn. The flameout resulted when the PI increased demand on the fuel system to increase forward airspeed. The increased fuel demand coupled with an inoperable fuel boost pump and an air leak between the fuel boost pump and the engine was too much for the fuel system to handle.

**Prevention techniques and procedures:** For a fuel boost pump failure, the proper procedure is to land as soon as practical. The PC in this case followed the proper emergency procedure. He was en route to the nearest secure area when the engine failed. Because of the soft sand in the landing area, he should have attempted to execute a minimum ground run autorotation. It should be noted that factors such as height perception and availability of relative motion cues greatly influence how well touchdown speeds can be ascertained.

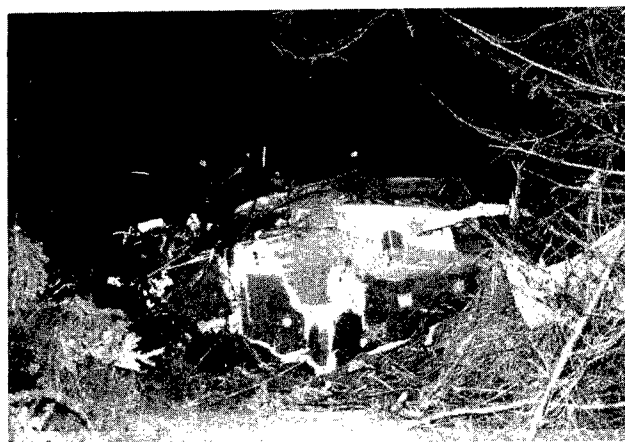
**Scenario 2.** At about 10 feet above the trees and 10 knots while flying NOE over a heavily wooded area, the engine surged and the aircraft abruptly yawed right. The engine then failed, accompanied by engine-out and low rotor RPM indications. The pilot on the controls placed the aircraft in a slightly nose-high attitude as the aircraft

■ **Result:** Two injuries, a destroyed aircraft, and a cost of \$3,984,147.

■ **Cause:** The fuel boost valve stem had been bent slightly when installed. The restricted fuel flow caused by the bend in the valve stem allowed the engine to function properly during low fuel demands but was not adequate for higher fuel demands. The bent valve stem prevented the engine fuel pump from providing an adequate volume of fuel required for the high power setting required for OGE maneuvers.

**Prevention techniques and procedures:** The cause of the engine failure was essentially the same as for Scenario 1, inadequate fuel flow at a time of high fuel demand. The difference is that this PC didn't have time to execute an autorotation.

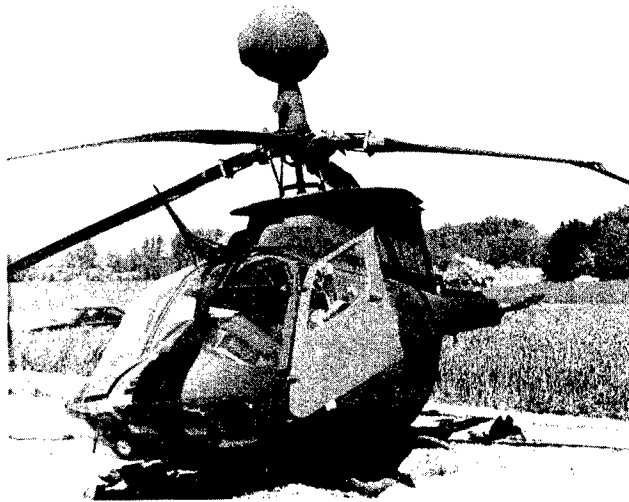
**Scenario 1.** While in cruise flight on a routine training mission, the IP initiated a simulated engine failure (SEF) as a demonstrated maneuver to the artillery fire support officer (AFSO). At 400 feet AGL, the IP attempted to make a power recovery. The aircraft lost power and began losing RPM. A near-vertical descent resulted, and the aircraft hit the ground hard.

■ **Result:** Damage cost of \$320,959.

■ **Cause:** The engine failed as a result of a loose compressor discharge pneumatic (PC) air line. The IP failed to recognize an engine-out condition before initiating a power recovery. He further erred by applying collective pitch to the main rotor in anticipation of rotor overspeed.

**Prevention techniques and procedures:** TC 1-209: ATM Observation Helicopter, OH-58D Aviator/Aeroscout Observer explains the procedure for doing simulated engine failure. While an actual engine failure does not often happen during a power recovery from an SEF, it seems almost axiomatic that if an engine will fail, it will fail during this recovery process. Ensure the maneuver is initiated only when a good landing area is available and can be reached. Anticipate what you would do if an engine failure did happen and you won't be surprised. Anticipate the use of collective to correct for high rotor RPM; do not lead with collective.

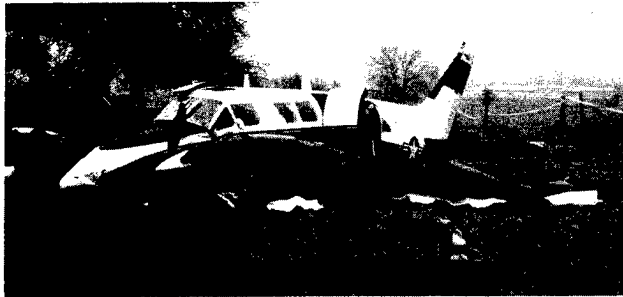
annual proficiency and readiness training (APART) evaluation. On climbout, after a no-flap, touch-and-go landing, the IP initiated a simulated single-engine failure. At 225 feet AGL, the aircraft yawed left and pitched slightly nose high. The aircraft continued to yaw and roll left at about 70 degrees angle of bank while descending. The aircraft struck the ground at about 90 knots, approximately 15 degrees left wing low and 10 degrees nose low. The aircraft slid approximately 160 feet before coming to rest in an upright position.

■ **Result:** Two injuries, a destroyed aircraft, and a cost of \$621,366.

■ **Cause:** The PI was slow to recognize uncoordinated flight and to take timely corrective action. The IP was slow to recognize the PI's failure to maintain coordinated flight and take corrective action.

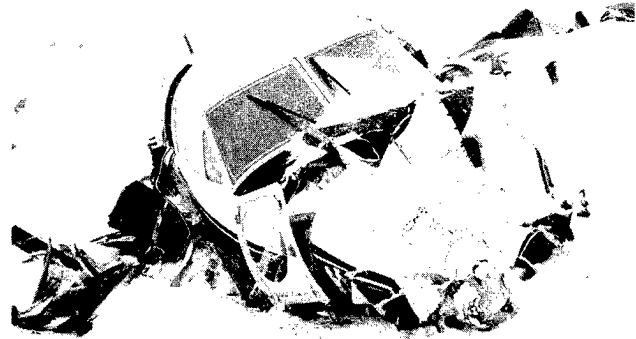
**Scenario 2.** The C-12F crew's preparation and departure for an IMC/IFR flight revealed that they were in a hurry. Later, the crew reported a

final approach fix inbound on instrument approach. As the aircraft continued a descent for landing, it impacted a snow-covered mountain at 2,300 feet MSL.

■ **Result:** Eight fatalities, a destroyed aircraft, and a cost of \$5,192,539.

■ **Cause:** The crew failed to follow published procedures for the intended approach and misidentified the aircraft's position on the approach. The aircraft was reported at an intersection inbound approximately 20 miles short of where the aircraft actually was. The aircraft descended out of altitude and went below the approach segment minimum altitude and impacted the mountain.

**Prevention techniques and procedures:** When a mission isn't coming together, try to step back and look at it objectively. If you feel uncomfortable about some aspect of a mission, talk about your concerns. Crew coordination *must* take place when operating in IMC conditions. Continue to validate your position. Always know where you are. Employ your navigational instruments properly. Cross-check, cross-check, cross-check.

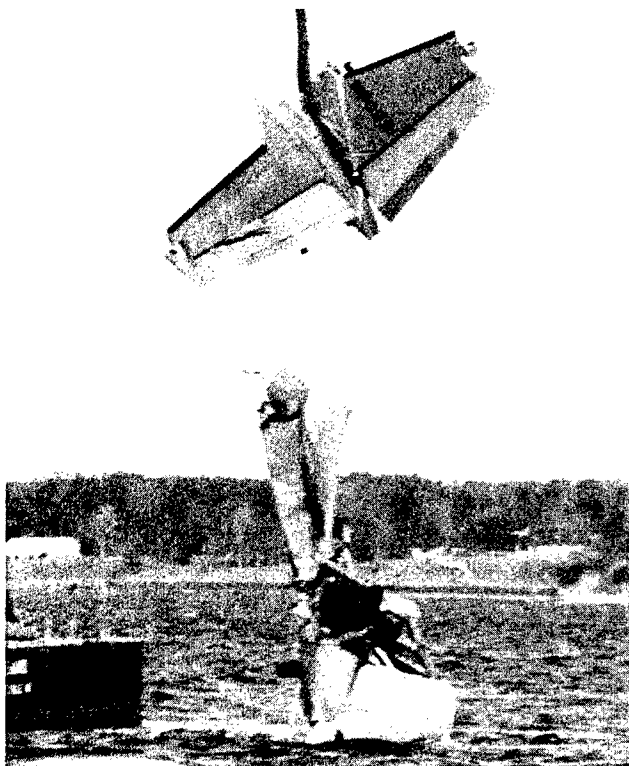
**Scenario 1.** The CASA C-212 was established on a left downwind at an altitude of approximately 1,200 feet MSL and a ground speed of approximately 120 knots. The airplane was observed to abruptly roll right approximately 60 degrees, pitch nose down approximately 80 degrees, and crash into a river.

■ **Result:** Five fatalities, a destroyed aircraft, and a cost of \$8,651,210.

■ **Cause:** The most probable scenario for this accident is: While attempting to descend to 500 feet MSL, both power levers were mistakenly retarded and the right power lever was placed in the Beta range. When the error was noticed, both power levers were advanced. But because the power levers were not symmetrical—the left was at idle and the right was in Beta—the left propeller immediately began producing thrust while the right propeller continued to produce drag. This asymmetrical thrust condition caused the aircraft to abruptly roll right and resulted in loss of aircraft control at an altitude that made recovery impossible in time to prevent impact.

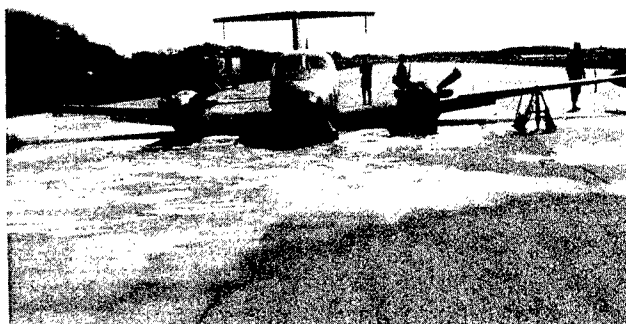
**Scenario 1.** The aircrew was conducting a training flight in an RC-12H. During the roundout for a power approach precision landing the crew heard an unusual scraping and ticking sound and noticed the aircraft fuselage was closer to the ground than it normally would be. Sheet metal on the underside section of the fuselage was damaged when it contacted the runway, engines received sudden stoppage damage, and all of the propeller blades were damaged.

■ **Result:** Damage cost of \$274,608.

■ **Cause:** The IP failed to follow procedures. He did not orally call out checklist items and ensure that actions were verified by using the

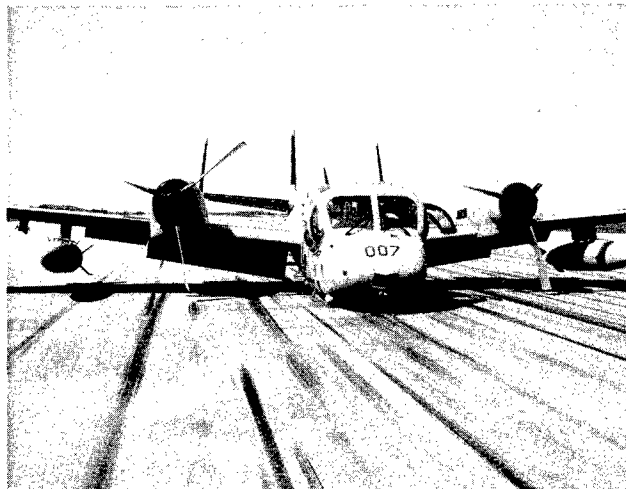
**Scenario 2.** The crew was performing an RL3 training flight in an OV-1D. While on downwind, the IP simulated failure of the No. 1 engine by reducing the No. 1 engine power lever. The IP announced the engine failure and told the PI to continue the pattern and perform a simulated single-engine landing. The PI continued with a normal pattern. As the aircraft approached the landing runway, the PI and IP noted that the flaps were at zero degrees. The PI applied full flaps. As the flaps extended to full-down position, the aircraft "ballooned." Both pilots had their attention

on the landing attitude of the aircraft. The aircraft continued to the touchdown point and landed gear up.

■ **Result:** Damage cost of \$5,879,892.

■ **Cause:** The IP failed to verify that the PI completed the before-landing or landing check. The IP was preoccupied with another aircraft in the traffic pattern and the change in attitude of his own aircraft during the final landing phase.
