# Aircraft Mishap Facts

## Second Half FY 84 Review

### Introduction

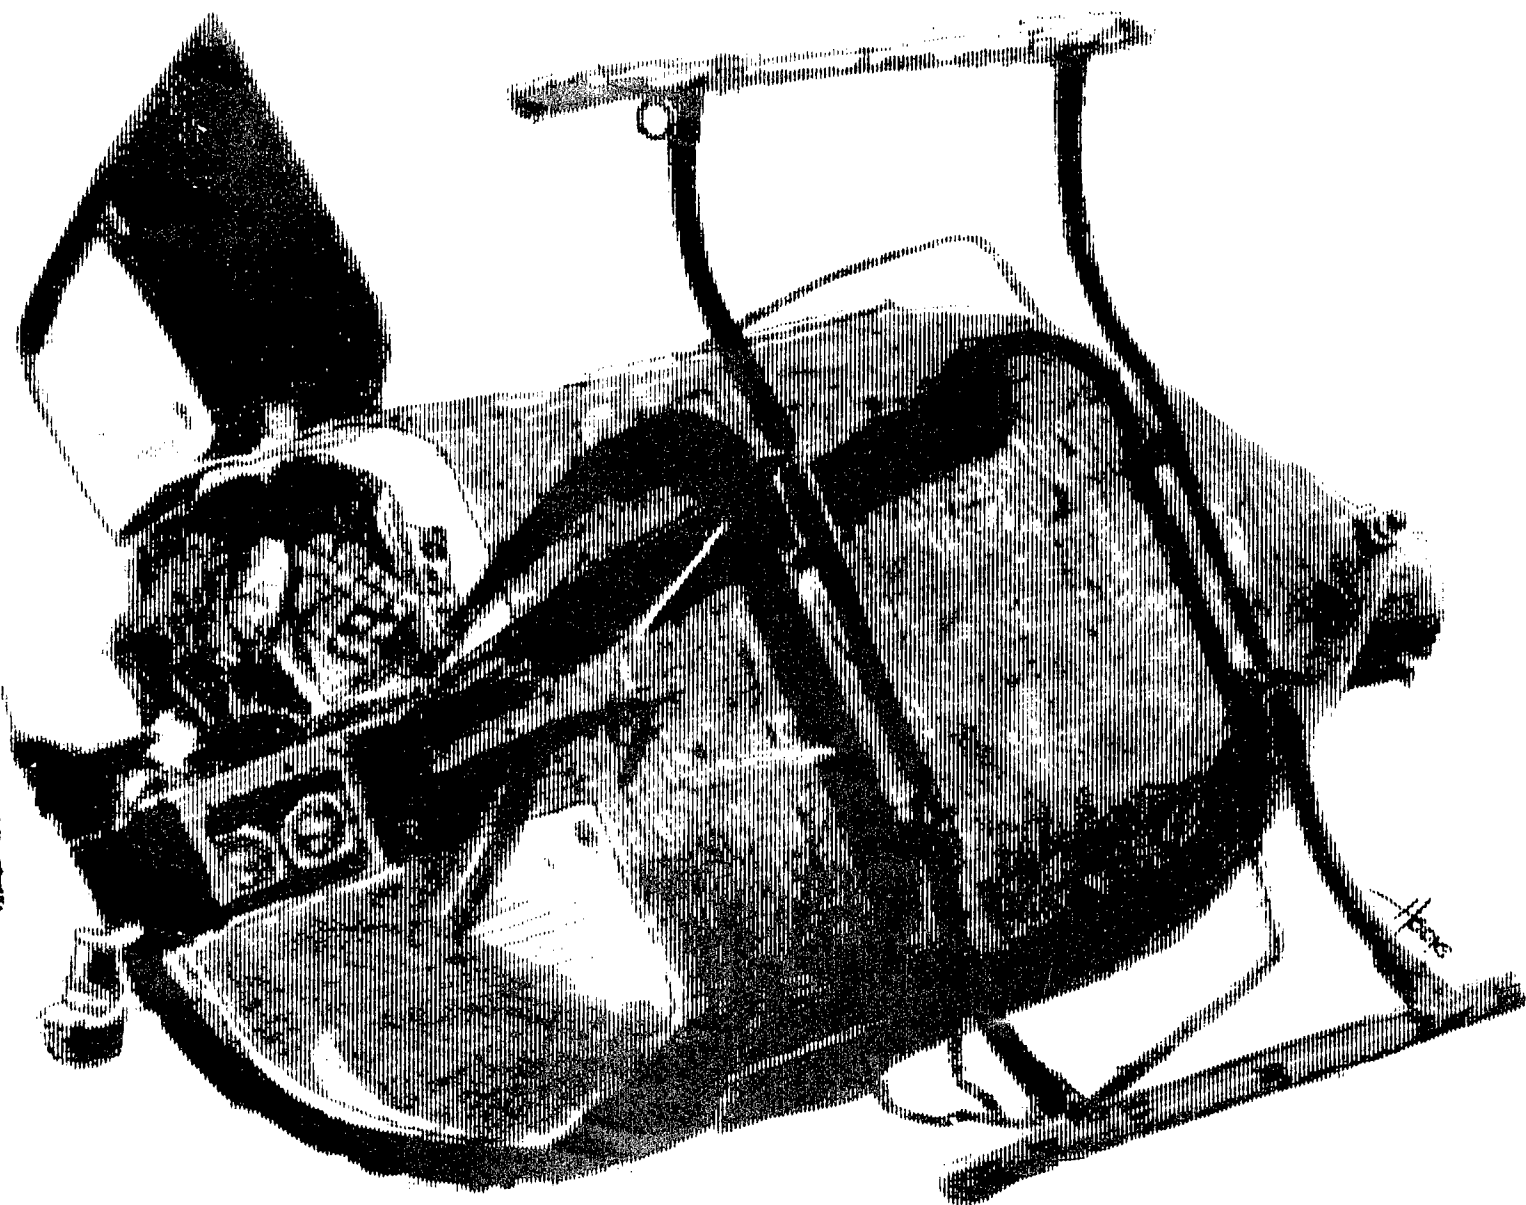
**Midair collision**

**UH-1H Class A mishap**

On 10/10/80, a UH-1H helicopter was flying at 10,000 feet AGL over a wooded area. It collided with a small, single-engine aircraft. The helicopter sustained significant damage to its rotor system and fuselage. The small aircraft was destroyed. The pilot of the small aircraft was killed. The pilot of the helicopter was rescued.
