# Study of Army Aircraft Maintenance-Related Mishap Experience

November 1981

DOC 81-11

## **1 October 1976 through 31 December 1980**

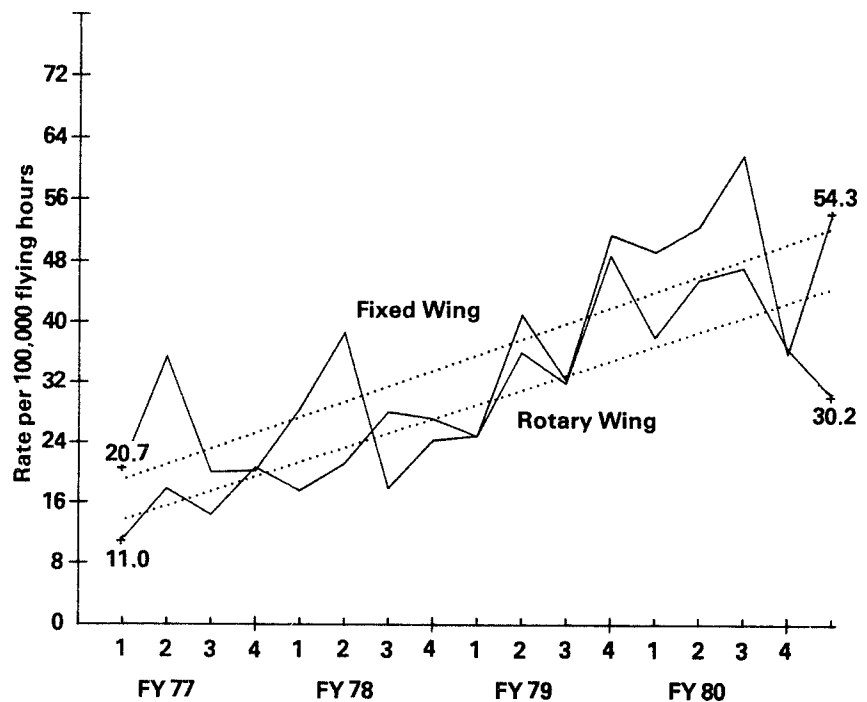
FIGURE 1.— Maintenance-Related Mishaps by Quarter

The maintenance-related mishap trend graph (figure 1) shows that while rates have varied from quarter to quarter, there has been an upward trend for fixed and rotary wing. Maintenance-related mishap rates for both fixed and rotary wing have doubled from FY 77 to FY 80. The trend lines for both aircraft increase on the same plane, indicating that factors causing the increase could be common to both type aircraft. Increased emphasis on reporting all mishaps has resulted in more mishaps being reported by the field. This is considered to be the most significant reason for the trend increase.
