ERDC/CHL TR-00-1

## **Demonstration Erosion Control Project Monitoring Program**

### **Fiscal Year 1995 Report**

David S. Biedenharn, Nolan K. Raphelt,  
and Chester C. Watson

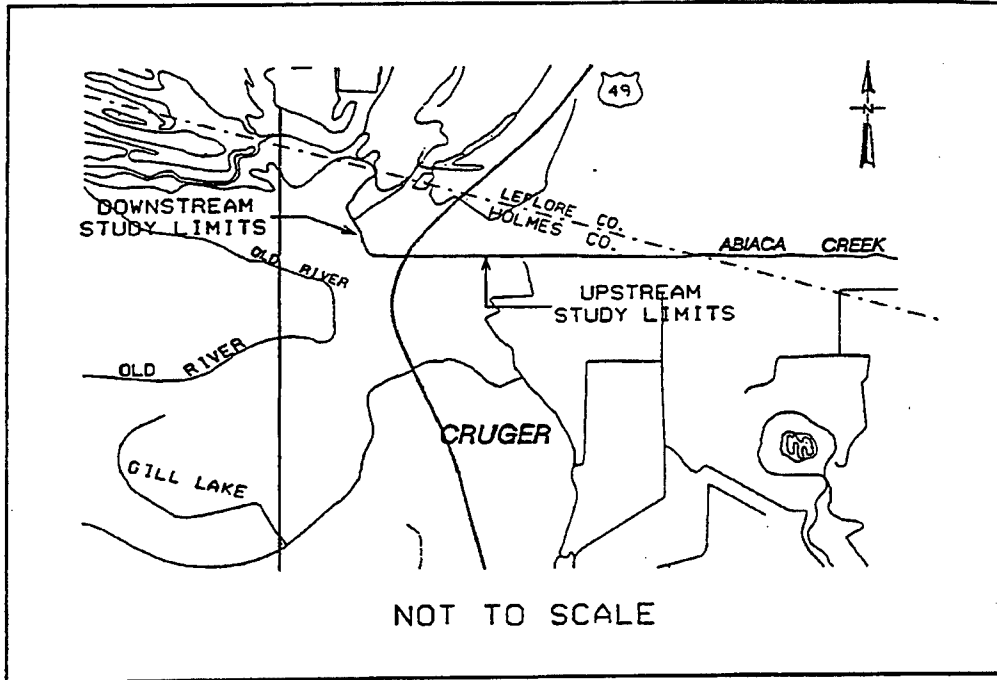
Figure 14. Abiaca Creek, site #21

Site No. 21 is near the mouth of Abiaca Creek at Highway 49 as the stream enters the wildlife area. The Vicksburg District has designed a sediment trap basin for this location by setting the levees back and allowing frequent overflow of the stream. The construction of the sediment trap was observed to under construction at the time of the 1995 inspection. The reach is approximately 4,000 feet in length and is shown on Figure 14. See Table 5 for summary results and Figure 15 for thalweg profiles.

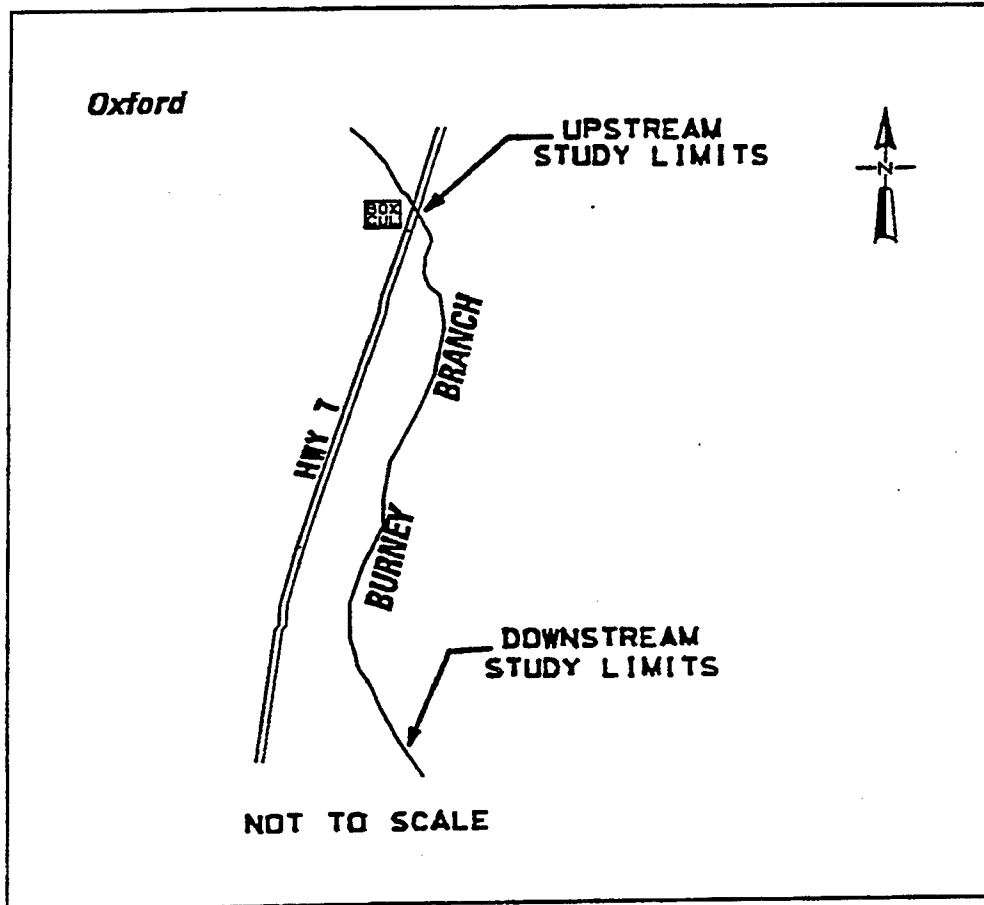
Figure 16. Burney Branch, site #12

Site No. 12 is located on Burney Branch near Oxford, Mississippi. The study reach begins at the Highway 7 crossing of Burney Branch and extends downstream for a distance of approximately one mile through a reach containing two SCS high-drop structures as shown on Figure 16. Burney Branch has a drainage area of approximately 10 square miles at this location. The site can be located on the Oxford quadrangle map, T9S, R3W, Sections 4 and 9. See Table 6 for summary results and Figure 17 for thalweg profiles.

The two high-drop structures have been very successfully utilized in rehabilitating this reach of Burney Branch. Both structures were constructed in 1982 by the SCS, and the effects of the structures on the channel were surveyed and analyzed by Watson et al. (1984). These structures were designed to contain the 100-year discharge and include the provision for floodplain storage using valley dams in conjunction with each structure. The original design of the structures provided for a bed slope of 0.0008 between structures, based on Lane's tractive stress analysis. The 1984 surveyed bed slope was 0.0012, indicating that the upstream sediment yield was greater than planned. Since 1984, several major channel stabilization projects have been constructed upstream. Channel stabilization under conditions of decreasing sediment supply is a situation that will be faced as the success of the DEC programs are realized. Potentially, upstream stabilization can cause stability problems downstream.

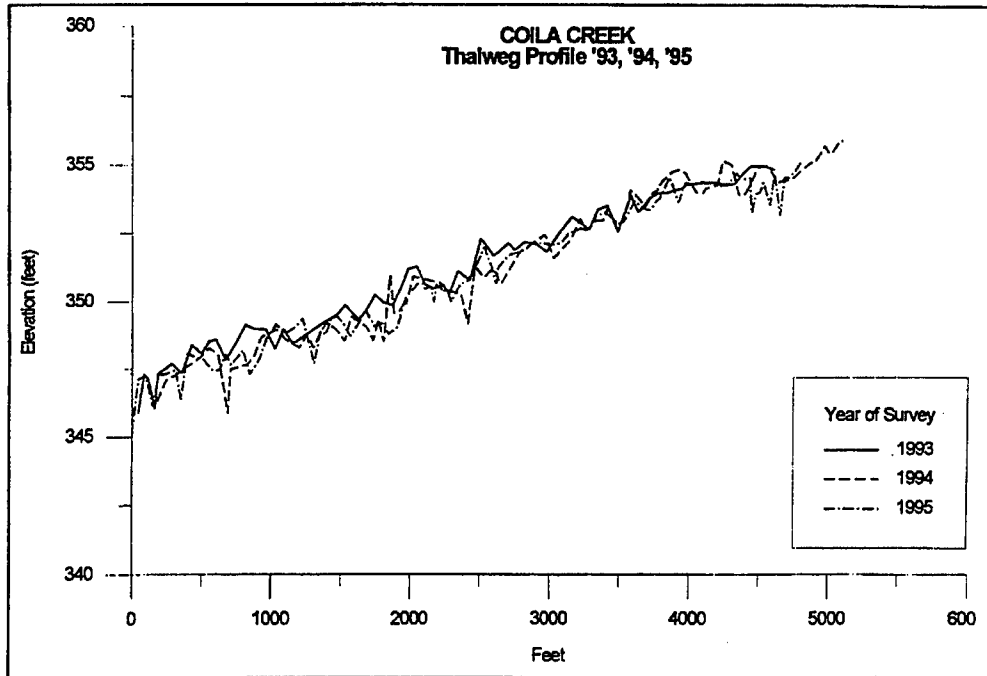
Figure 19. Thalweg profiles for Coila Creek, site #5

The reach thalweg profile has no significant trends, and the bank stability was poor only near the confluence with Abiaca Creek in a bendway. The  $D_{50}$  of the reach was sampled and analyzed to be 10 mm, which does not allow reliable SAM computations using the sand-bed based equations. The upper portion of the reach is has a very stable inner-channel with a gravel bed and overhanging riparian vegetation.

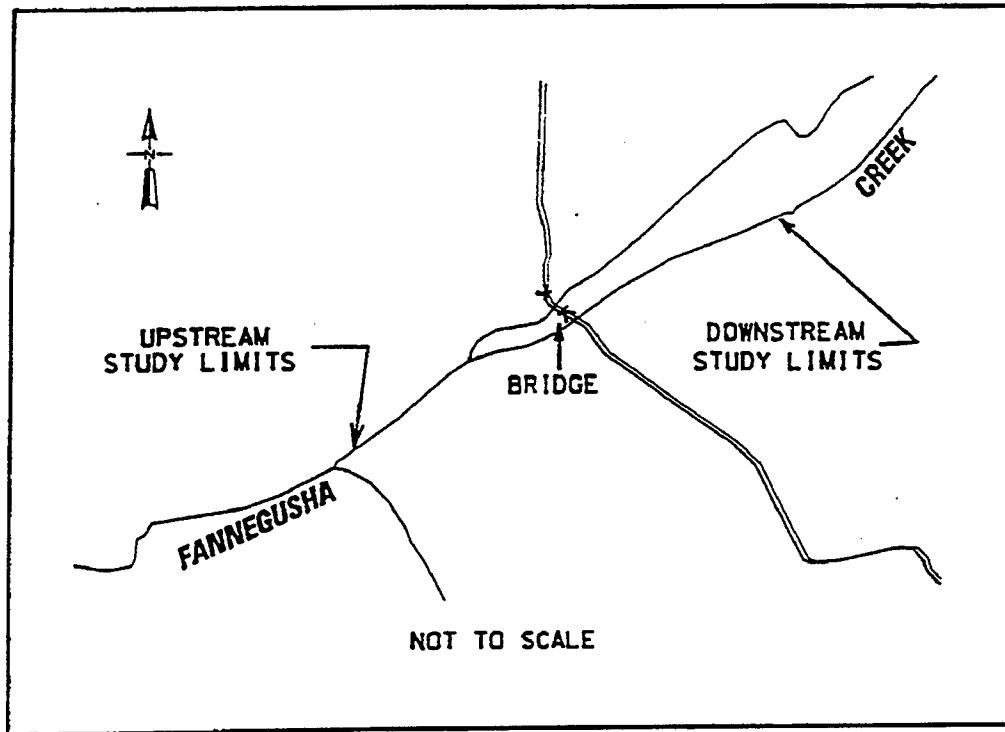
Figure 20. Fannegusha Creek, site #2

Site No. 2 is located on Fannegusha Creek, also in the Black Creek watershed, and can be found on the Coila quadrangle map in T16N, R3E, Sections 1 and 2. As shown in Figure 20, the study reach is approximately 4,000 feet in length, 2,000 feet upstream and downstream of a county road bridge. The watershed area at the site is approximately 18 square miles. HEC-1 hydrology and HEC-2 hydraulics were developed by Northwest Hydraulics Inc. (1989). This reach was chosen as representing a very unstable sandbed channel. See Table 7 for summary results and Figure 21 for thalweg profiles.

A low-drop structure was constructed in 1993 approximately 1500 feet downstream of the bridge. The stream bed appears to be aggrading for a distance of approximately 1500 to 2000 feet upstream of the structure. The bridge was replaced in 1994 due to earlier channel widening. Observations indicate that the channel will continue to widen as over-steepened banks continue to fail, due to previous bed

degradation.

Bed degradation upstream of the bridge will continue as a headcut progresses upstream. At present, the headcut is located approximately 1200 feet upstream of the bridge. Another grade control structure has constructed upstream of the study reach; however, the primary sediment supply to the reach may be entering the channel in a large left bank tributary that is near the upstream extent of the reach. An investigation of this tributary is recommended for the purpose of developing stabilization plans.

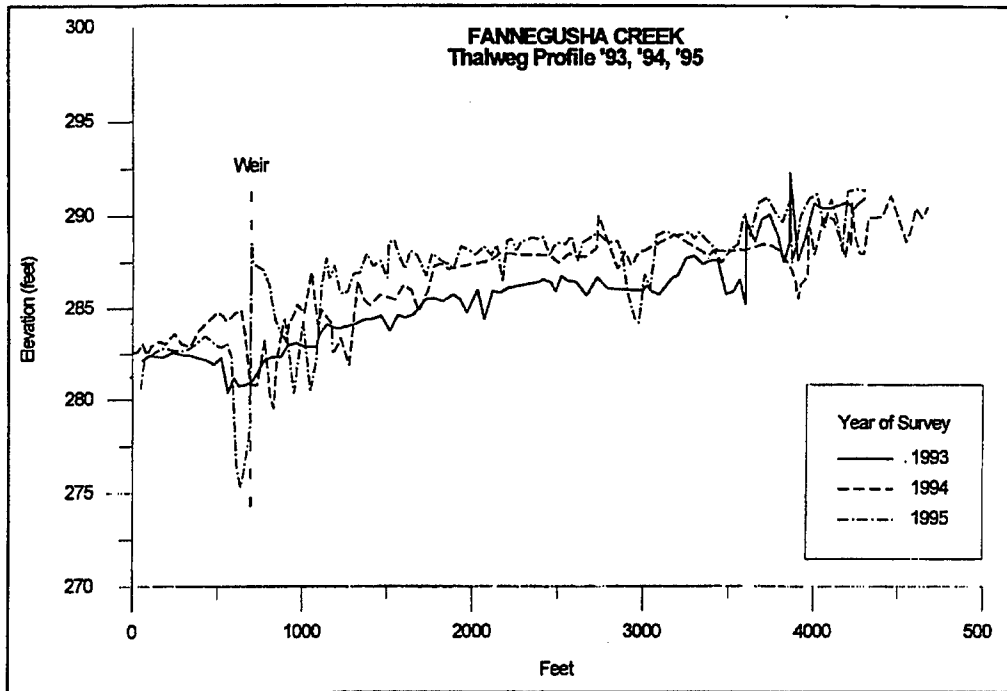
Figure 21. Thalweg profiles for Fannegusha Creek, site #2

BURBANK results (Table 8) indicated the banks are generally stable. The reach averaged SAM results portray a generally stable hydraulic condition; however, the channel response to the recently constructed grade control structure is very dynamic and continue upstream. Although the upstream portion of the study reach is a CEM 2, the overall reach has been classified CEM 4.

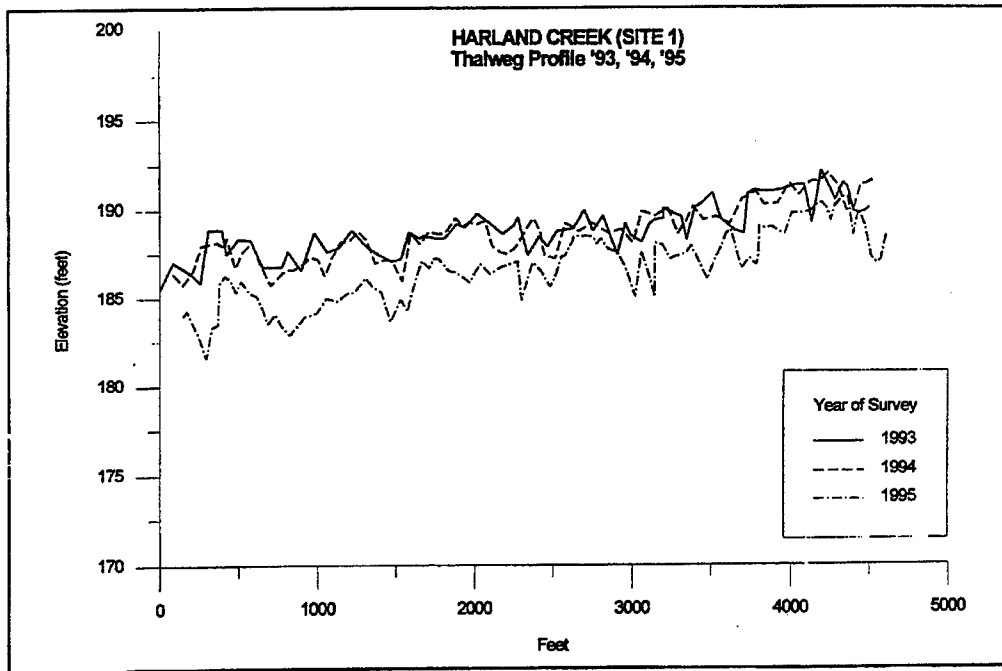
Figure 23. Thalweg profiles for Harland Creek, site #1

The thalweg profile (Figure 23) for the reach indicates a consistent degradation along the reach. Field evidence indicates that the reach has degraded, and significant bank erosion was noted. The longitudinal riprap placed in the lower 2000 feet of the reach experience minor launching, and no bank instability was noted along the riprap. The upstream, unprotected, portion of the reach had severe and consistent bank erosion, demonstrating the effectiveness of the downstream riprap. Additional bank stabilization for Harland Creek should be considered. A short gap in protection on the left bank downstream of the left bank tributary should be considered for construction.

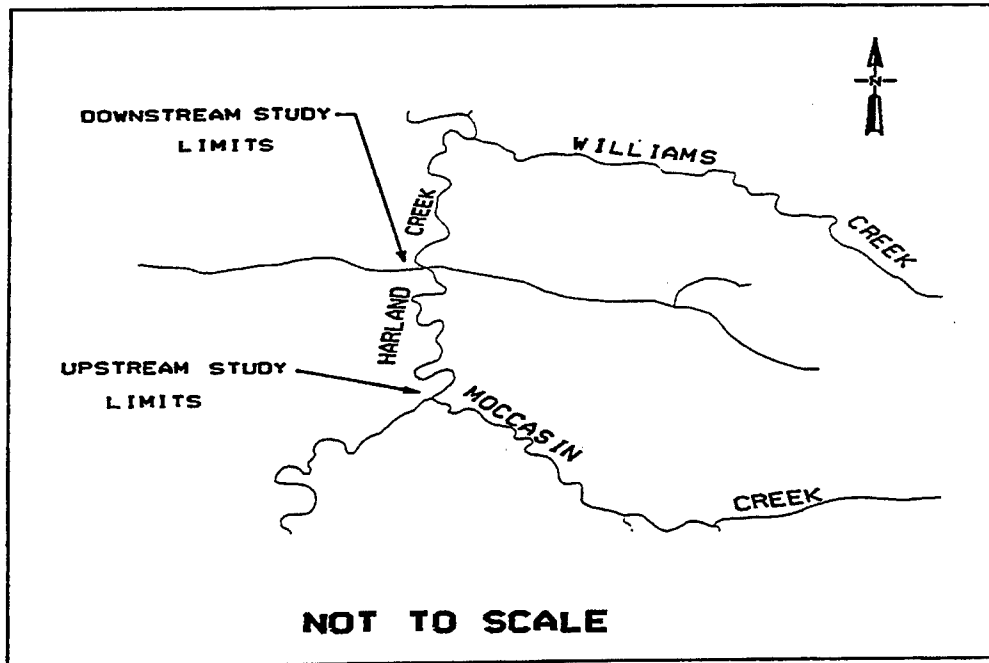
Figure 24. Harland Creek, site #23

From the previous site, the next county road bridge downstream is near the upstream extent of the Harland Creek-Willow Post site (Figure 24). The site continues downstream for approximately two miles to the next county road bridge and encompasses an intensive bank stabilization treatment of willow posts and upstream angled rock dikes. The rock dikes are referred to as bendway weirs. See Table 10 for summary results and Figure 25 for thalweg profiles.

Large gravel bars were observed in the field inspection of October, 1994. Some of these bars were in atypical positions for a meandering stream, indicating that the deposits occurred during the recession of a major flood event. It is expected that lower flows will continue to re-work these deposits. Two additional factors that may contribute to the aggradation is the degradation of the upstream site, and the increased roughness caused by the bendway weirs and the willow posts.

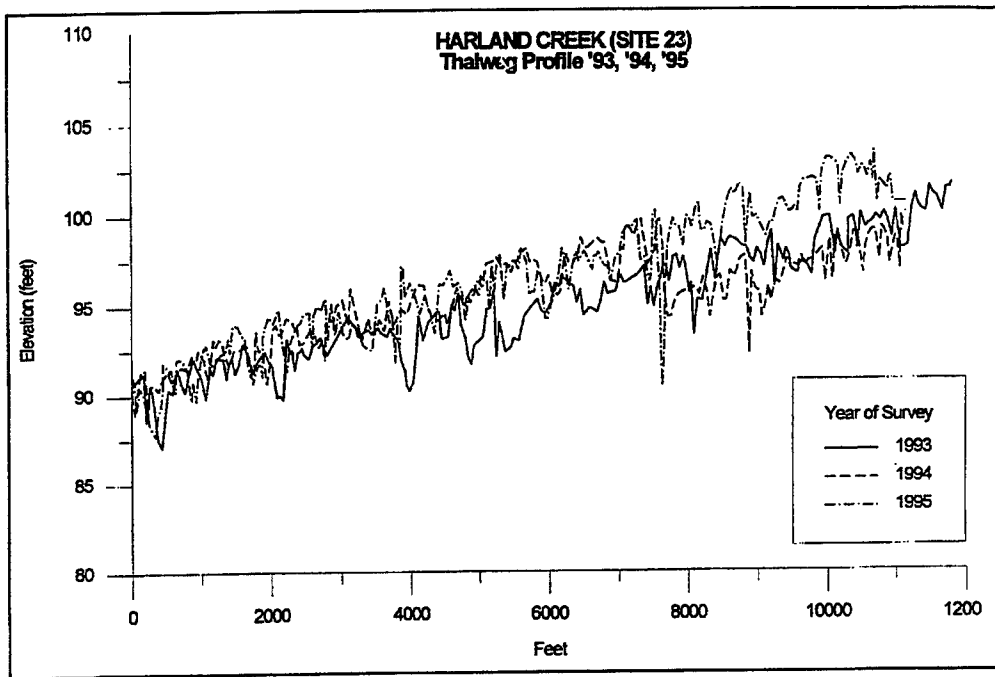
Figure 25. Thalweg profiles for Harland Creek, site #23

As shown in the thalweg profile, Figure 25, the primary difference between the

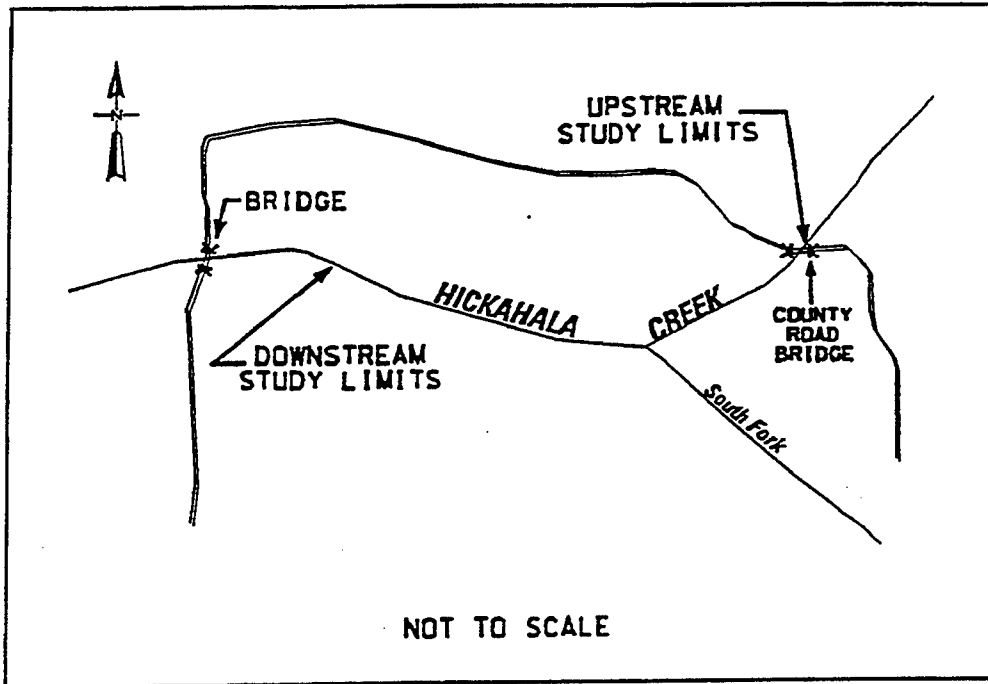
Figure 26. Hickahala Creek, site #11

Site No. 11 is located in the upper watershed of Hickahala Creek, and has a watershed area of approximately 9 square miles. The site is located on the Tyro quadrangle map in T5S, R5W, Sections 2 and 3, a portion of which is shown as Figure 26. The site begins at a county road bridge and extends downstream to the confluence with the South Fork, and continues downstream on Hickahala Creek for approximately 1000 feet. The total study reach is approximately 4000 feet in length and includes two existing structures. A third structure is located on the South Fork about 700 feet upstream of the confluence with Hickahala creek. The lower portion of the study reach is actively incising into a cohesive clay bed. The upstream portion of the study reach is relatively stable with a sand bed. The reach was selected to monitor the response of the structures. See Table 11 for summary results and Figure 27 for thalweg profiles.

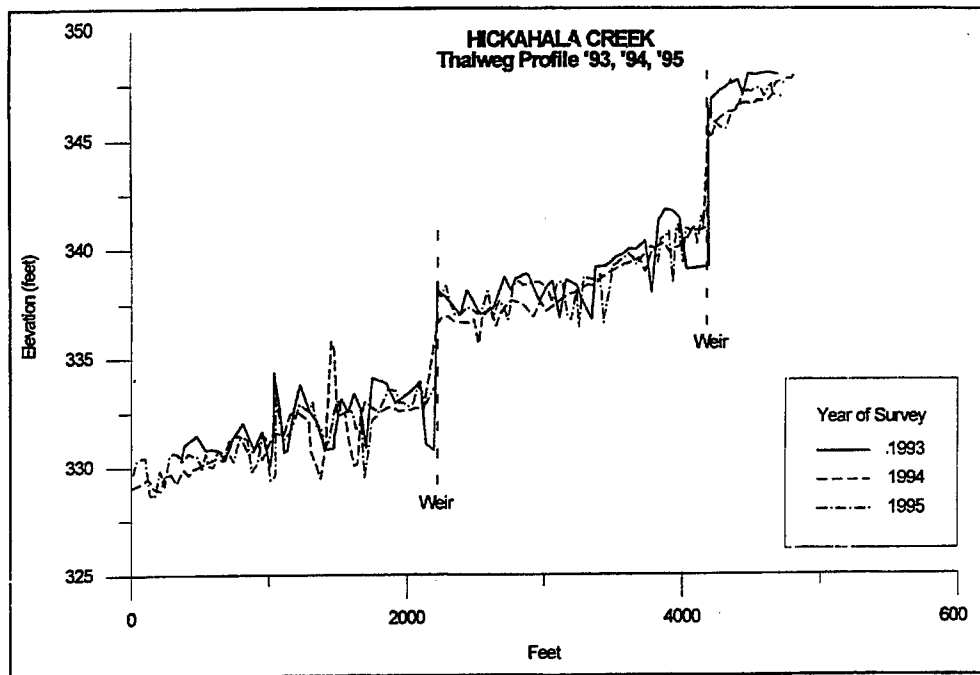
Figure 27. Thalweg profiles for Hickahala Creek, site #11

The downstream portion, Segment 1, is not influenced by a downstream grade control, although County bridge construction at the time of the last inspection may provide some control. The bed of Segment 1 is the erosion resistant clay commonly found at knickzones, and has been classified as CEM 2. The thalweg profile indicates that the bed is eroding very slowly (Figure 27). Some filling was observed in Segment 2 as a result of the downstream grade control structure.

SAM results indicate that hydraulic slope is continuing to increase and to narrow, and BURBANK results indicate that the banks are stable for the conditions tested for Segments 1 and 2 (Table 11). Segment 2 should continue to respond to the structure with filling in the lower and middle portion of the segment, and the upper portion may degrade at the upstream structure lower apron. Segment 1 will continue to slowly erode until the clay material is breached, at which time headcutting will resume. At the time of the last inspection, an active headcut was observed in the upper portion of Segment 1.

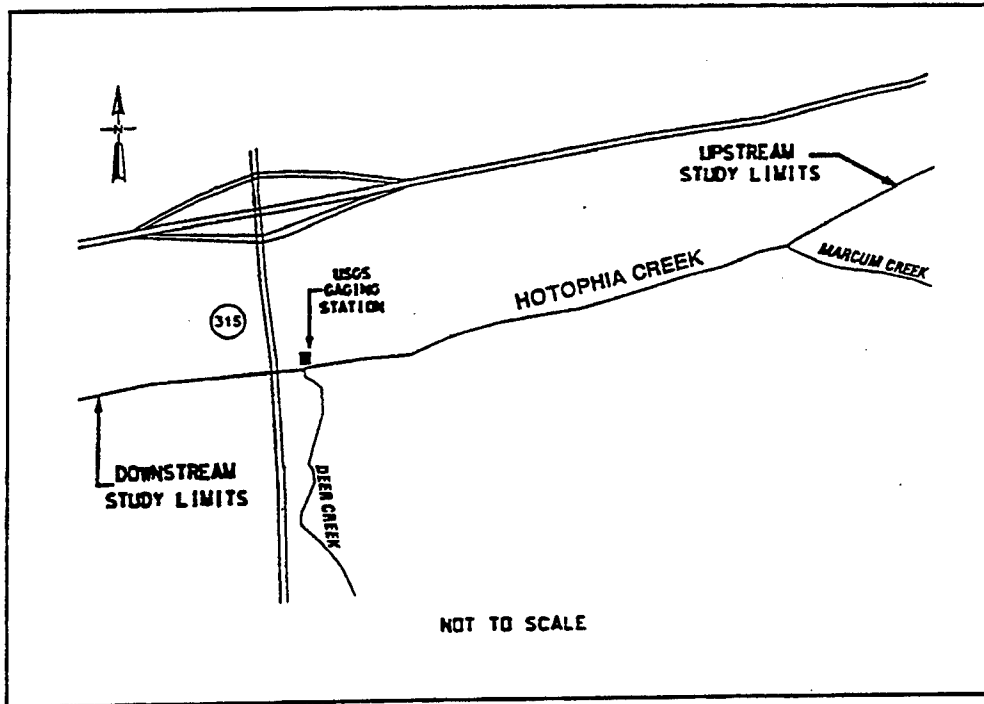
Figure 28. Hotopha and Marcum Creek, Site #13

Site No. 13 is located on Hotopha Creek, west of Oxford, Mississippi. As shown in Figure 28, the site encompasses approximately two miles of Hotopha and Marcum Creeks and is located on the Sardis quadrangle map T9S, R6W, Sections 1 and 2, and in T9S, R5W, Section 6. The watershed area at the site on Hotopha Creek is approximately 17 square miles. A USGS gauging station is located at the Highway 35 bridge crossing of the Creek several miles downstream of the site. The study reach includes the confluences of Marcum Creek and Deer Creek with Hotopha Creek. A low-drop is located at the downstream extent of Hotopha Creek, a high-drop is located immediately upstream of the Highway 315 bridge, and a high-drop is located on Hotopha Creek immediately downstream of the confluence with Marcum Creek. Two low-drops are situated on Deer Creek, and one low-drop is located on Marcum Creek approximately 800 feet upstream of the confluence with Hotopha Creek. A third high drop has been constructed upstream of the site. WES-installed stream gauging is available at the high-drop near the confluence of Marcum and Hotopha Creeks. See Table 12 for summary results and Figure 29 for thalweg profiles.

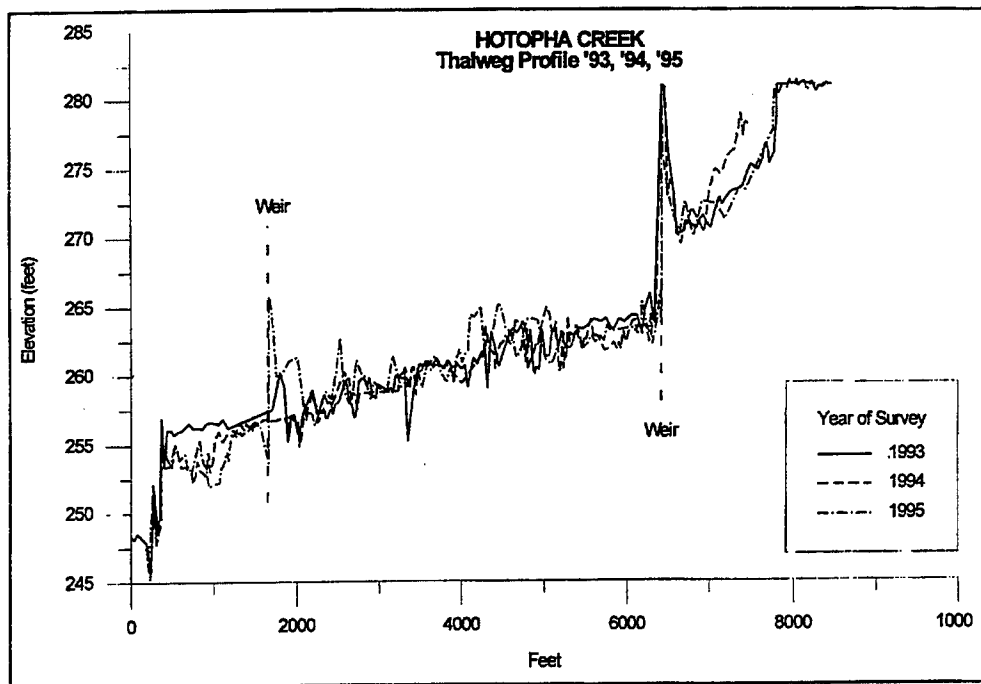
Figure 29. Thalweg profiles for Hotopha Creek, Site #13

The thalweg profile, Figure 29, indicates that degradation is occurring in Segment 1, and is moving upstream to the downstream high drop. This incision is in response to sediment storage in the upstream structures. The surveyed profile indicates that some filling has occurred in Segment 2, and that very little filling occurred in segment 1. The three high drop structures and the upstream drop box culvert have provided massive sediment storage and pooling of water, and the response to these structures will occur slowly. The pools upstream of the high drop may persist for several years, and biological sampling could document the changes in habitat as the pools evolve.

All three segment have been classified as unstable, and each segment is ponder by the downstream structure. Segment 1 is degrading in response to the reduction in upstream sediment supply, and segments 2 and 3 are filling slowly. No CEM classification was made due to ponding, which was not a condition envisioned in the original model. The SAM calculation of the sediment transport capacity for Segment 1 is 3.5 times the capacity for Segment 2, and Segment is 1.6 times the Segment 2 capacity. Therefore, Segment 1 will degrade and Segment 2 will continue to aggrade if sediment supply is available. BURBANK results indicate bank instability can be expected, especially if the zero friction angle assumption occurs (Table 12).

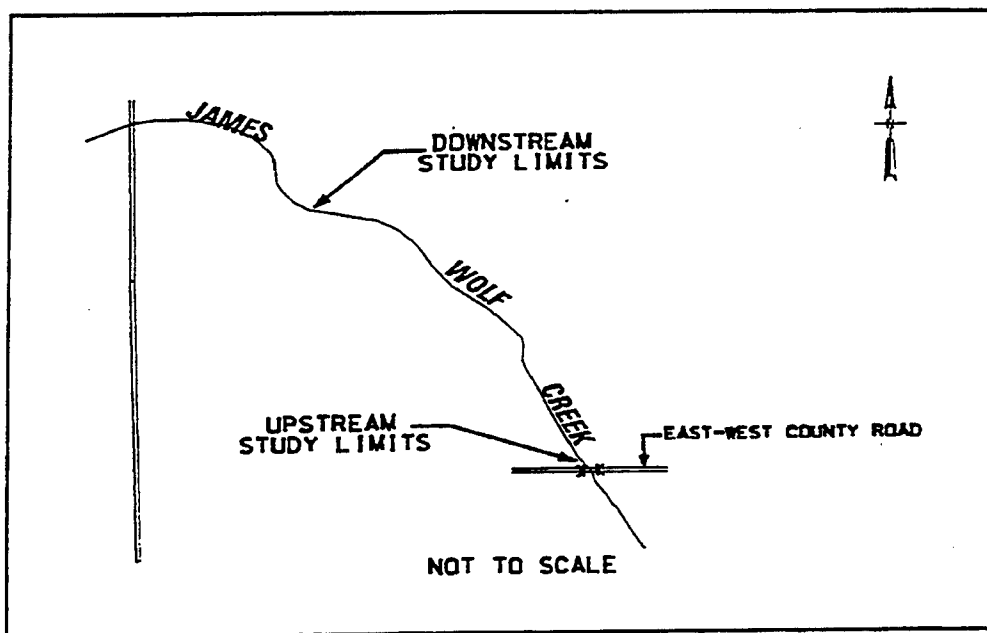
Figure 30. James Wolf Creek, site #19

Site No. 19 is located in the Hickahala Creek watershed on James Wolf Creek. At this location, James Wolf has a drainage area of approximately 11 square miles; however, it is extremely deep and wide. The site is located on the Tyro quadrangle map in T5S, R5W, Section 28. The study reach is shown on Figure 30, and extends downstream of the east-west county road for a distance of approximately 4,000 feet encompassing a low-drop structure. This low-drop structure appears to be stabilizing the bed of the stream; however, the banks remain unstable due to the significant depth.

The stream is sand bed and at low flow conditions, the channel may be dry. The drop structure on the James Wolf Creek monitoring reach has required significant repair since construction and was rebuilt in 1995. Two additional drop structures were constructed on James Wolf Creek downstream of the monitoring reach during 1993 and 1994, and the downstream portion of the reach was stabilized in 1995 using longitudinal riprap. See Table 13 for summary results and Figure 31 for thalweg profiles.

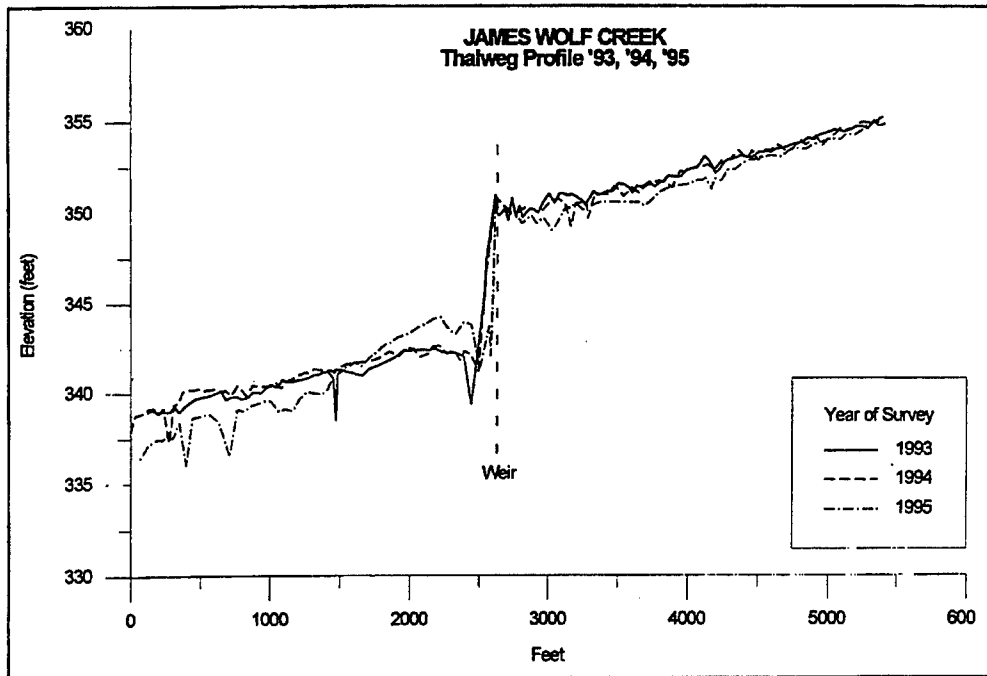
Figure 31. Thalweg profiles for James Wolf Creek, site #19

The thalweg profile indicates that both segments degraded on the order of 1 to 2

feet (Figure 31). Sediment transport capacity in the range of 3000 mg/l and the channel slope, 0.0017, are approximately the same for both segments. BURBANK results based on surveys prior to the longitudinal riprap emplacement indicate that Segment 1 banks are 100% at risk, and that Segment 2, upstream of the structure, are 50% to 60% at risk. The Segment 1 bank stabilization should improve stability. SAM results indicate that the channel is relatively steep and wide at the 2-year discharge (Table 13).

Rebuilding the drop structure and downstream longitudinal riprap improves the stability of this system. Kudzu will continue to dominant the vegetation, restricting development of more desirable vegetation that could improve bank stability and increase roughness. However, channel response is slow and the rate of change is dependent on upstream sediment supply.

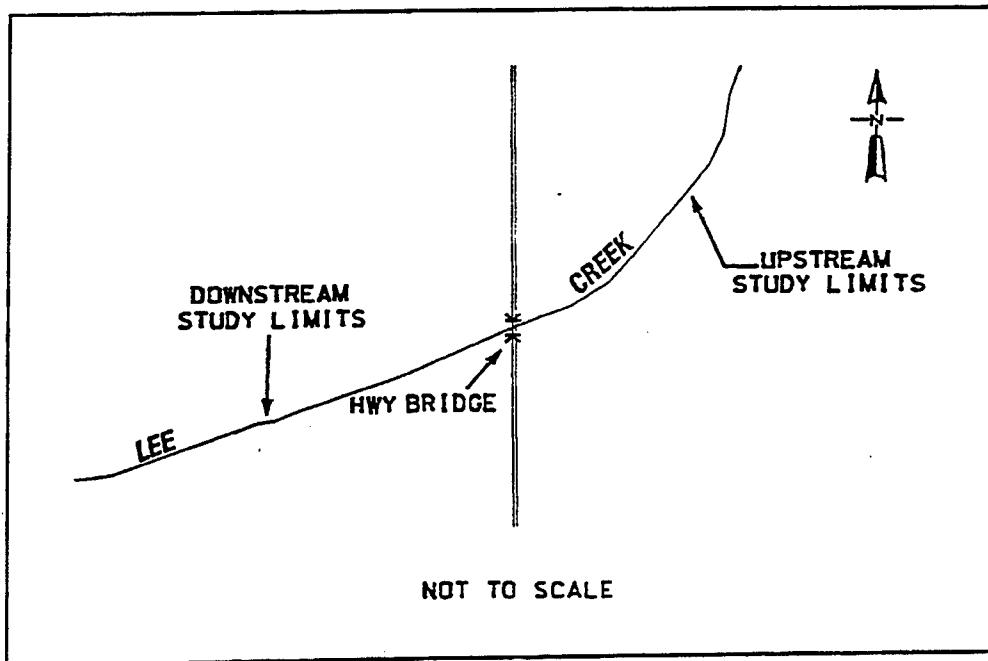
Figure 32. Lee Creek, site #10

Site No. 10 is on Lee Creek in the Coldwater River basin, approximately 6 miles north of Victoria, Mississippi. The site can be located on the Byhalia quadrangle map in T2S, R4W, Sections 9 and 10. As shown in Figure 32, the study reach extends approximately 2,000 feet upstream and downstream of the Highway bridge. The channel is relatively stable and is transporting minor amounts of gravel in a sand bed. Upstream of the bridge, the channel exhibits some meandering and apparently has not been channelized. Downstream of the bridge, the channel is stable with mature, 14-inch diameter trees near the low-water surface. The remnants of spoil

During October, 1994 discussions with Mr. John Kearl, the property owner at the site, he requested a drop pipe be considered for the left bank in the filed upstream of the site. He also alluded to the loss in conveyance at the site. The upstream channel banks are in a cotton field and are covered with kudzu. Debris and willow trees in the channel have formed divided flow reaches in the upstream portion of the reach. Consideration should be given to eradicating the kudzu, channelization, and re-vegetation. The downstream channel has little kudzu due to cattle feeding, birch trees along both banks, and have better conveyance and stability.

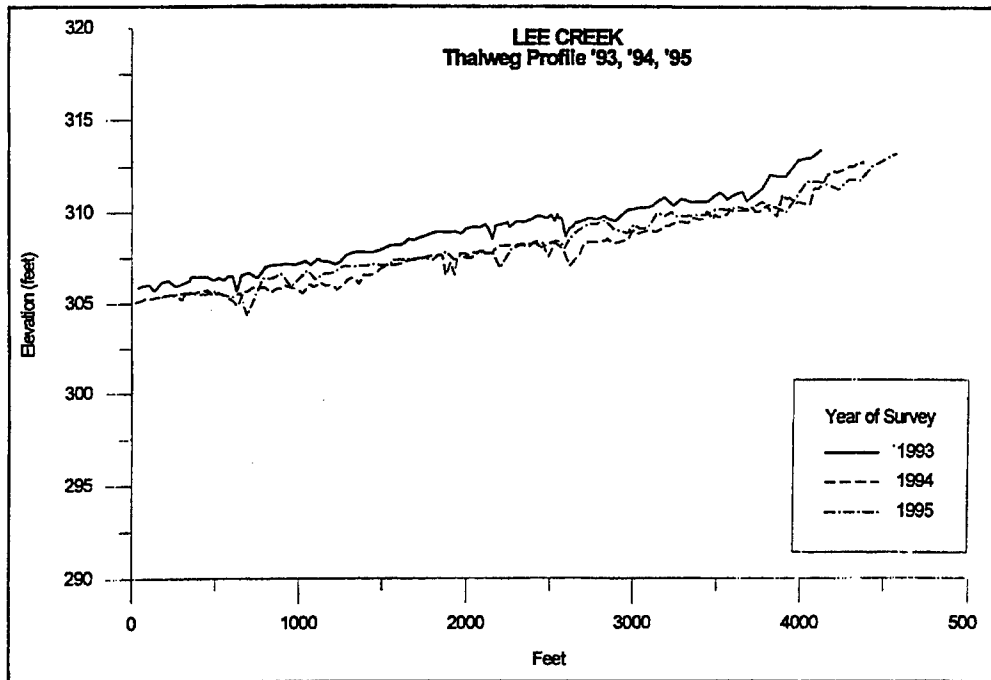
Figure 33. Thalweg profiles for Lee Creek, site #10

BURBANK results indicate confirm that the banks are stable. SAM results indicate that the slope has changed little since 1993, however, average width is decreasing due to upstream loss of conveyance (Table 14).

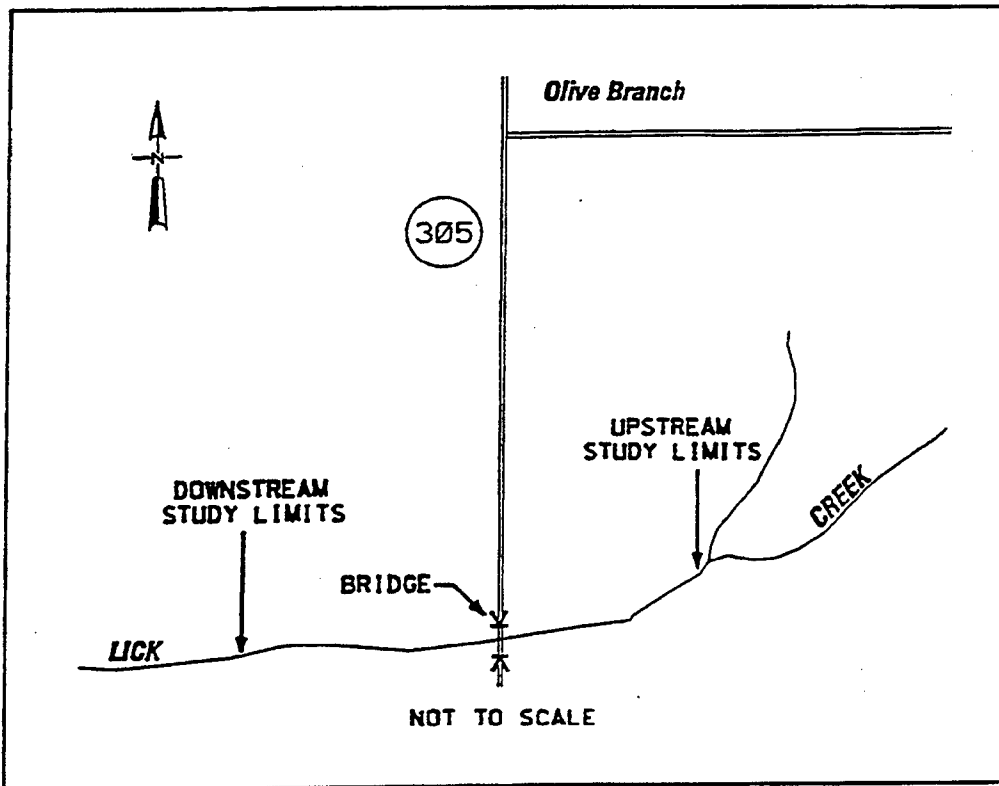
Figure 34. Lick Creek, site #8

Site No. 8 is on Lick Creek in the Coldwater River basin, approximately 2 miles south of Olive Branch, Mississippi. Construction of a high-drop structure was started in late 1994 to protect the Highway 305 bridge. As shown in Figure 34, the study reach is approximately 4,000 feet in length, 2,000 feet upstream and downstream of the bridge, in T2S, R6W, Section 3. This site is on the Hernando quadrangle map and has a watershed area of approximately 8.5 square miles. See Table 15 for summary results and Figure 35 for thalweg profiles.

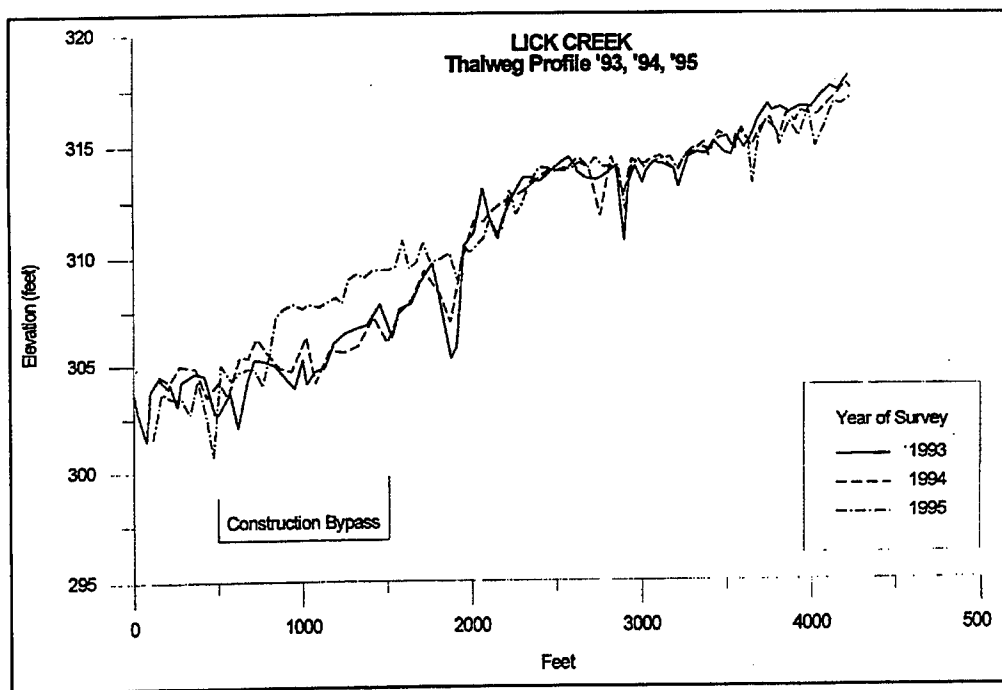
Figure 35. Thalweg profiles for Lick Creek, site #8

A high-drop structure was under construction at the time of the November, 1994 field inspection, and is located at approximate station 18+00 of the accompanying thalweg profile, Figure 35. The construction was not complete at the time of the January, 1995 survey, and the survey was made through the construction bypass as indicated in the figure. As shown on the thalweg profile, the riprap placed at the bridge (Station 20+00) as a temporary measure has helped to slow the incision that is continuing upstream and downstream of the bridge. Degradation is continuing downstream of the structure and can be expected to continue after the closure of the structure. The backwater of the structure should assist in halting the upstream incision if the knick zones have not progress too far upstream to be affected by the high drop. The high drop will protect the highway bridge. In general, the Lick Creek site is a CEM type 3 downstream and through the bridge, is a type 2 at the upper extent of the site. Presently, the upstream extent of the site is incising into resistant clay (Table 15).

The SAM analysis indicates that the slope width has been increasing. BURBANK analyses indicates that three feet of additional degradation will destabilize 50% of the Segment 1 surveyed banks and 12% of the Segment 2 surveyed banks with the assumption of zero friction angle. Left bank drainage upstream of the bridge is poor, with standing water in the adjacent field. Channel incision and a saturated left bank may combine to result in greater instability than in other similar streams. A drop pipe could be added to improve bank drainage. The high drop structure will improve the stability of the upstream channel reach, and it will be of interest to observe the upstream and downstream channel response following construction completion (Table 15).

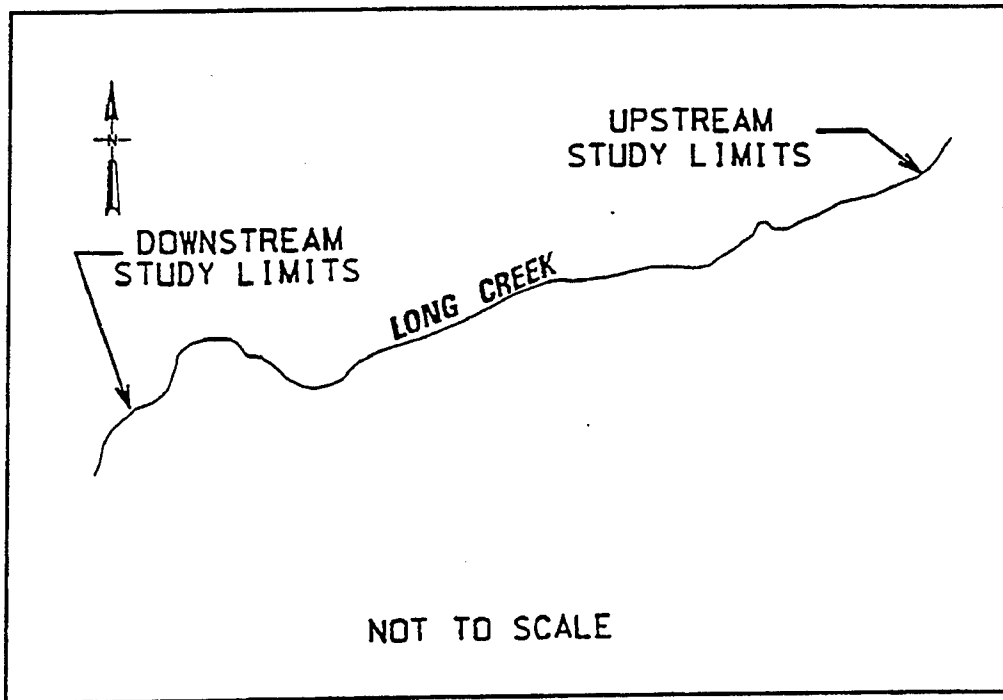
Figure 36. Long Creek, site #20

Site No. 20 is located on Long Creek, T10S, R6W, Sections 4, 5, and 8 as shown on Figure 36. The site can be found on the Oakland quadrangle map and has a watershed area of about 11 square miles. Three low-drop structures were existing prior to 1991 and the fourth was constructed in 1993 at the downstream limit of the monitoring reach. A fifth structure was constructed in 1993 downstream of the reach. The study reach is approximately 2 miles in length, extending downstream from the eastern boundary of Section 4. The site also includes a reach that has been monitored by the Vicksburg District and includes the bank stability sites reported by Thorne et al., 1990. Portions of the reach are very unstable and are presently incising. The reach downstream of the existing structures has a clay bed that was slowly incising prior to 1993. This clay bed was a very narrow, deeply incised channel along some reaches and has begun filling, a result of the new downstream structure. See Table 16 for summary results and Figure 37 for thalweg profiles.

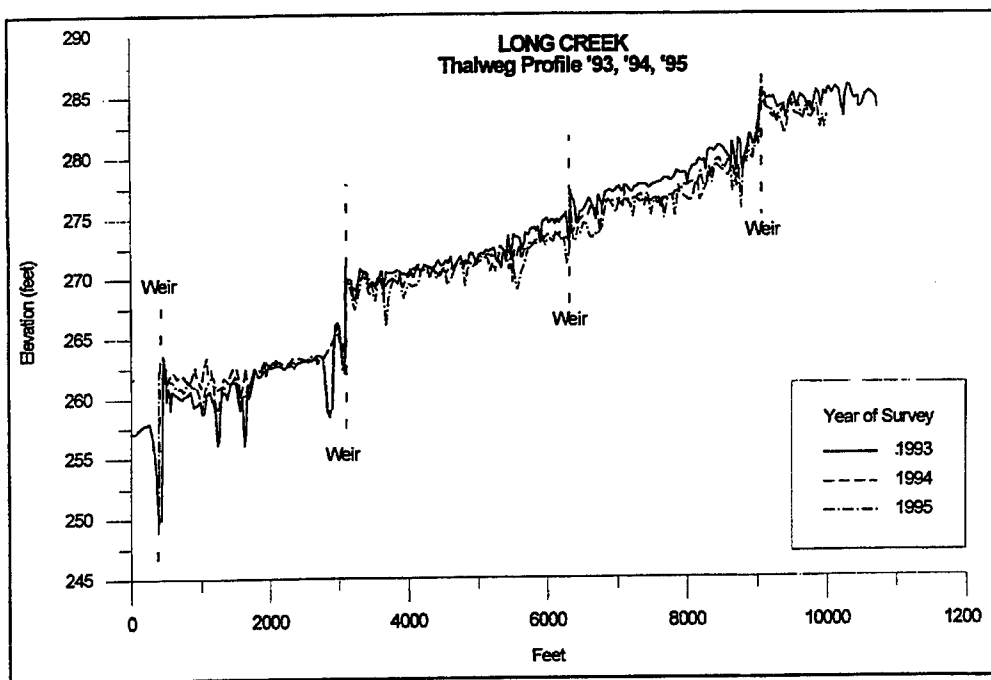
Figure 37. Thalweg profiles for Long Creek, site #20

Long Creek is divided into four segments: at station 0+00 at the fourth downstream drop structure; at approximate station 32+00 at the older low drop structure; at approximate station 68+00 at the next upstream low drop structure; and at approximate station 90+00 at the upstream weir. Figure 37 shows a thalweg profile of Long Creek. Segment 1 aggradation occurred in the period from completion of the lower drop in 1993 through the 1994 survey, and minor degradation occurred in 1994. Significant thalweg change is within 300 feet downstream of the upper weir. At this location, headcutting is moving into the weir. Numerous beaver dams that are present in segments 2, 3, and 4.

BURBANK analyses shows the significant improvement in bank stability moving upstream from Segment 1 at 33% to 0% in Segment 4. Without structural control, degradation would be continuing and the effects of 3 feet of degradation indicated in the tabulation are from 100% in Segment 1 to 6% in segment 4, which demonstrates one of the positive aspects of low drop grade control (Table 16).

Monitoring of the longterm slope adjustment of the site will furnish unique information pertaining to channel adjustment in a channel that is limited in width adjustment. From an operational viewpoint, degradation is moving up to the upstream weir and should be monitored for the safety of the structure. The upstream weir is not a low drop structure; it is an at-grade sheet pile and concrete cap with no stilling basin.

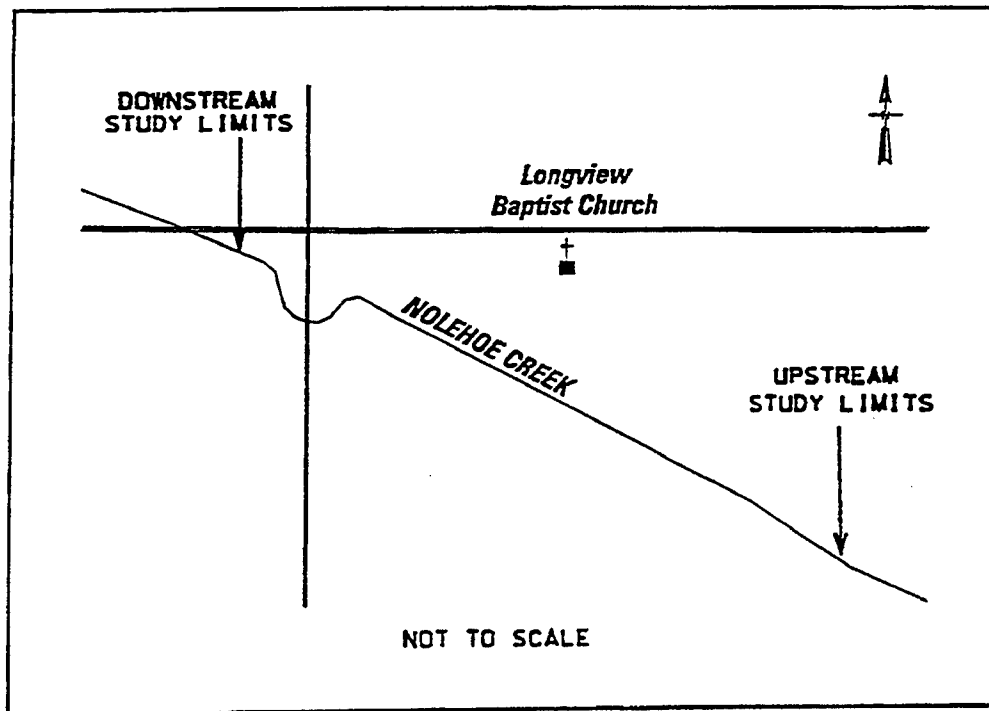
Figure 38. Nolehoe Creek, site #7

Site No. 7 is located on Nolehoe Creek in the Coldwater River basin near the community of Olive Branch, Mississippi. The site is located on the Hernando quadrangle map, T1S, R7W, Section 35 and has a drainage area of approximately 3.7 square miles. The study reach is approximately 4,000 feet in length, extending downstream from a box culvert, as shown in Figure 38. The channel is extremely unstable and is deeply incised. Bed material load ranges in size from fine sand to gravel with a mean diameter in excess of 30 mm. Two low-drop structures were planned for the reach; however, permission to construct the structures was not been received from the landowner. Stream stage recording stations have been installed by WES at the downstream roadway culvert. See Table 17 for summary results and Figure 39 for thalweg profiles.

This incising reach is between upstream and downstream box culverts and the reach is representative of suburban development which is occurring in the metro-Memphis area. An interview with a local landowner confirmed that a major cutoff of the channel had been made in the last ten years. These conditions are typical of the result of ill-planned local development improvements, and the documentation of the resulting problems may be of value in assisting future local drainage planning.

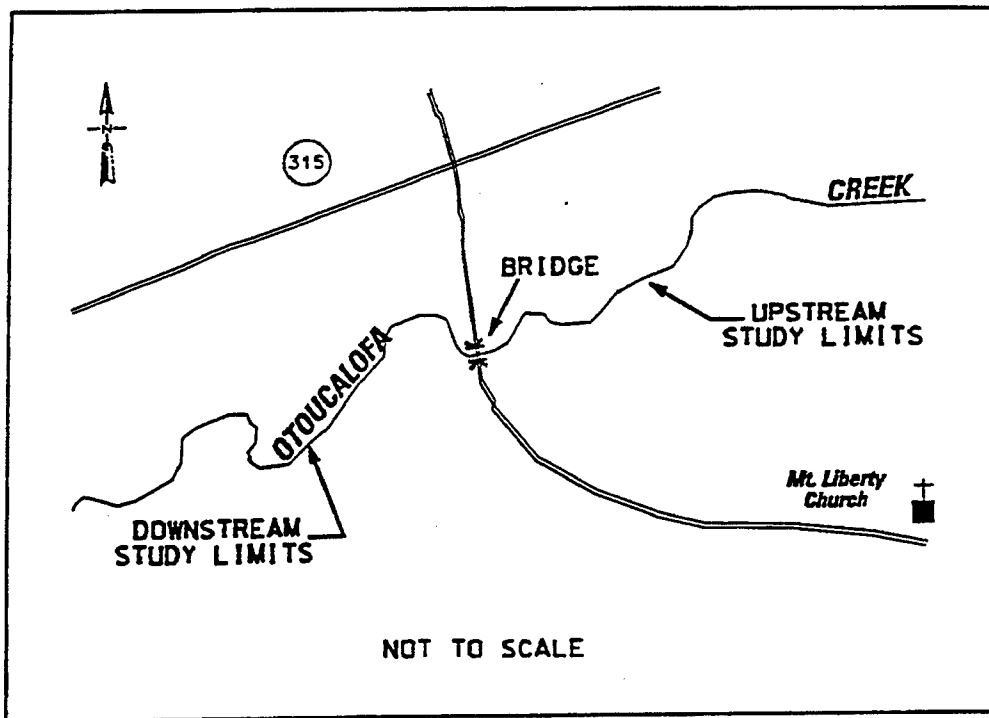
Figure 40. Otoucalofa Creek, site #14

Site No. 14 is on Otocalofa Creek, east of Water Valley, Mississippi. The study reach is 4,000 feet in length, 2,000 feet upstream and downstream of the Mt. Liberty Church Road bridge, in T11S, R3W, Sections 4 and 5, of the Water Valley quadrangle map as shown in Figure 40. The watershed area at the site is approximately 41 square miles. See Table 18 for summary results and Figure 41 for thalweg profiles.

Presently, only riprap dikes and longitudinal dikes are constructed throughout the reach. The reach was observed to be actively incising in 1994 and this incision is occurring at an elevation below the recently placed stone. This site provided a unique opportunity to observe the riprap subjected to severe degradation, and some of the stone placed in the upstream Segment 2 has launched and was no longer visible during the November, 1995 inspection.

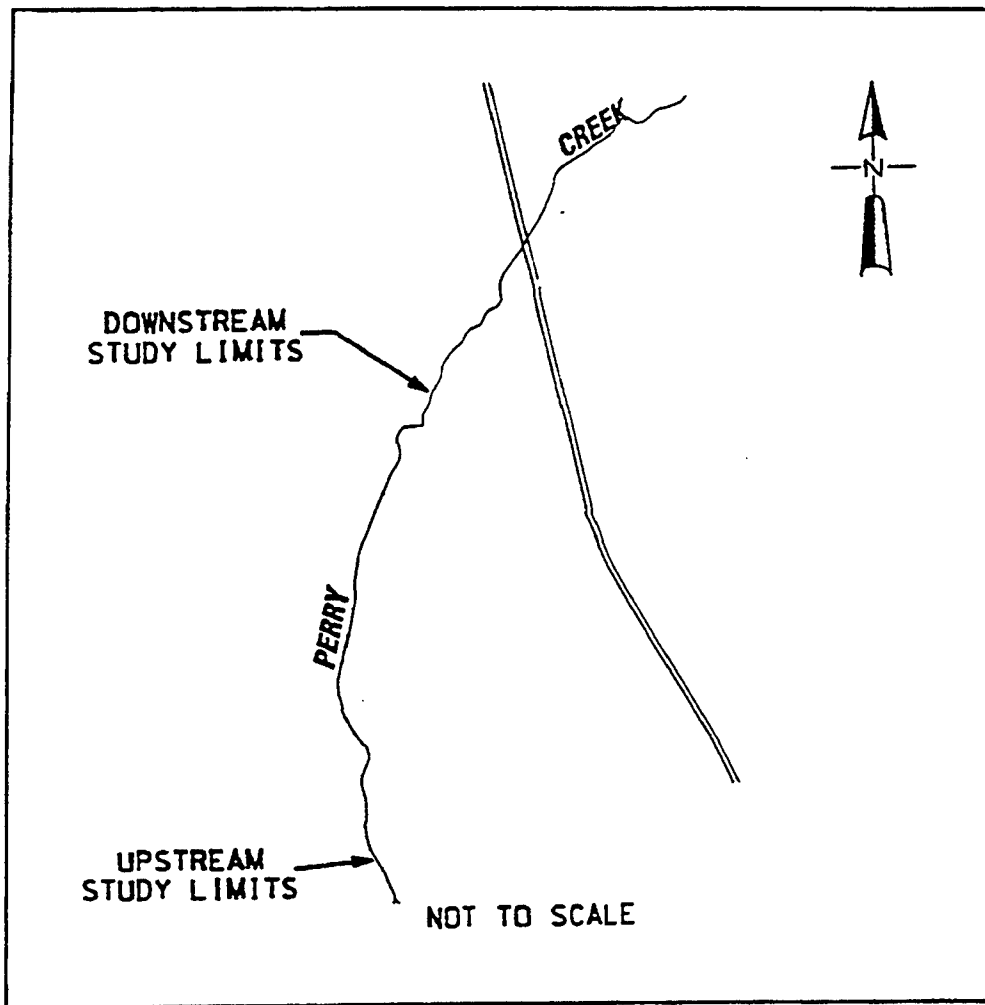
Figure 42. Perry Creek, site #16

Site No. 16 is located on Perry Creek as shown in Figure 42. The study reach begins approximately at the T21N, R4E, Section 1 northern line and continues upstream through Sections 2 and 11. The study reach is located on the McCarley quadrangle map. The entire study reach length is approximately 2 miles, as shown in Figure 3.#. Four low-drop structures were completed during 1994. This site will allow the investigation of the effects of four structures in series. Prior to construction the site was unique because within the study reach, the channel moved from a deeply incised stream at the downstream end to a stream that might have existed prior to channelization at the upstream end. See Table 18 for summary results and Figure 43 for thalweg profiles.
