ERDC/CHL TR-00-1

## **Demonstration Erosion Control Project Monitoring Program**

### **Fiscal Year 1995 Report**

David S. Biedenharn, Nolan K. Raphelt,  
and Chester C. Watson

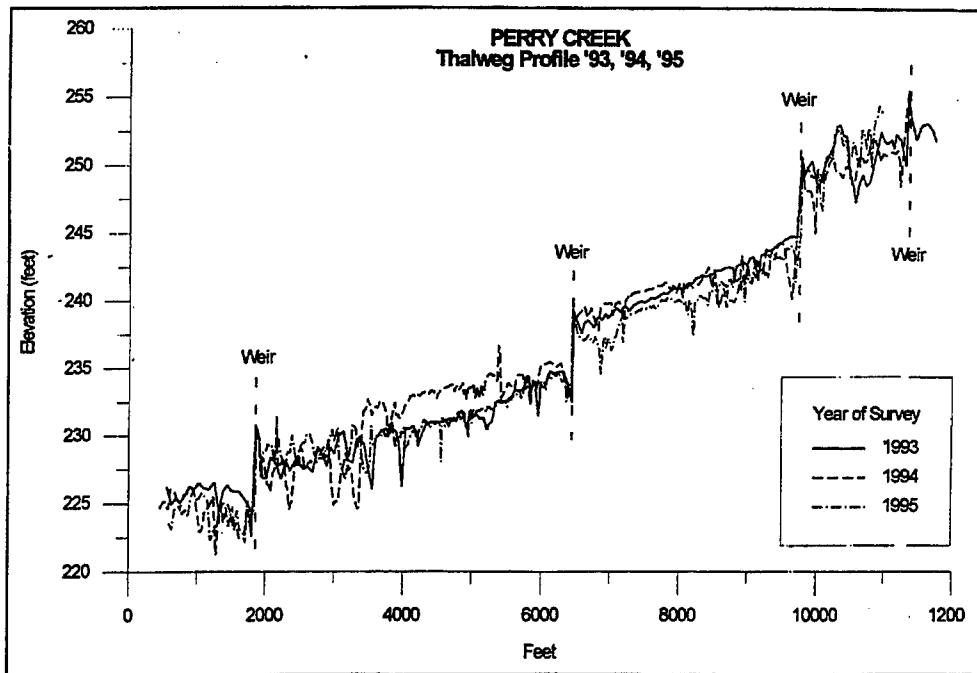
Figure 43. Thalweg profiles for Perry Creek, site #16

Downstream of the lower grade control structure, Segment 1, is ponded as a result of a downstream shale outcrop. The extent and durability of the shale is unknown, and failure of the existing headcut will result in 2 to 3 feet of degradation moving into the structure (Perry #3). Upstream of this structure, the channel is ponded. Segments 1 and 2 transport less than 1000 mg/l. Segment 3 is responding to the structure (Perry #4) and some incision is continuing upstream. A gully on the left bank approximately 500 feet downstream of Perry #5 should be considered for a drop pipe. Although the slope in Segment 4 is very steep, the bed is relatively erosion resistant ironstone and may respond slowly.

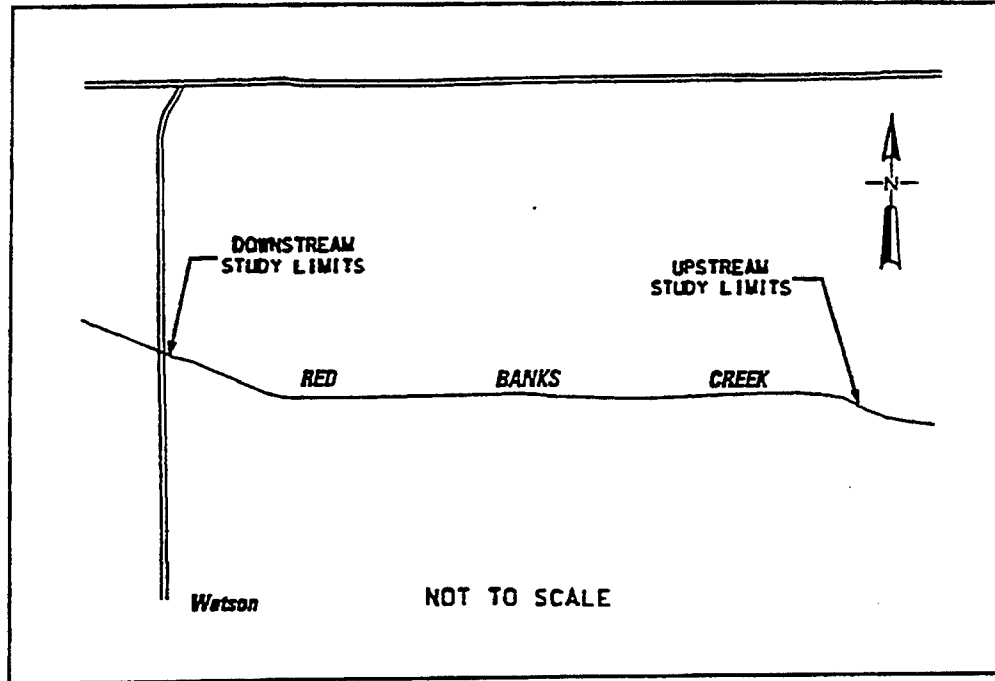
Figure 44. Redbanks Creek, site #9

Site No. 9 is located on Red Banks Creek in the Coldwater River basin. As shown on Figure 44, the study reach extends approximately 2.5 miles upstream from the bridge on the county road between the communities of Warsaw and Watson, Mississippi. This site can be located on the Byhalia quadrangle map, T3S, R5W, Section 24, and R4W, Section 19 and 20, and has a watershed area of approximately

Site No. 9 includes four Chevron dikes and longitudinal riprap for channel stabilization. Bank stabilization, at times along both banks, and grade control have combined to reduce bank erosion; however, the reach is generally unstable with little evidence of berm formation or developing riparian vegetation associated with a naturally stabilizing channel. No CEM designation has been given to this reach.

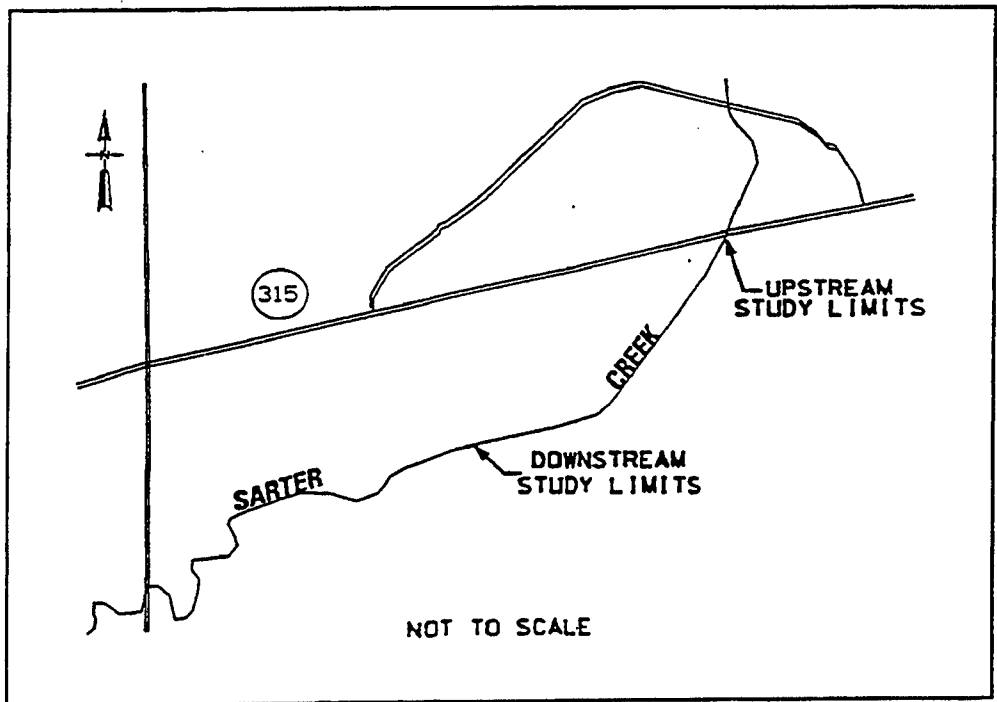
Figure 46. Sarter Creek, site #15

Site No. 15 is on Starter Creek, which is a tributary of Otoucalofa Creek upstream of Site No. 14. Starter Creek is located on the Paris quadrangle map and has a watershed area of approximately 6.4 square miles. The study reach is 4,000 feet in length and is almost completely straight as a result of previous channelization, as shown in Figure 46. This site extends downstream of the Highway 315 bridge. The site is unusual in that it has remained relatively unchanged since channelization; however, it is apparent that headcutting affected the reach in 1993 and continued to degrade the bed in 1994. See Table 20 for summary results and Figure 47 for thalweg profiles.

The 1995 profile indicates continuing incision. Field inspection in November, 1995 confirmed several headcuts, and that numerous beaver dams are playing an important role in maintaining the stability of the channel. The channel ranges from a CEM 4 at the downstream extent to CEM 2 upstream, and has been given a CEM 3 designation overall. Riprap grade control should be considered for the site.

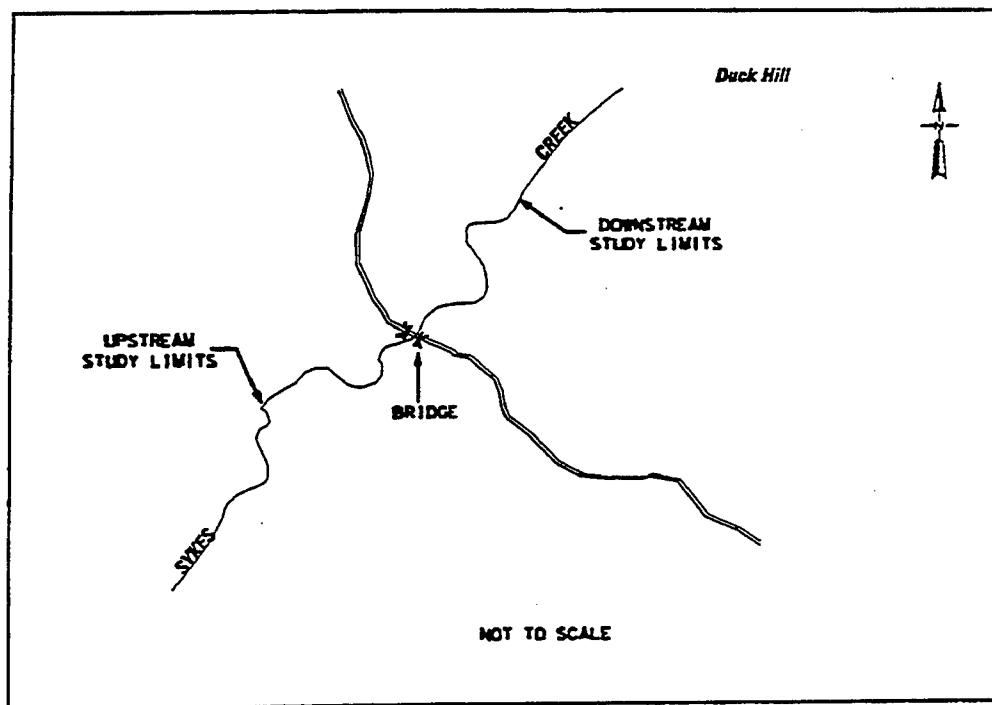
Figure 48. Sykes Creek, site # 17

Site No. 17 is located on Sykes Creek as shown in Figure 48. The study reach extends 2,000 feet upstream and downstream of the county road bridge across Sykes Creek located in T21N, R5E, Section 27. This site is found on the McCarley quadrangle map. Gauging had been available for the approximate 12.3 square mile watershed area at the county road bridge, however, construction of a new county bridge was in progress in November, 1995 and no gauging instrumentation was in place. See Table 21 for summary results and Figure 49 for thalweg profiles.

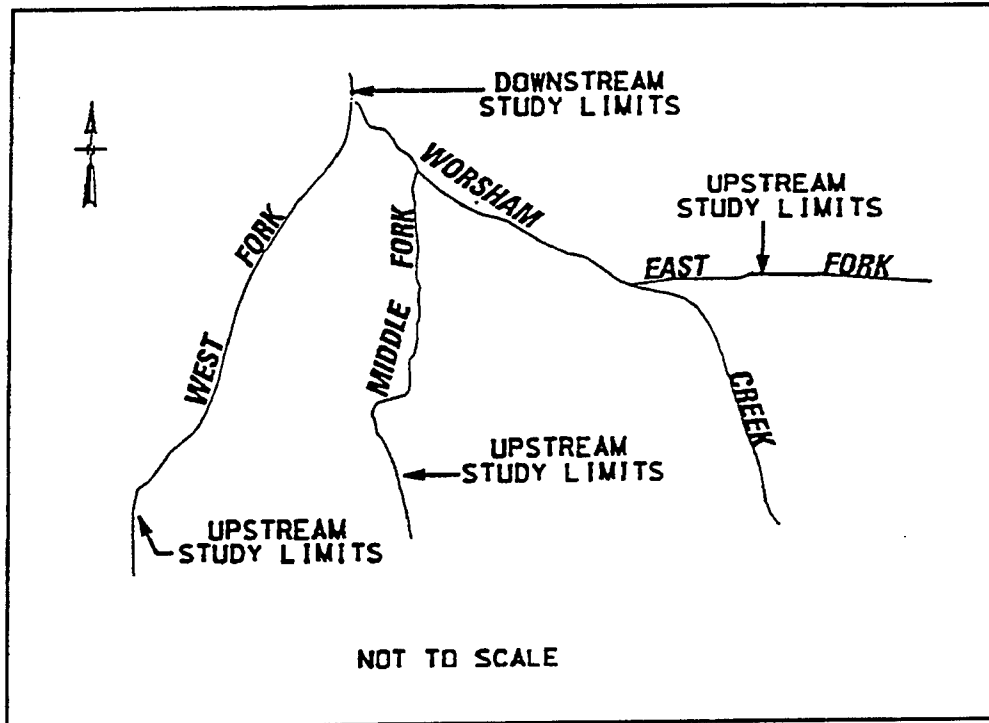
Figure 50. East Worsham Creek (Site 18a), Middle Worsham Creek (site 18b), and West Worsham Creek (Site 18c)

Site No. 18, comprising 18a, 18b, and 18c, is a study reach encompassing portions of Worsham Creek, East Worsham Creek, West Worsham Creek, and Middle Worsham Creek, as shown in Figure 50. The site is located on the Duck Hill quadrangle map in T20N, R6E, Sections 14, 15, 16, 21, 22, and 23. The total stream length being surveyed is approximately 3.5 miles and the watershed area at the

confluence of Worsham and West Fork is approximately 19 square miles. The streams are deeply incised and active. Ten low-drop structures have been constructed in Site 18.

The downstream extent of the Site 18a, defined as East Worsham, is the confluence with Middle Worsham, which is the first confluence downstream of the highway bridge. The reach is divided into three segments. Segment 1 extends upstream from the confluence to the downstream, older structure. The short reach between the two structures is Segment 2. Segment 3 is upstream of the middle structure. The 2-year water surface slope and width as a percentage of the minimum slope and width at minimum slope for the for three segments, and the results of the BURBANK analysis are shown in the accompanying table. The thalweg profile (Figure 51) indicates the location of the structures and the variations in the profile. Downstream of Worsham No. 1 at approximately 38+00, the clay knickzone has begun to fail. In November, 1995 an inner channel was observed to have incised through the clay and to widen. With the failure of the resistant material, active headcutting will increase and will increase the stress at the upstream structure. Between Worsham No. 1 and No. 2, Segment 2 is an eroding channel with bank instability. A longitudinal stone toe along the left bank from structure to structure, with consideration of constricting the approach to No. 1, could improve bank stability and decrease the transport capacity.

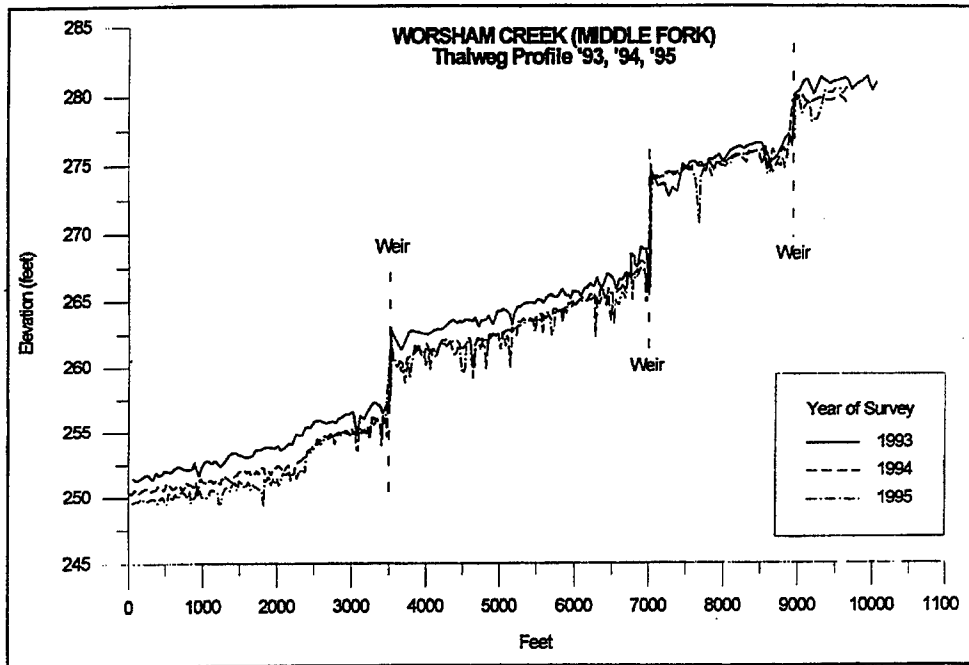
Figure 52. Thalweg profiles for Middle Worsham Creek, site 18b

The downstream extent of Middle Worsham is at the confluence with West Worsham Creek. The total reach is approximately 10,000 feet in length and is divided into four reaches by three ARS-type, low drop structures. See Table 23 for summary results and Figure 52 for thalweg profiles. The accompanying thalweg profile, Figure 52, depicts the degradation that has occurred since 1992 in the lower two segments. The primary location of degradation during the 1994-1995 period was the downstream portion of Segment 1. The table of BURBANK results clearly shows the value of the grade control structures in reducing or maintaining low bank height. Percentage of

bank height unstable for the zero friction angle decreased from 67% in the lower reach to only 3% for the upstream reach. Unfortunately, in the lower reach with no grade control, the percentage of bank unstable will increase as the channel degrades. Minor degradation is continuing at the upstream extent of Segment 2, and incision was observed in the field at Segments 1 and 2. Sediment has filled to the crest of the structure in Segment 3.

Immediately upstream of the confluence of West and Middle Worsham, Segment 1 has a shallow depth of sand, less than 2 feet, for most of segment up to the confluence with East Worsham. Upstream of this confluence, the channel is narrower and nick zones are present. Two drop pipes had been cleared for surveying in 1994 and were not constructed in 1995 in this reach. Again in Segment 2, as the upstream structure is approached nick zones are present and massive bank failures are present. Headcutting in the upstream portion of Segment 3 is moving into the older structure at a slow rate, and the upstream structure basin has significant sand deposits and willow growth. Upstream of the third structure, knickpoints are present at several locations. The right bank is eroding and consideration should be given to fencing the right bank upstream of the third structure to limit cattle access. Consideration of some form of grade control should be made at the upstream extent of Segment 4.

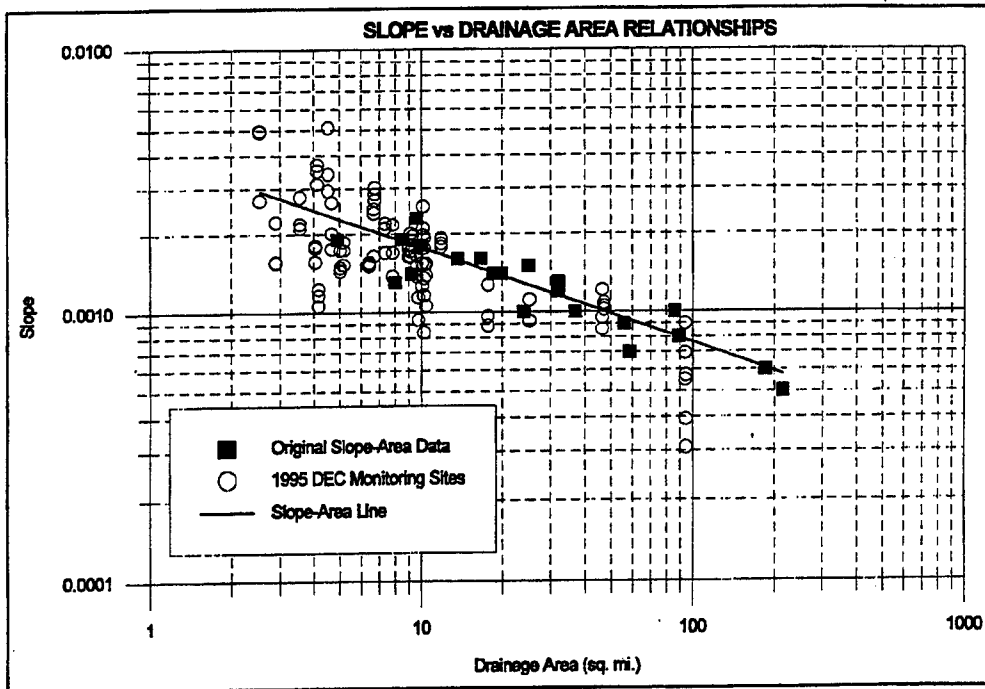
Figure 54. Slope vs drainage area relationship

of stable channel reaches. Figure 54 depicts the original data, the regression of the original data, and data from the 1995 DEC monitoring reaches. Stability was generally defined in terms of the Channel Evolution Model (CEM) (Schumm, et al., 1984). Regression of the original data used in GDM No. 54 results in the following relationship:

One factor to consider is that drainage areas for the DEC monitoring reaches are generally smaller than the original-data drainage areas. As shown in Figure 54, only one reach less than 8 square miles was included, whereas, the DEC monitoring reaches are primarily in the range of 2 to 10 square miles. Figure 55 is a comparison of the DEC monitoring reach energy slope data shown as CEM types, and the GDM No. 54 slope-area curve. For the portion of the slope-area curve greater than 10 square miles, most of the reaches are CEM 4 or CEM 5, indicating a reasonable degree of stability. For drainage areas less than 10 square miles, the slope-area curve is defined by CEM 2 or CEM 3, generally unstable reaches. The CEM 4 less than 10 square miles in drainage area are below the relationship.

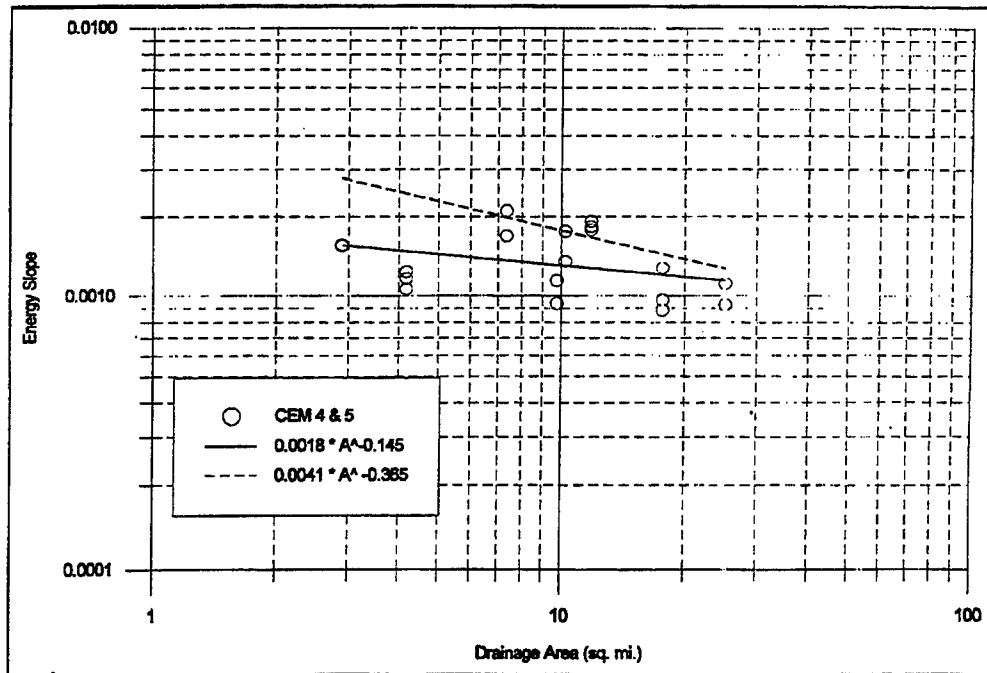
Figure 56. 1995 CEM data with two regressions

Figure 56 is similar to Figure 54, with the following exceptions: a.) 1995 DEC monitoring reach data for only CEM 4 and CEM 5 reaches are plotted; and b.) these data exclude reaches that are ponded because ponding was not included in the original conception of the CEM. A new regression was made of the plotted data and the following relationship was plotted using a solid line (Figure 56):

using the same parameters as previously noted. The GED No. 54 relationship is shown above as the dash line. One of the primary reasons for lowering the relationship is that

the sediment supply to the reaches has been reduced by the numerous drop pipes, land use improvements, and bank stabilization measures that have been employed by the DEC programs. Stability, as defined by the CEM criteria, includes a balance between sediment supply and sediment transport capacity. As the sediment supply has been reduced, the stable slope must also be reduced. Therefore, although the slope-area curve is a useful benchmark for comparison of reaches, the curve will require updating as success occurs in reducing sediment supply. The new relationship has a statistically poor fit; however, it demonstrates that the slope-area relationship must be re-evaluated. Consideration should be given to using design procedures that explicitly include sediment supply and transport capacity.

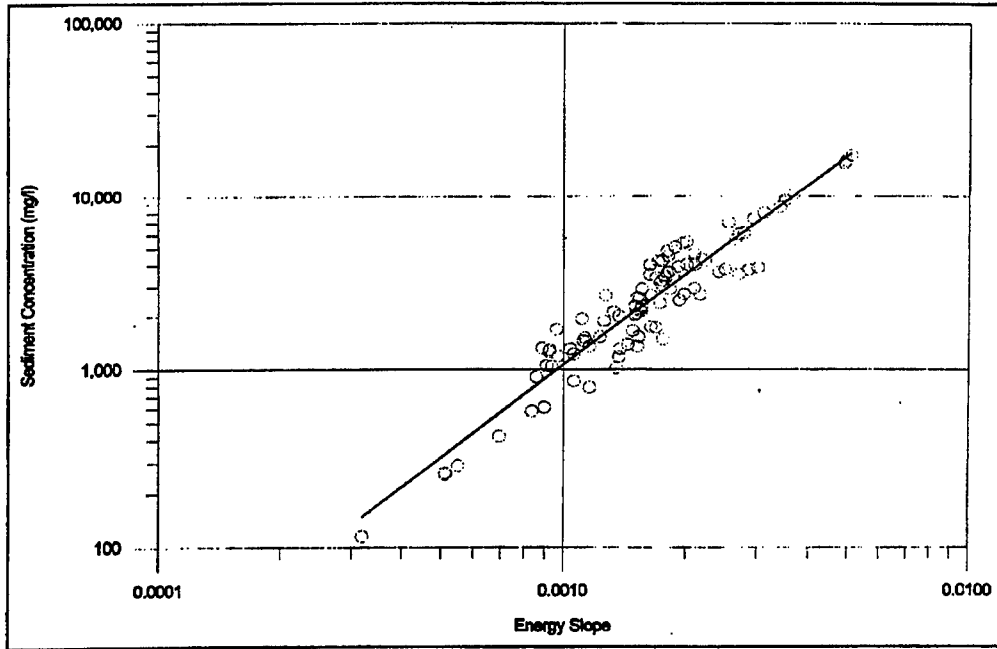
Figure 57. Relationship between energy slope and computed sediment concentration For DEC monitoring reaches

Unfortunately the slope-area regional stability curve, although useful, does not explicitly include sediment yield or sediment transport capacity. The relationships only implicitly include the sediment yield of the stable channels used in the data base. Figure 57 depicts the relationship between the energy slope and the computed sediment concentration in the DEC monitoring reaches. A regression expression for the data is:

with the units of concentration as mg/l, and  $S$  is the energy slope. The coefficient of determination ( $R^2$ ) is 0.89. As shown in Figure 4.4, the sediment concentration for  $S = 0.0009$  is approximately 1000 mg/l, for  $S = 0.004$  the concentration is approximately 10,000 mg/l. Figure 4.5 shows the slope-area curve from GDM No. 54, and has values of sediment concentration taken from Figure 4.4 for selected drainage areas. Therefore, using the slope-area curve for stable channel design would require the designer to accept 712 mg/l at 90 square miles, 2849 mg/l at 10 square miles, and extrapolating the relationship, 7170 mg/l at 2 square miles.

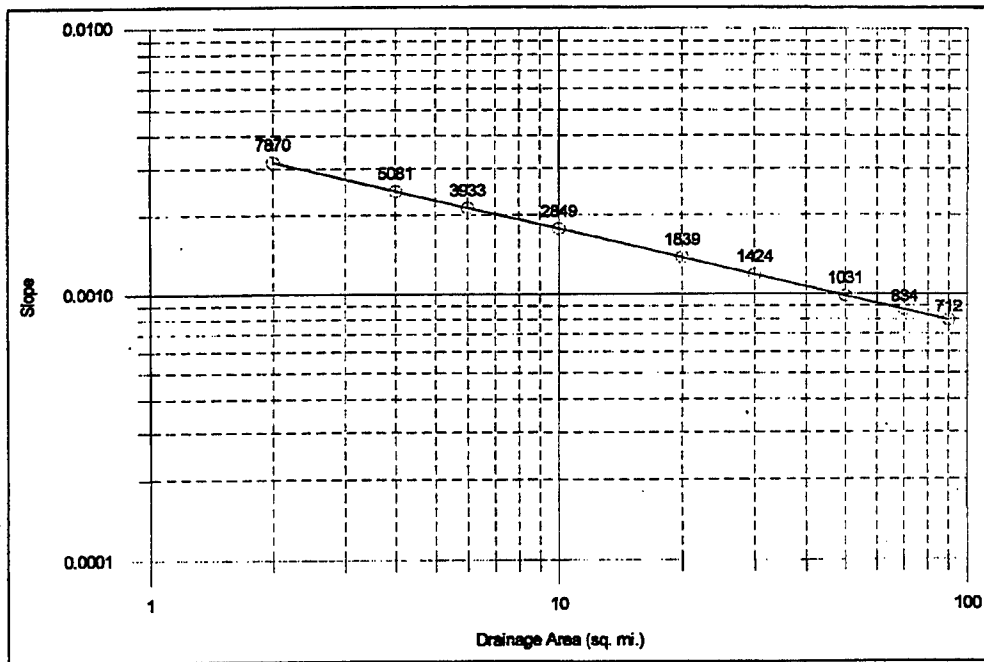
Figure 58. Sediment concentration for the 2-year discharge along the GDM No. 54 slope-area curve

The consequence of designing grade control using the GDM No. 54 slope-area curve, when considered in a sediment transport frame of reference, can be examined in a general sense using data from the DEC monitoring reaches. The average sediment transport capacity expressed as a concentration for all of the DEC monitoring reaches at the 2-year discharge is 3428 mg/l. The average drainage area for the DEC monitoring reach segments with grade control is 7.4 square miles, and from Figure 4.5 the average sediment concentration is 3446 mg/l using the GDM No. 54 slope-area curve. Therefore, reaches that include grade control structures designed using the GDM No. 54 slope-area curve may reduce sediment concentration in those reaches, however, the reaches would continue to contribute sediment at the same or greater concentration as compared to the present overall average concentration. A new procedure should be considered to enable design for reduction of sediment yield.
