# Metallurgical Examination of a Failed Blade Lag Shock Absorber (Part No. 114H6802) From a CH-47D Chinook Cargo Helicopter

ARL-TR-2191

March 2000

**Marc S. Pepi, Scott M. Grendahl, and Victor K. Champagne**  
Weapons and Materials Research Directorate, ARL

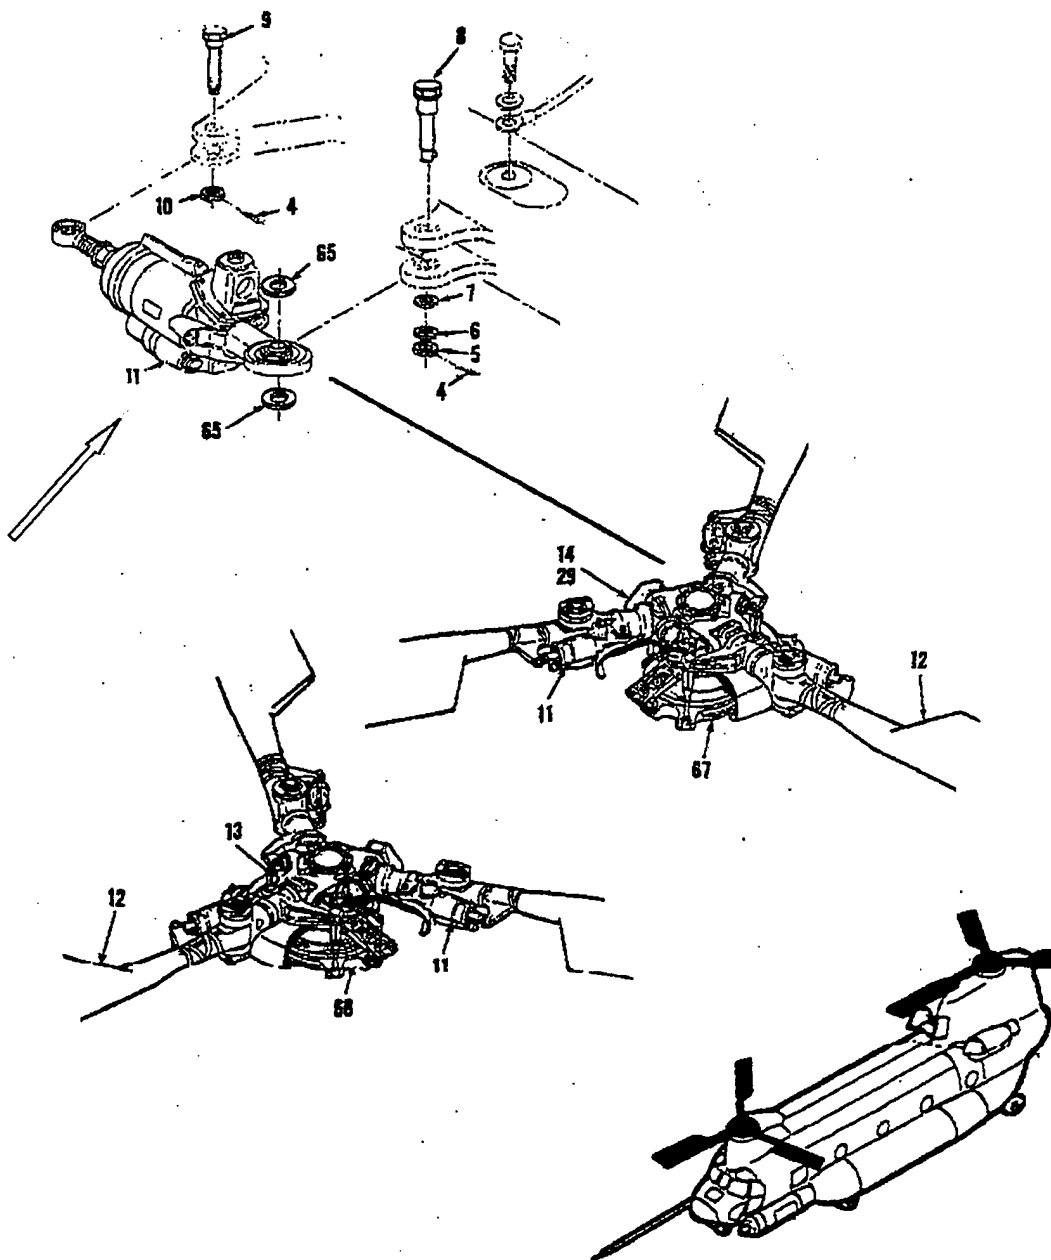
**Figure 3. Schematic Showing the Location of the Blade Lag Shock Absorber on the CH-47D Chinook Helicopter.**

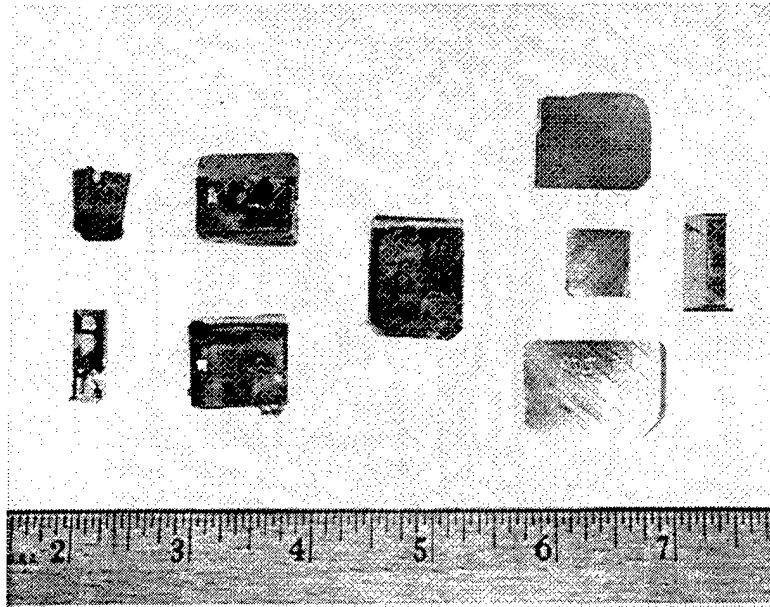
**Figure 4. Sections of the Failed Blade Lag Shock Absorber as Received From Boeing; Reduced 31%.**

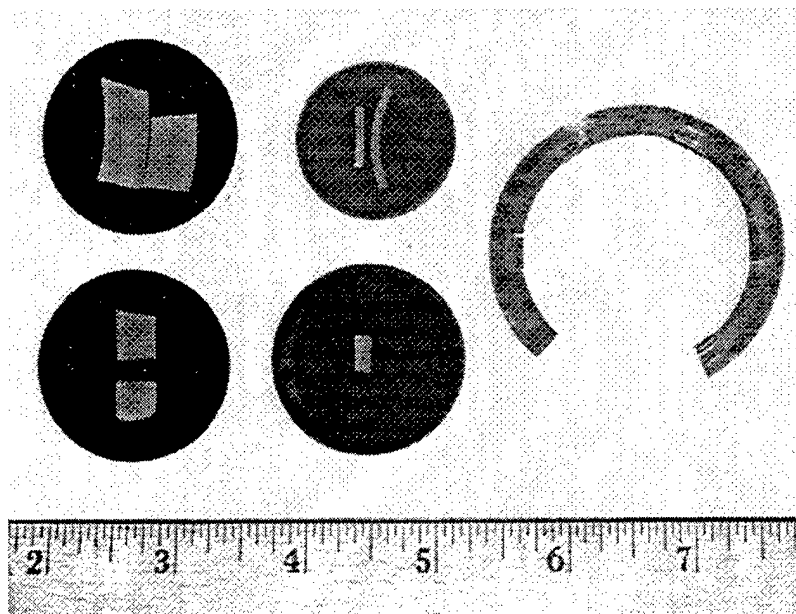
**Figure 5. Mounted Samples of the Failed Blade Lag Shock Absorber and a Sectioned Collar as Received From Boeing; Reduced 28%.**

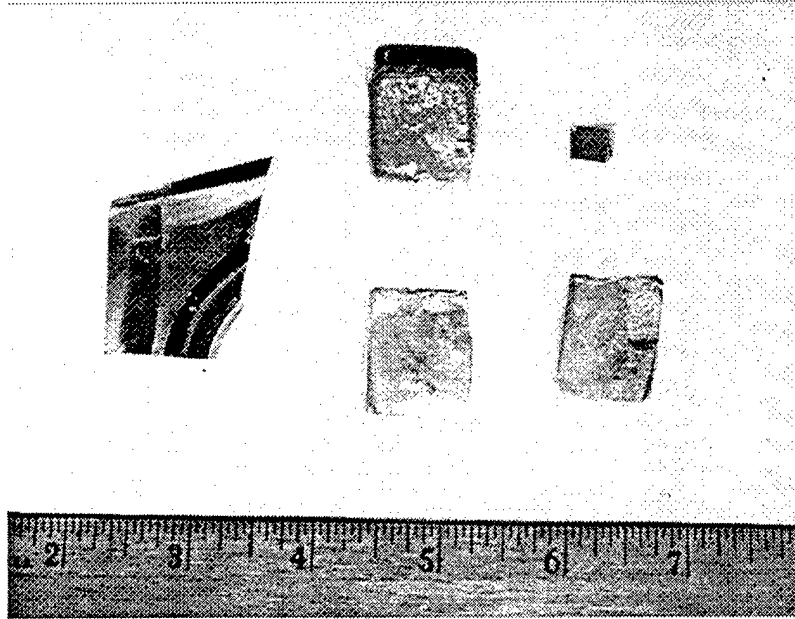
**Figure 6. Sections of the Failed Blade Lag Shock Absorber Including Fracture Surfaces as Received From Boeing; Reduced 31%.**

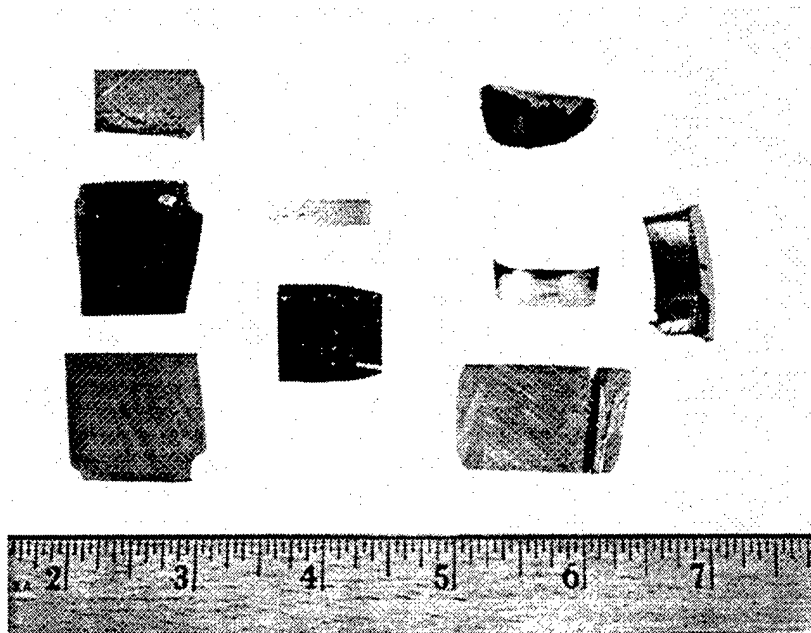
**Figure 7. Additional Sections of the Failed Blade Lag Shock Absorber as Received From Boeing; Reduced 31%.**

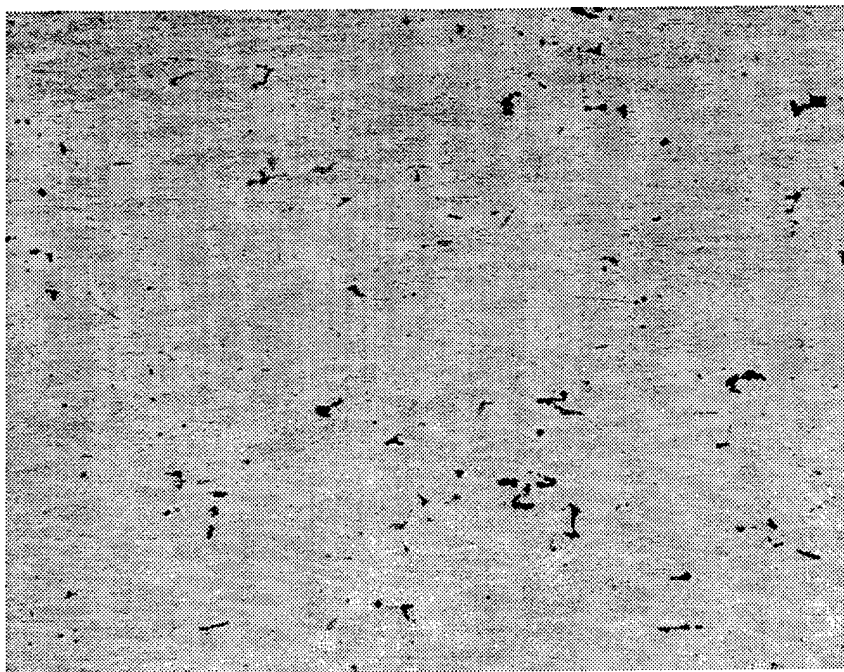
**Figure 16. Micrograph of the Etched Microstructure of the 7075 Alloy; Keller's Etch, Magnification 200 $\times$ .**

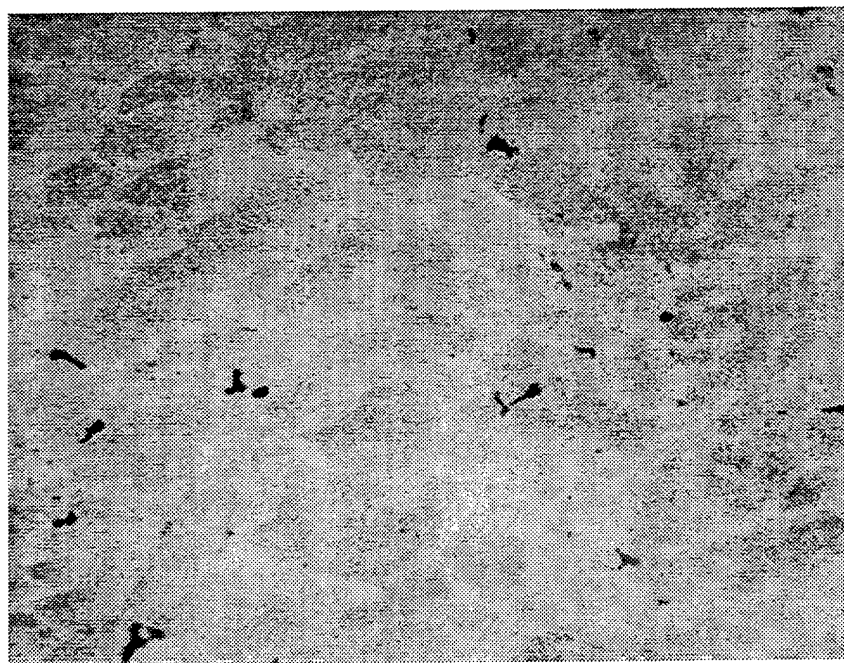
**Figure 17. Micrograph of the Microstructure Shown in Figure 16, at Higher Magnification; Keller's Etch, Magnification 500 $\times$ .**

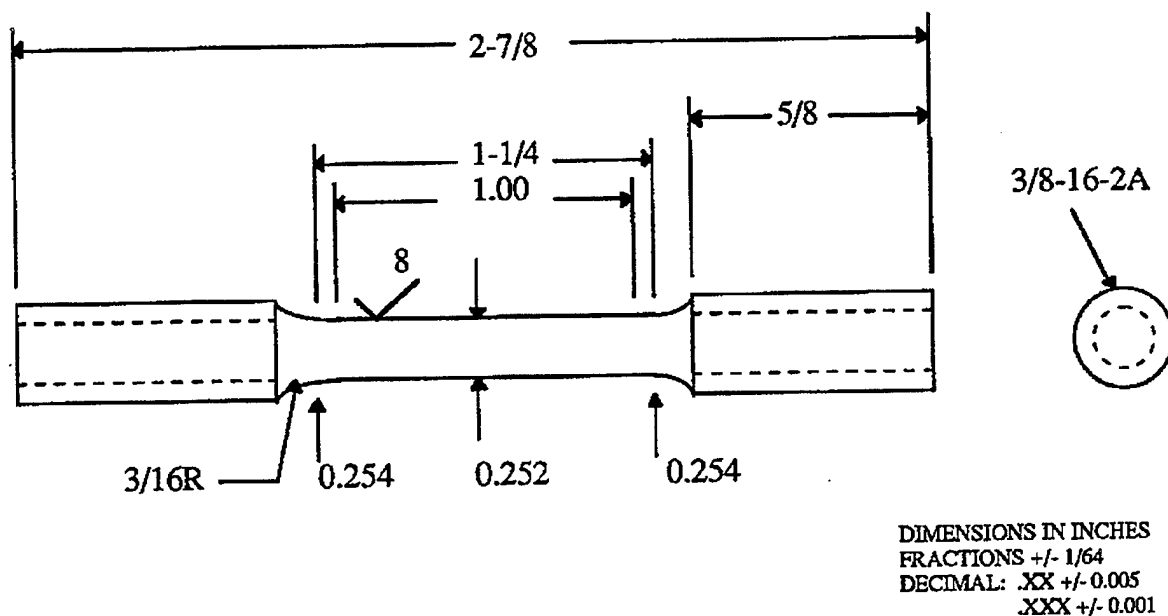
**Figure 24. Schematic Showing Dimensions of Tensile Specimens Sectioned From the Blade Lag Shock Absorber Housing and Tested by ARL; Specimen Conformed to ASTM E8 [4].**

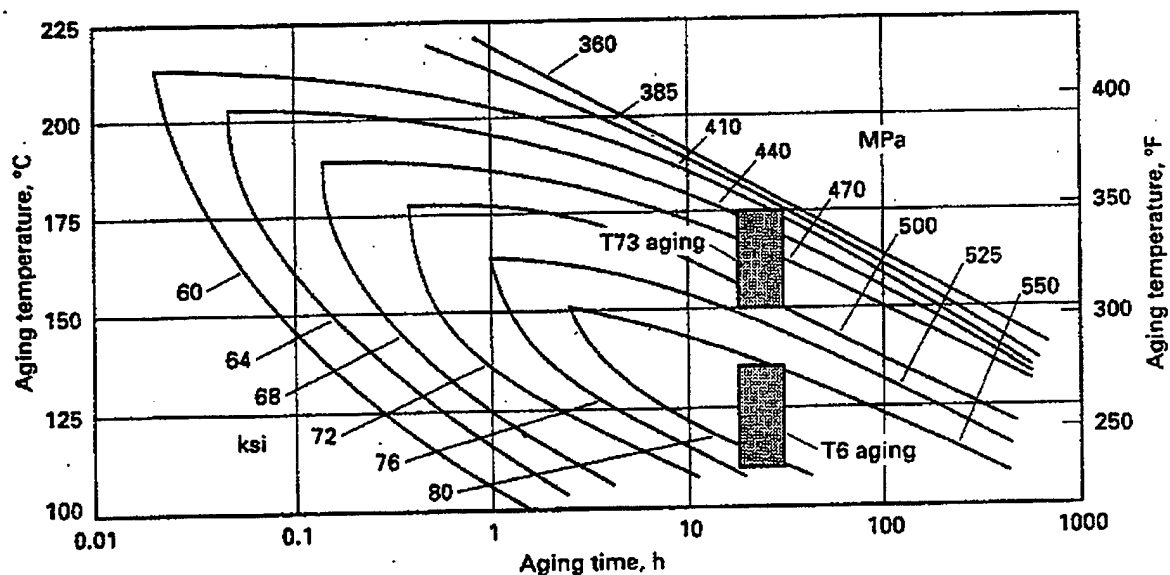
Type 7075 aluminum in the -T73 condition offers a superior combination of high strength and resistance to stress corrosion and exfoliation corrosion. The strength is less than that of the -T6 temper, but the corrosion resistance is greater (as strength increases, corrosion resistance tends to decrease for this alloy). However, the properties obtained by this condition are extremely sensitive to small variations in aging times and aging temperatures (approximately five times greater sensitivity than that of the -T6 condition, for comparison). Consequently, control of both temperature and time to achieve the mechanical properties and corrosion resistance specified for these tempers is more critical than the control required in producing the -T6 temper [5]. The -T6 aging temperature can range from ~225° F to ~275° F with a variation in UTS of only 4 ksi. However, it has been shown that variations of 50° F during the -T73 aging treatment affects the UTS of -T73 by as much as 16 ksi. (Figure 25 [11]). In addition, the rate of heating from the first to the second aging step has to be taken into account since precipitation also occurs during this period. In order to determine whether the alloy had been properly aged, hardness and conductivity testing was performed. The material exhibited hardness and conductivity measurements within the respective limits but at the low end of the conductivity range and the high end of the hardness range. Tensile testing was conducted as the deciding factor to determine whether the proper aging sequence was performed, since the conductivity measured between 38.0 and 39.0% IACS (per MIL-A-22771 [3]). Testing tensile performed by ARL revealed yield strengths greater than the maximum requirement for four of the five specimens. Taking into account the tensile testing performed by Boeing, a total of five of eight specimens failed to meet this requirement. This showed that the material may not have been properly aged per the requirements of MIL-A-22771 [3]. It is possible that this would have facilitated intergranular attack, but it is also possible that the rework solutions may have had the same effect on properly aged 7075-T73 material.

Figure 25. Iso-Yield Strength Curves for Aluminum Alloy 7075 [11].

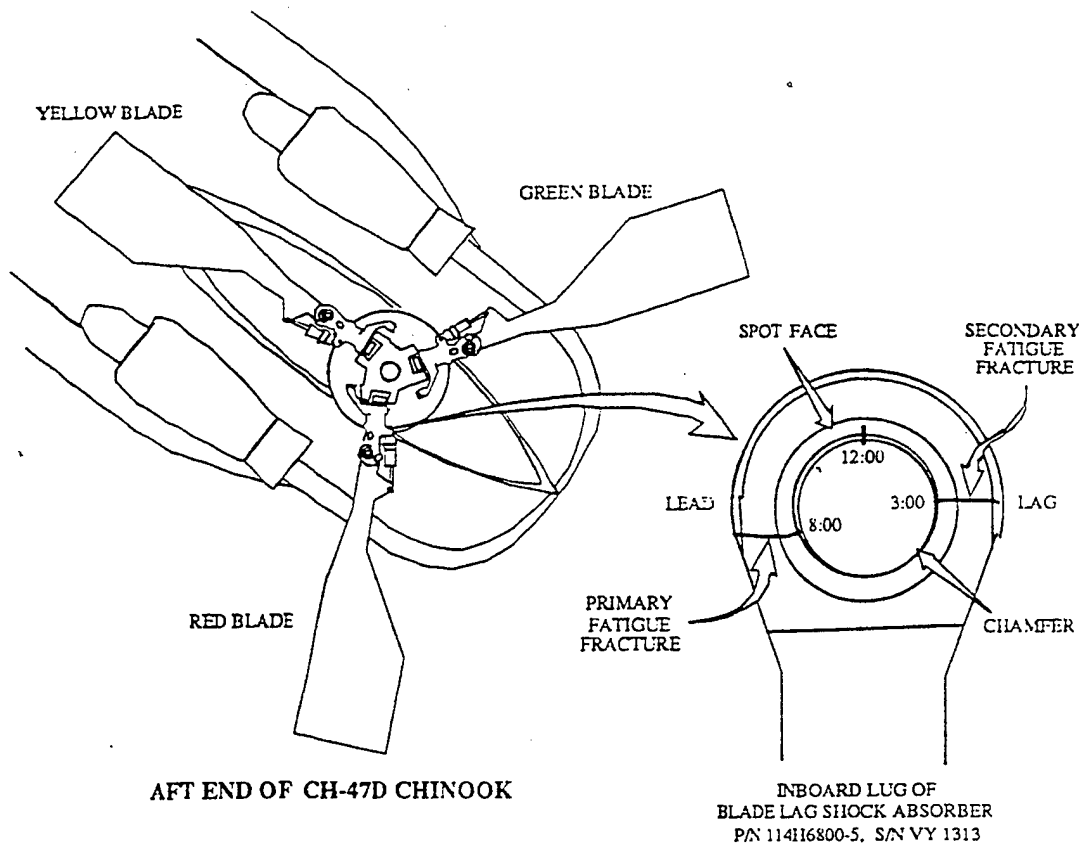
Figure 1  
Sketch illustrating the location of the through fractures in the inboard lug of the aft red shock absorber
