ERDC/CERL TR-00-24

## **Condition Assessment of Building 6237, Old Hospital Complex, Fort Carson, CO**

August 2000

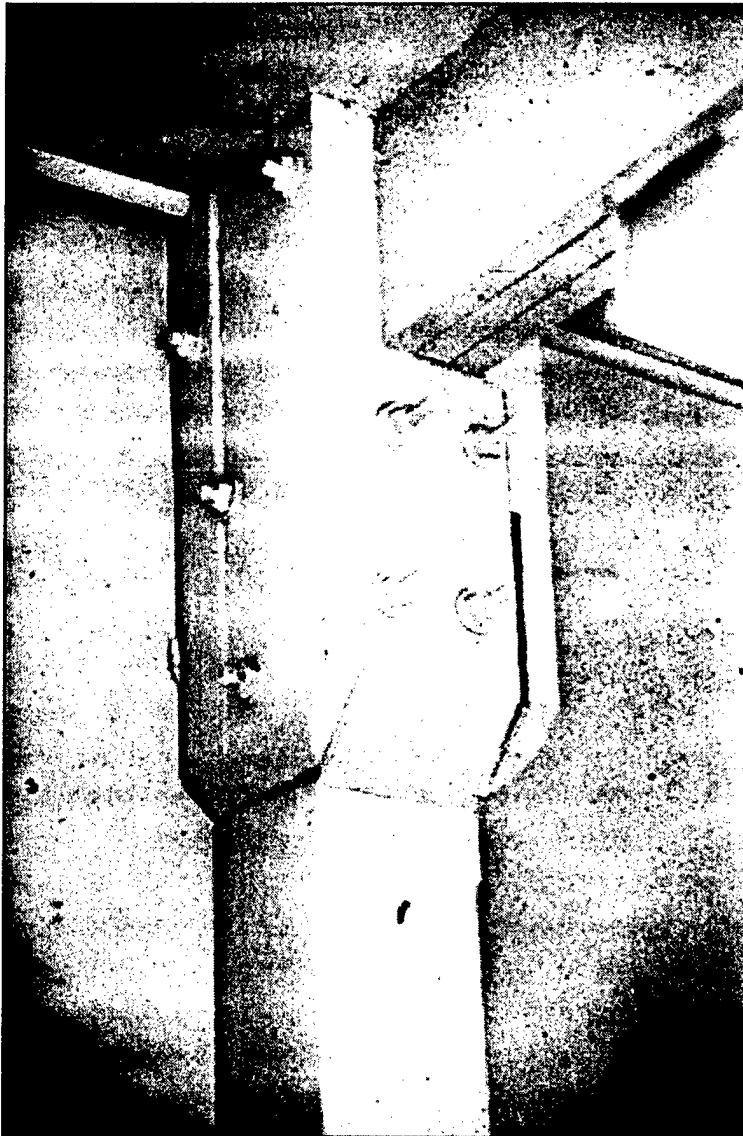
Figure 3-9. Beam pocket detail.

umn tops. A "beam pocket" is created by lapping 2 X 8s over the outer surfaces of the column; the beams are bolted through this beam pocket (Figure 3-9). Within the center core of the building, joists are carried by load-bearing 2 X 4 stud walls. Solid blocking between joists at the beams and bearing walls prevents overturning. There is one row of cross bridging within each span. Floor sheathing consists of nominal 1-in. boards placed diagonally across the joists.

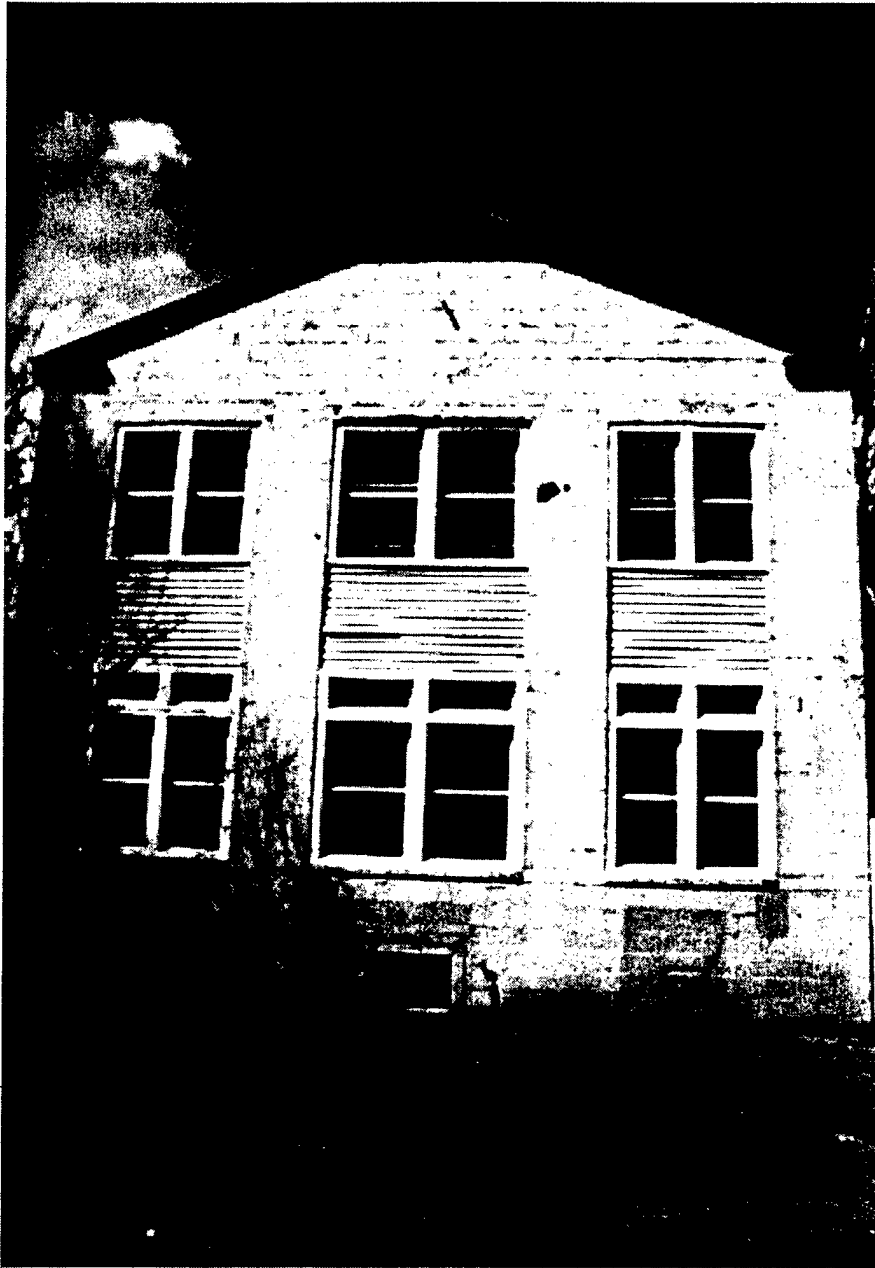
Figure 3-13. Gable end.

When viewed from the ground, each side of the gable appears to be quite flat and straight (Figure 3-13). The ridge appears to be flat and straight. No sagging was evident in any part of the roof. No further inspection was conducted from the outside.

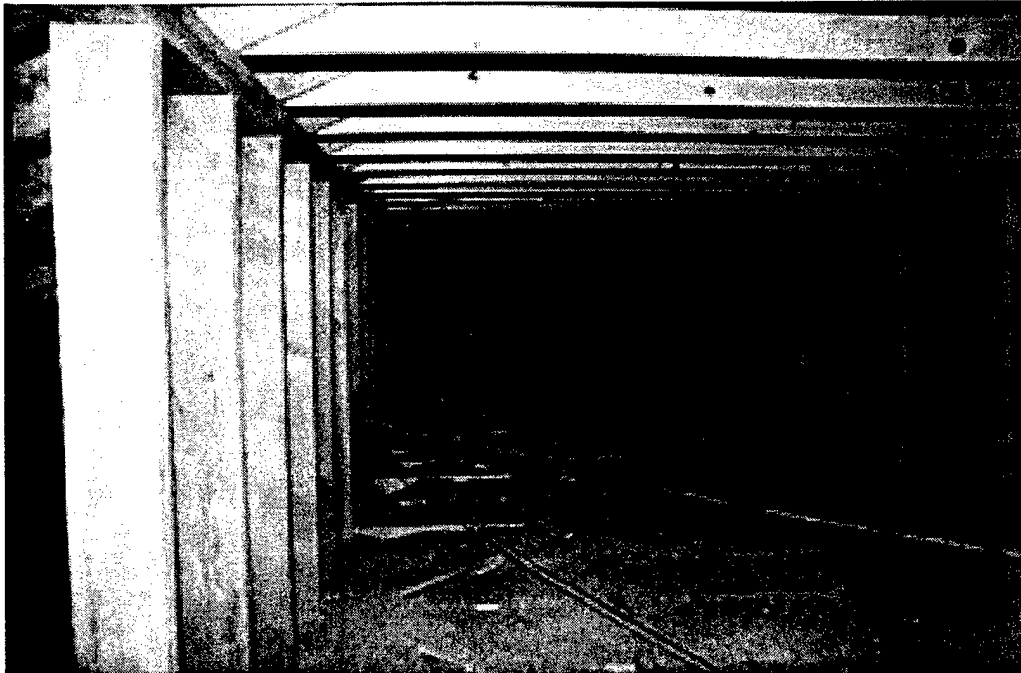
Figure 3-14. Roof framing — rafters and knee walls.

When viewed from below (from the attic spaces), the roof framing system appeared to be straight and true (Figures 3-14 and 3-15). Rafters were generally free from checks and knots. Pencil marks were observed, presumably made during construction, and members were still aligned with the marks. Structural members and sheathing appeared to be clean, with no evidence of water damage, or even staining. The bottom edges of rafters, in all locations, were aligned, with no saddles or sagging observable. There was no visible nail pulling, splitting, dislocation, or other sign of distress to suggest excessive uplifting at the eaves. Ridge boards were level and straight. The only irregularity observed in ridge boards was due to the slightly different dimensions of each individual 2 X 8. Knee walls were plumb, with no dislocation observed. Several ceiling joists were tested for level in several locations within each building bay. Some cracking was observed in ceiling surfaces (see "Ceiling Finishes" under Interior Construction). The joists above, however, were found to be level, with no signs of deflection or deformation.

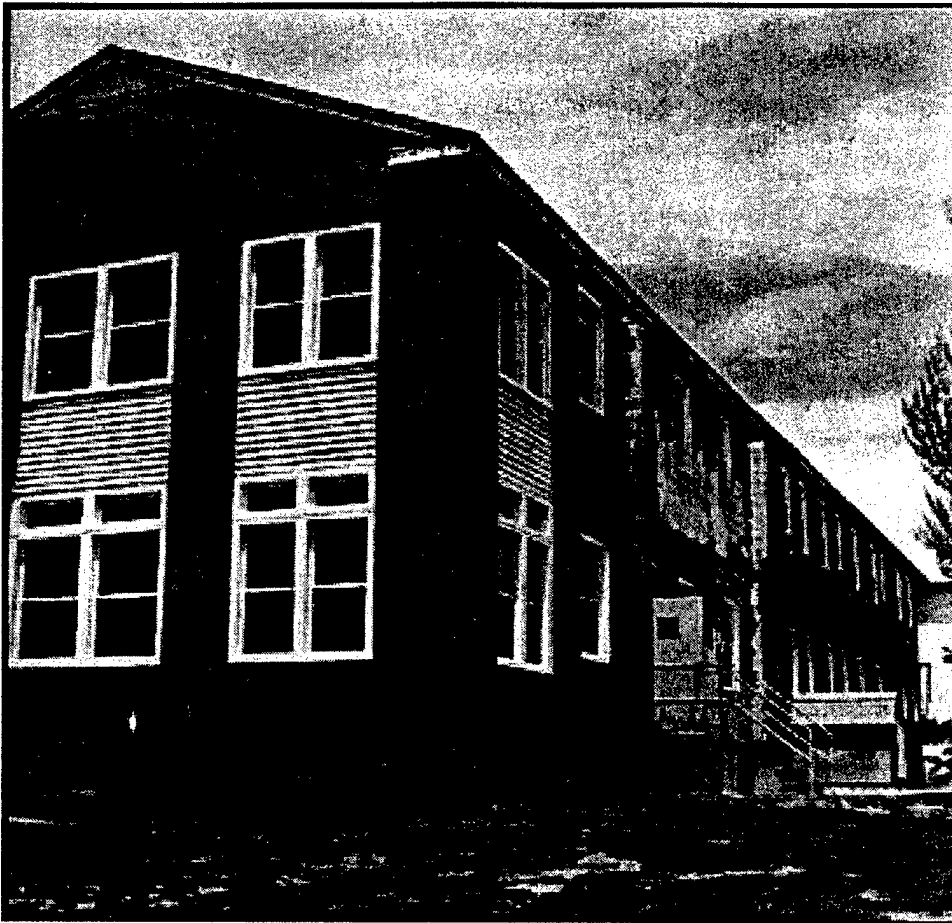
Figure 3-29. Original clapboard siding in stairwells.

One of the few architecturally defining features of the building is the panels between first and second floor windows at the stairwells. They are presently covered in vinyl siding. However, wood clapboard siding is present in similar buildings in the complex. This siding is framed into openings (similar to window framing) in the masonry wall (Point S and Figure 3-29). The vinyl would have to be removed and the original clapboard siding restored or replaced with a historically correct profile.

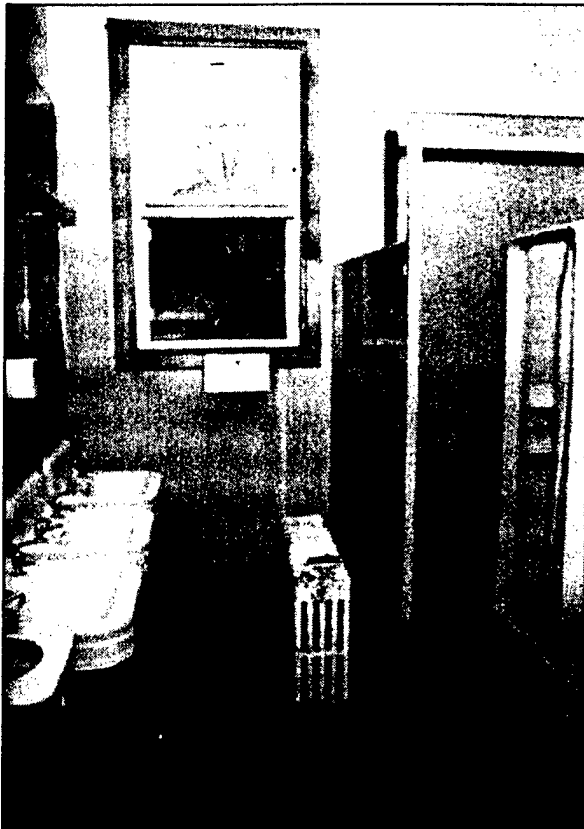
Figure 3-33. Group bathroom.

- Four group bathrooms (two on each floor), each consisting of three toilets, one urinal, four lavatories, and two showers (one of which was formerly a bathtub). All fixtures remain in place (Figure 3-33).
- Four lavatory rooms (two on each floor), each consisting of one bidet and one lavatory. Some bidet fixtures remain in place (Figure 3-34).
- Six private patient rooms (three on each floor), each having one toilet and one lavatory. Toilets and some lavatory fixtures remain in place (Figure 3-35).
- Four service closets (two on each floor), each having one janitor's sink, which remain in place (Figure 3-36).
