Periodic Inspection Report No. 4
West River
Townshend, Vermont

Townshend Lake

October 1996

US Army Corps
of Engineers

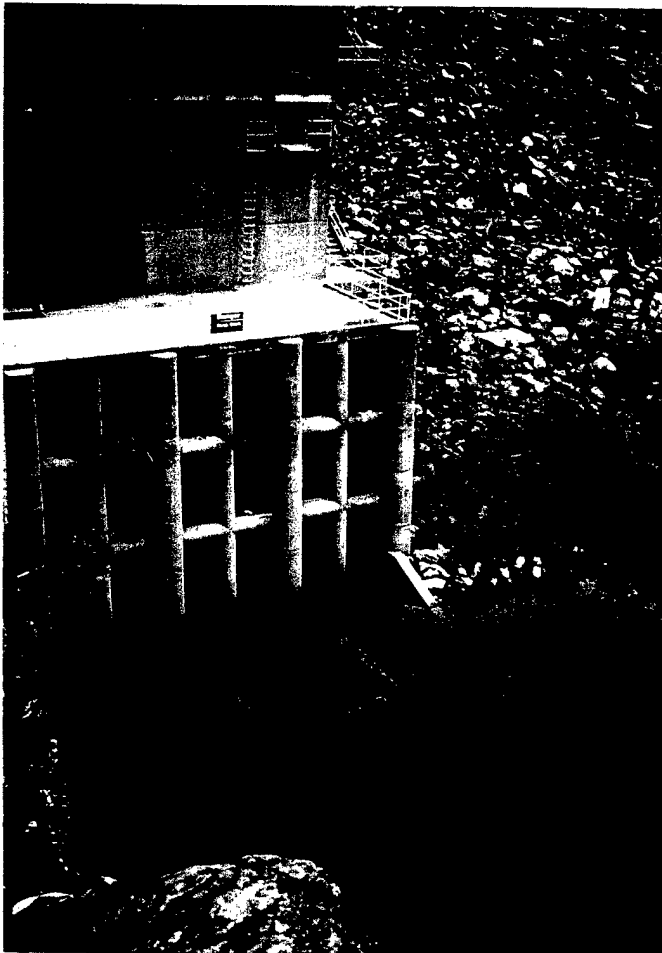
PHOTO A-14. General
view of upstream
control weir and trash
rack.

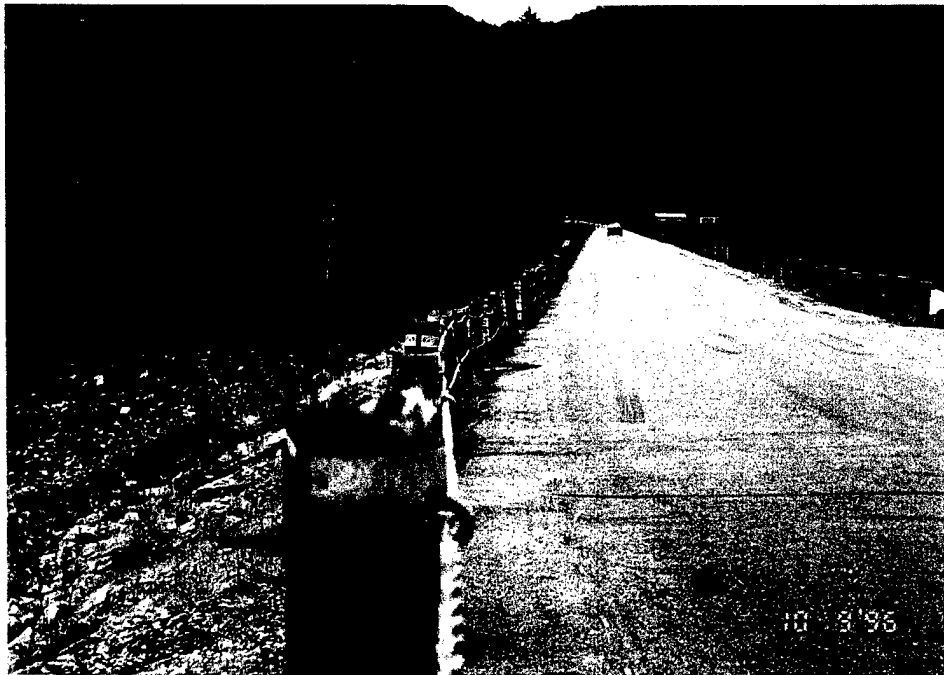
PHOTO E-3: Crest of dam, looking towards right abutment. Note posts moved out of alignment by snow plows.

(a) Vertical Movement. As shown on Plate 3, the surveys indicate that the largest vertical movement of any one crest monument from 1978 to 1996 was 0.37 ft (4.43 in), measured at monument T-11. This movement is attributed to the monument having sustained physical damage from snow plowing prior to the 1996 survey. Excluding monument T-11, the largest settlement was 0.13 ft (1.56 in), which occurred at monument T-6. Monuments T-3 through T-6, all located above the old river valley where the embankment has its greatest height,

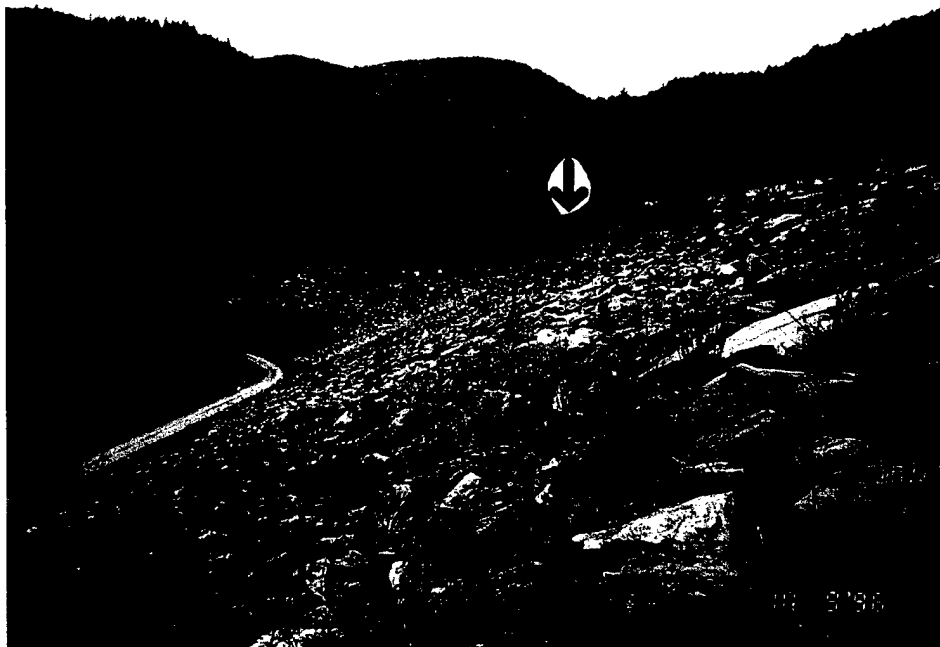
PHOTO E-7: General view of downstream slope of dam. Note tree growth at top of rock fill blanket (at arrow).

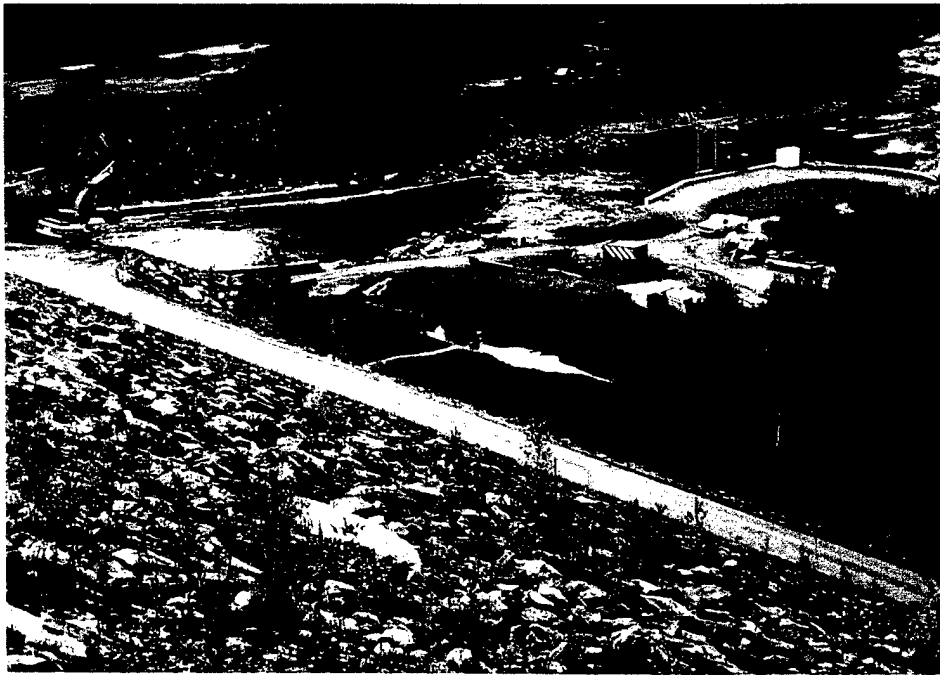
and E-10, Appendix II. No subsidence or movement of the rock fill slope immediately above the seepage area was observed.

PHOTO E-10: View of seepage pool and outlet channel. Note seepage at downstream toe.
