CORROSION EXPERIENCE WITH TYPE 316 STAINLESS STEEL  
IN SODIUM-POTASSIUM EUTECTIC ALLOY AT 1400°F

**IDAHO NUCLEAR CORPORATION**  
NATIONAL REACTOR TESTING STATION  
IDAHO FALLS, IDAHO

IN-1185  
Issued: October 1968  
Metals, Ceramics and Materials  
TID-4500

T. L. Hoffman

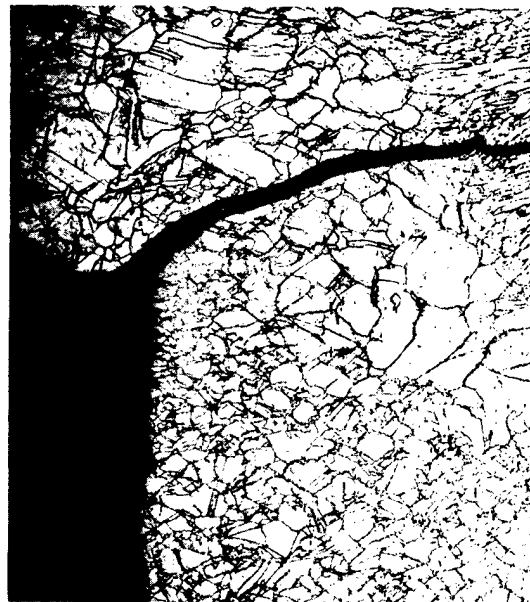
Figure 10 NaK expansion tank weld failure after 3,240 hours at 1100-1400°F service.

During the post-failure examinations of two pipe tee connectors, cracks were observed in welds; in addition, adjacent piping which was exposed for a total of 17,024 hours was cracked. Cracks were propagated both transgranularly and intergranularly, as shown in Figure 10. Notches which are sites for local stress raisers were found in each of these weld structures.

A microscopic examination of cross sections of the pipe-weld-pipe joint revealed only one crack in the weld and none in the piping. The crack was propagated both through the grains as a transgranular fracture and between the grains as an intergranular fracture, as shown in Figure 10. No plastic deformation of the grains of the weld occurred. No sigma phase or carbide precipitation at the grain boundaries of either the wrought piping or the case weld deposit was found. Electron microscope fractographs of this weld are typified by classic striations or crack arrest lines shown in Figure 12. By comparing this fractograph against published<sup>(15)</sup> standards, the fatigue failure appeared to be caused by multi-cycle, low stress forces. Evidence of "dimples", typical of ductile fractures, were absent.

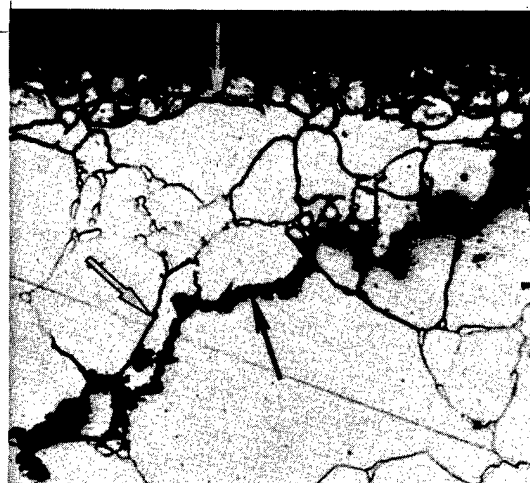
Figure 16 Crack on inside of pipe tee connector after 15,800 hours of service at about 1100-1400°F. Fine black lines indicated by white arrows are grain boundaries outlined by etching. Black arrow shows the crack.

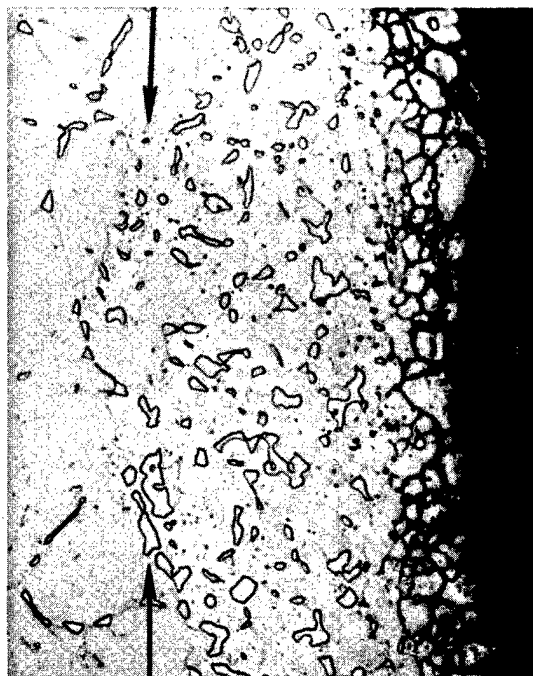
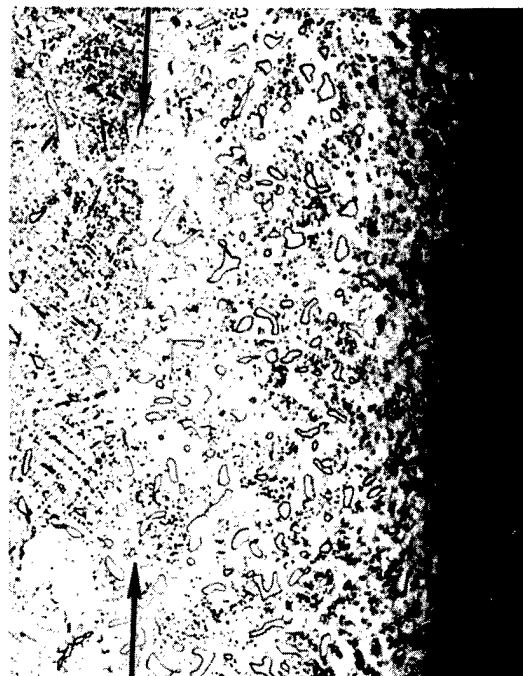
Additional metallographic examination of the pipe tee and connector material provided useful information for the evaluation of the effects of the prolonged exposure to high temperatures and NaK. Figures 17 and 18 are identical areas before and after etching with modified Vilella's etch composed of 1 part HF, 2 parts  $HNO_3$ , and 3 parts glycerol. The modified Vilella's etch ( $\sim 15$  seconds) attacked a layer of material approximately 0.0008 to 0.001 inch thick on the NaK side of the tee and connector. Etching the same material an additional 30 seconds brought out the structure shown in Figure 19. Three regions are evident--the outer region with the heavy grain boundaries, a second region running from the heavy grain boundary area to the black arrows, and a third one comprising the remainder of the wall thickness. Figure 20 shows the same sample after being repolished and then re-etched with the standard

Figure 17 Internal crack in wall of connector. (Same area shown in Figure 16.)

Figure 18 Internal crack in wall of connector. (Same area shown in Figure 16.)

By repolishing the samples once more and re-etching with Vilella etchant, sigma phase was tentatively identified as being the large microconstituents shown in Figures 19 and 20. These particles were stained various opalescent colors by Murakami's etchant; thus, further confirming the presence of sigma phase. The fine precipitates evident in Figure 18, are most likely chromium carbides since sigma phase forms

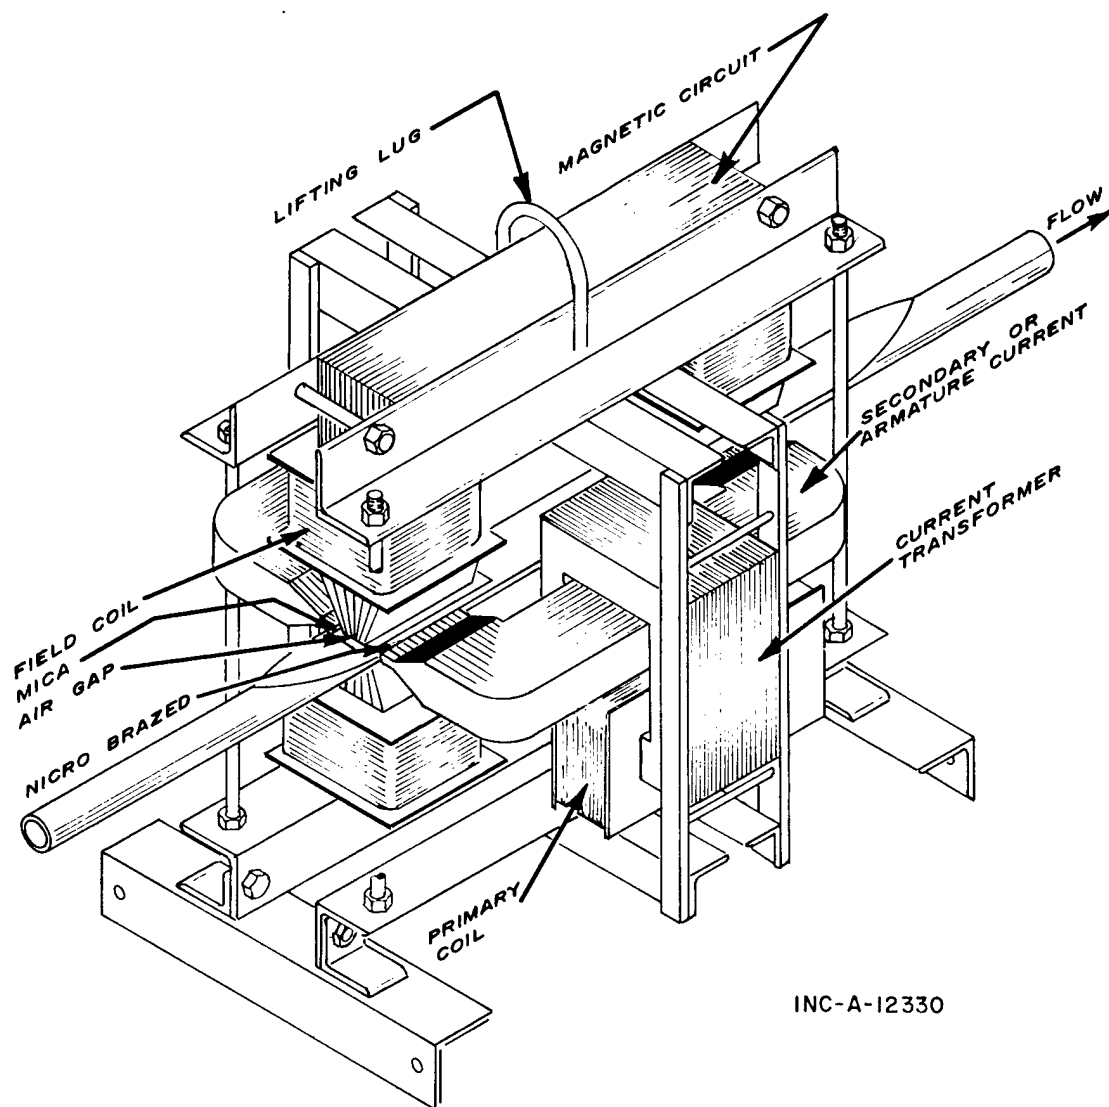
After dismantling the field coil, current transformers, and primary coils, a pin-hole was observed on top of the suction side of the pump tube just under the mica which insulates the field coil from the tube as shown in Figures 32 and 33. Using a 1/4-inch fly-cutter, the tube was machined to expose the NaK side of the pin-hole, Figures 34A, 34B, and 34C.

Figure 32 NaK electromagnetic pump.
