CH-47 accident summary

CH-47 ACCIDENT SUMMARY

1 July 1966 through 30 June 1967

by
P. R. Thompson

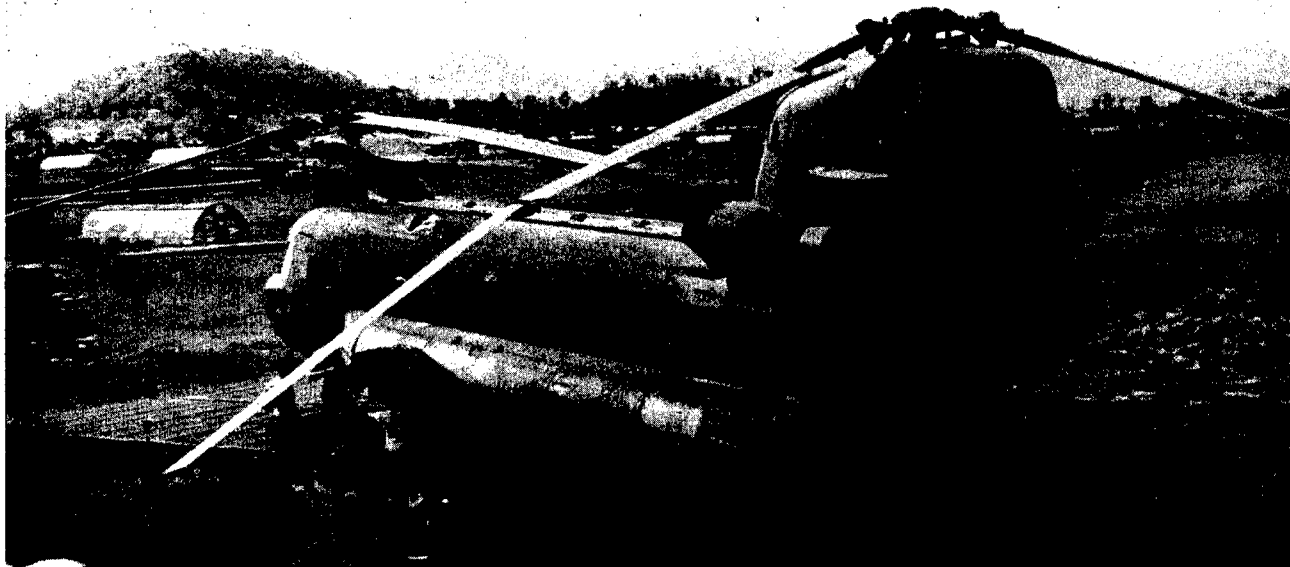
011506—Aircraft disintegrated in air. Six crew-

members and three passengers killed. Caused by fatigue failure of spar of one aft rotor blade at station 200.5.

011506-Fatigue failure of aft rotor blade spar caused aircraft to disintegrate during flight.
