UH-1 ACCIDENT SUMMARY

Majors, Minors,
Incidents,
Forced Landings,
Precautionary Landings

1 JULY 1960 THROUGH
30 JUNE 1965

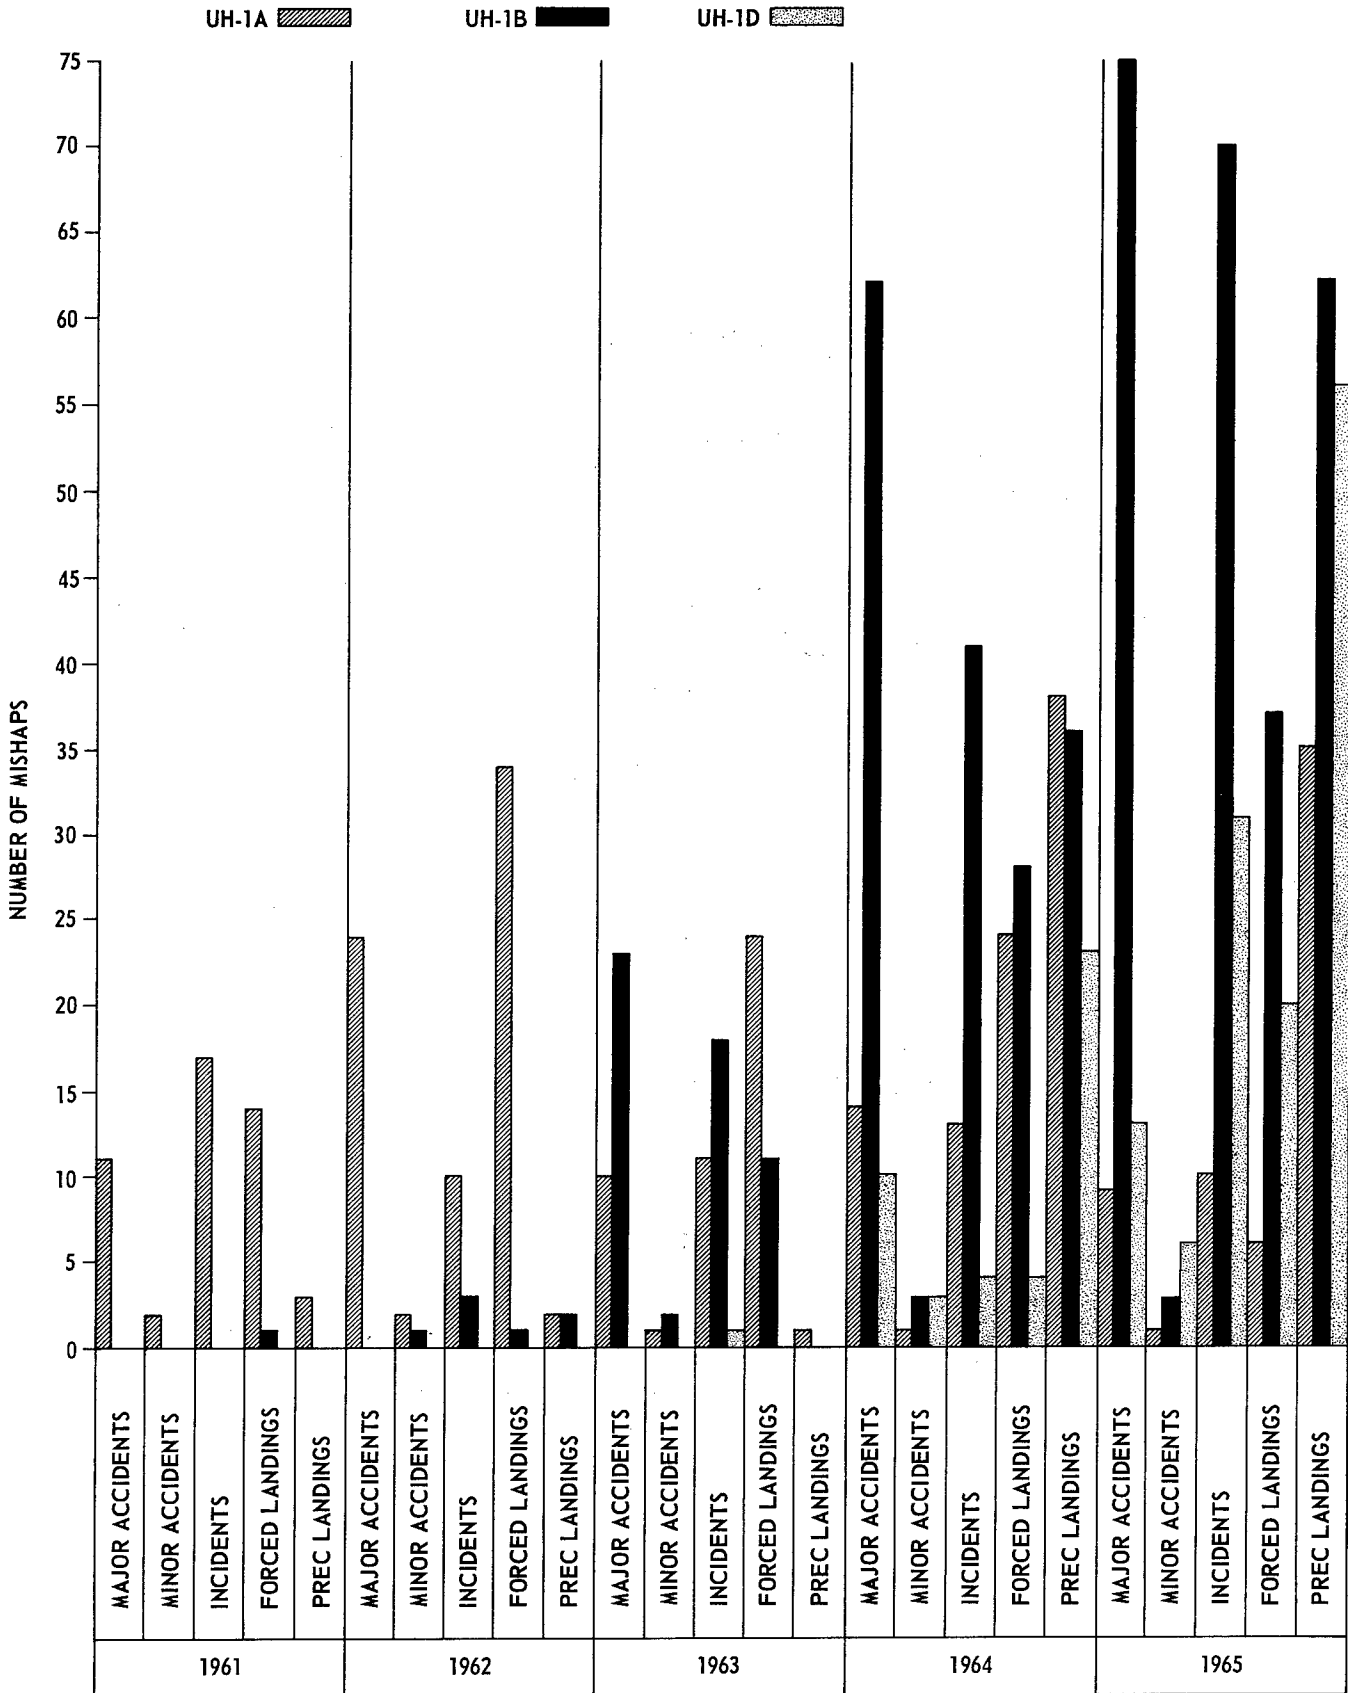
FIGURE 1
TOTAL MISHAPS BY NUMBER AND TYPE
FY 1961-1965

a. Of the 967 mishaps which happened during the five year period shown in figure 1, 840 (approximately 87%) happened during the three year period FY 1963-FY 1965. UH-1B and UH-1D model aircraft were added to the inventory and increased flying requirements, including expanded training, were added to meet the demand of the Vietnam conflict.

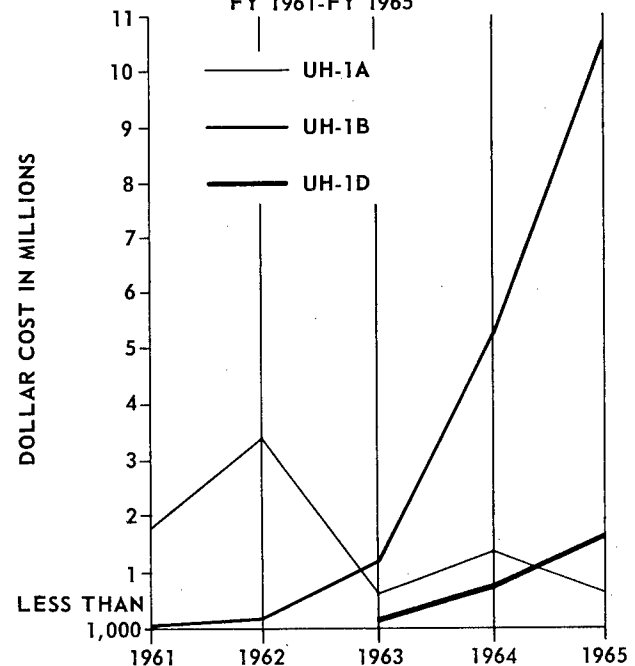
FIGURE 2
DOLLAR COST OF ALL ACCIDENTS AND INCIDENTS
FY 1961-FY 1965

b. Figure 2 shows the dollar cost of UH-1 mishaps. The cost of repairing aircraft damaged by accident is directly proportionate to the severity of the accident and the original cost. As equipment becomes more complex, mishap costs rise. This is evidenced by the cost of UH-1B mishaps which rose to more than \$10,000,000 during FY 1965. The cost for all Army aviation mishaps during FY 1965 exceeded \$26,000,000.
