## AIRCRAFT ACCIDENT REPORT

CRASH DURING LANDING  
FEDERAL EXPRESS, INC.  
MCDONNELL DOUGLAS MD-11, N611FE  
NEWARK INTERNATIONAL AIRPORT  
NEWARK, NEW JERSEY  
JULY 31, 1997

**NTSB/AAR-00/02**

**DCA97MA055**

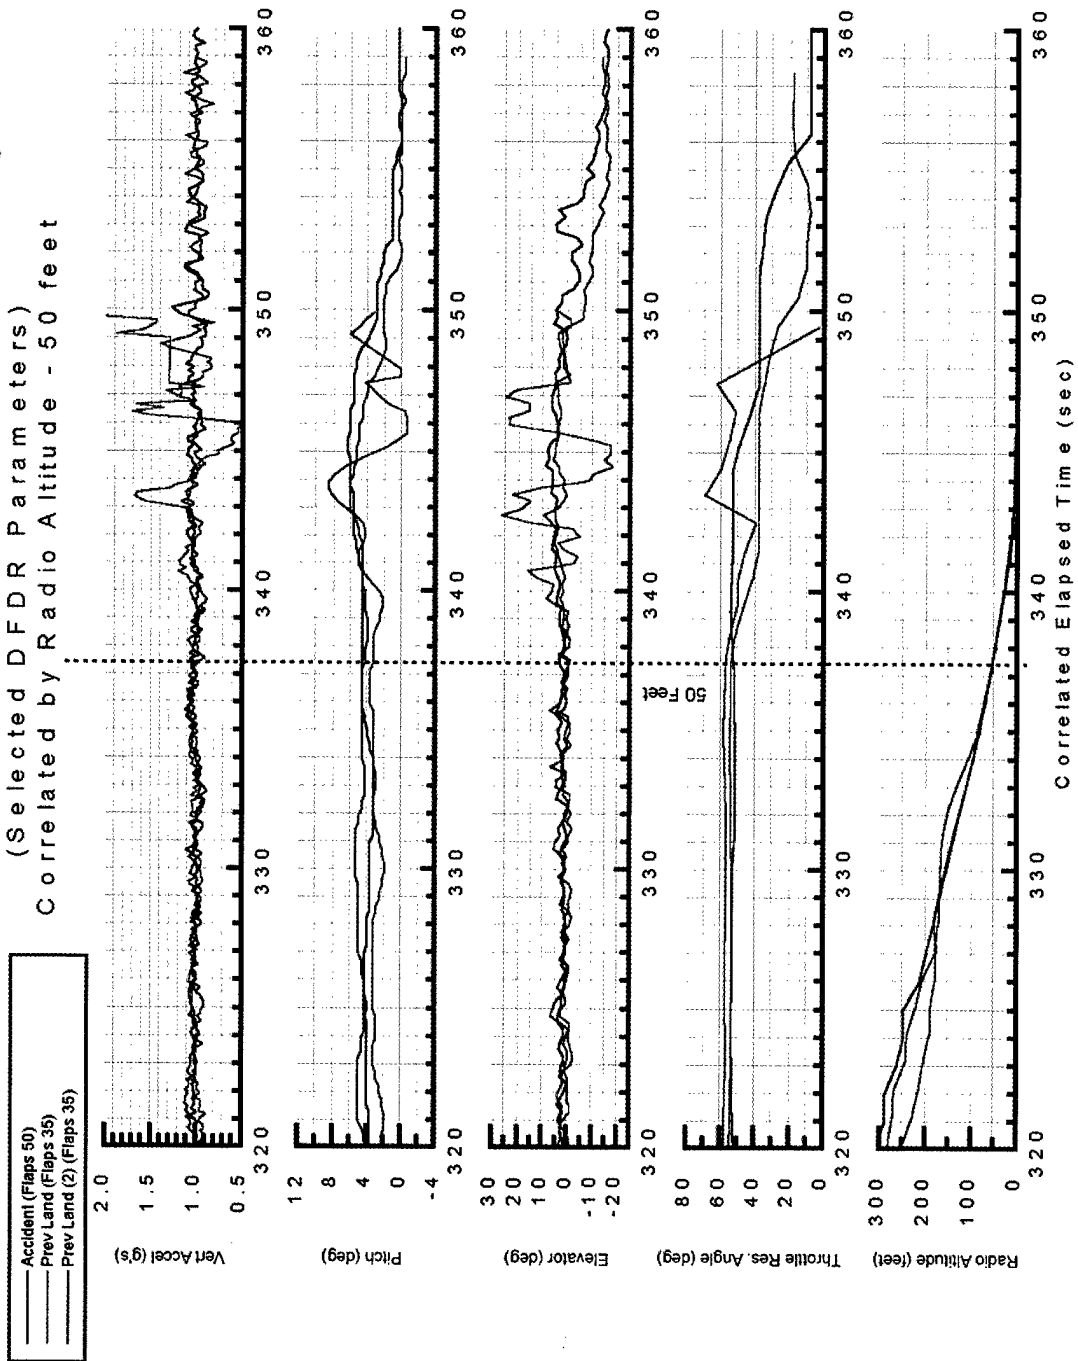
**Figure 5.** Comparison of selected DFDR parameters for accident landing and previous two landings (correlated by radio altitude - 50 feet).

As the airplane touched down at 0132:18.6, pitch attitude and vertical acceleration were increasing (along with engine speeds). It touched down 1,126 feet beyond the runway displaced threshold with a 7° nose-up pitch attitude. Vertical speed at the time of the first touchdown was about 7.6 feet per second (fps).<sup>23</sup> Vertical acceleration peaked at 1.67 g. About 1/2 second after the first touchdown, the FDR recorded an 18° AND elevator deflection (maximum possible MD-11 AND elevator deflection is 27°) and a TRA decrease.<sup>24</sup> At 0132:19, rudder deflection decreased to near zero, and the magnetic heading stabilized at 217.4° (the published magnetic heading for the runway was 219°). Pitch attitude peaked at 8.44° and began decreasing. Thrust continued to increase with  $N_1$  values of about 65 percent. Airspeed began to increase and the airplane became airborne.<sup>25</sup>

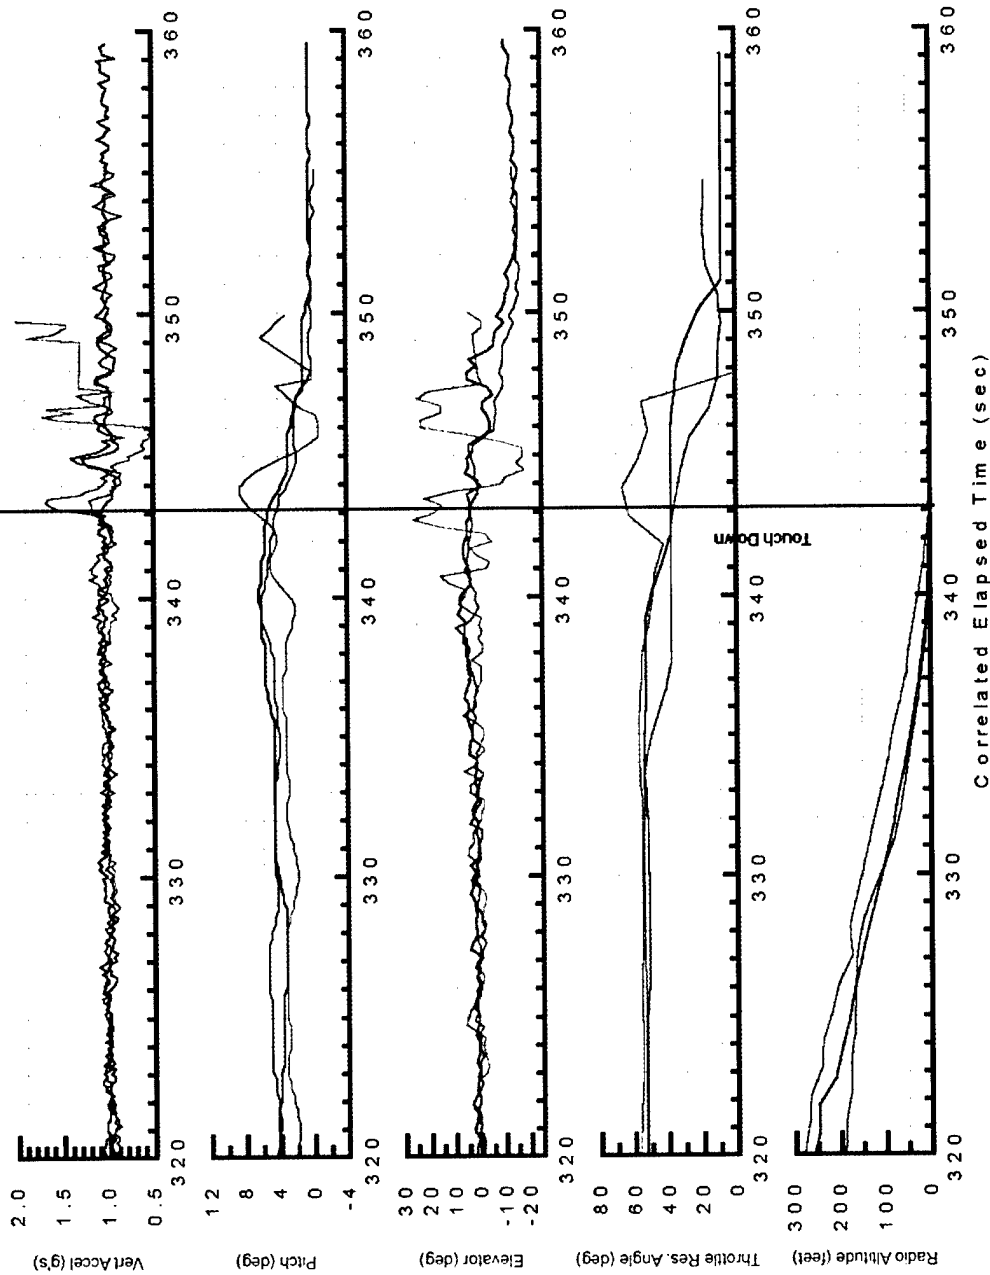
**Figure 6.** Comparison of selected DFDR parameters for accident landing and previous two landings (correlated by first touchdown).
