*Monitoring Completed Navigation Projects Program*

## **Periodic Inspection of St. Paul Harbor Breakwater, Alaska**

Robert R. Bottin, Jr., and Alan C. Jeffries

February 2001

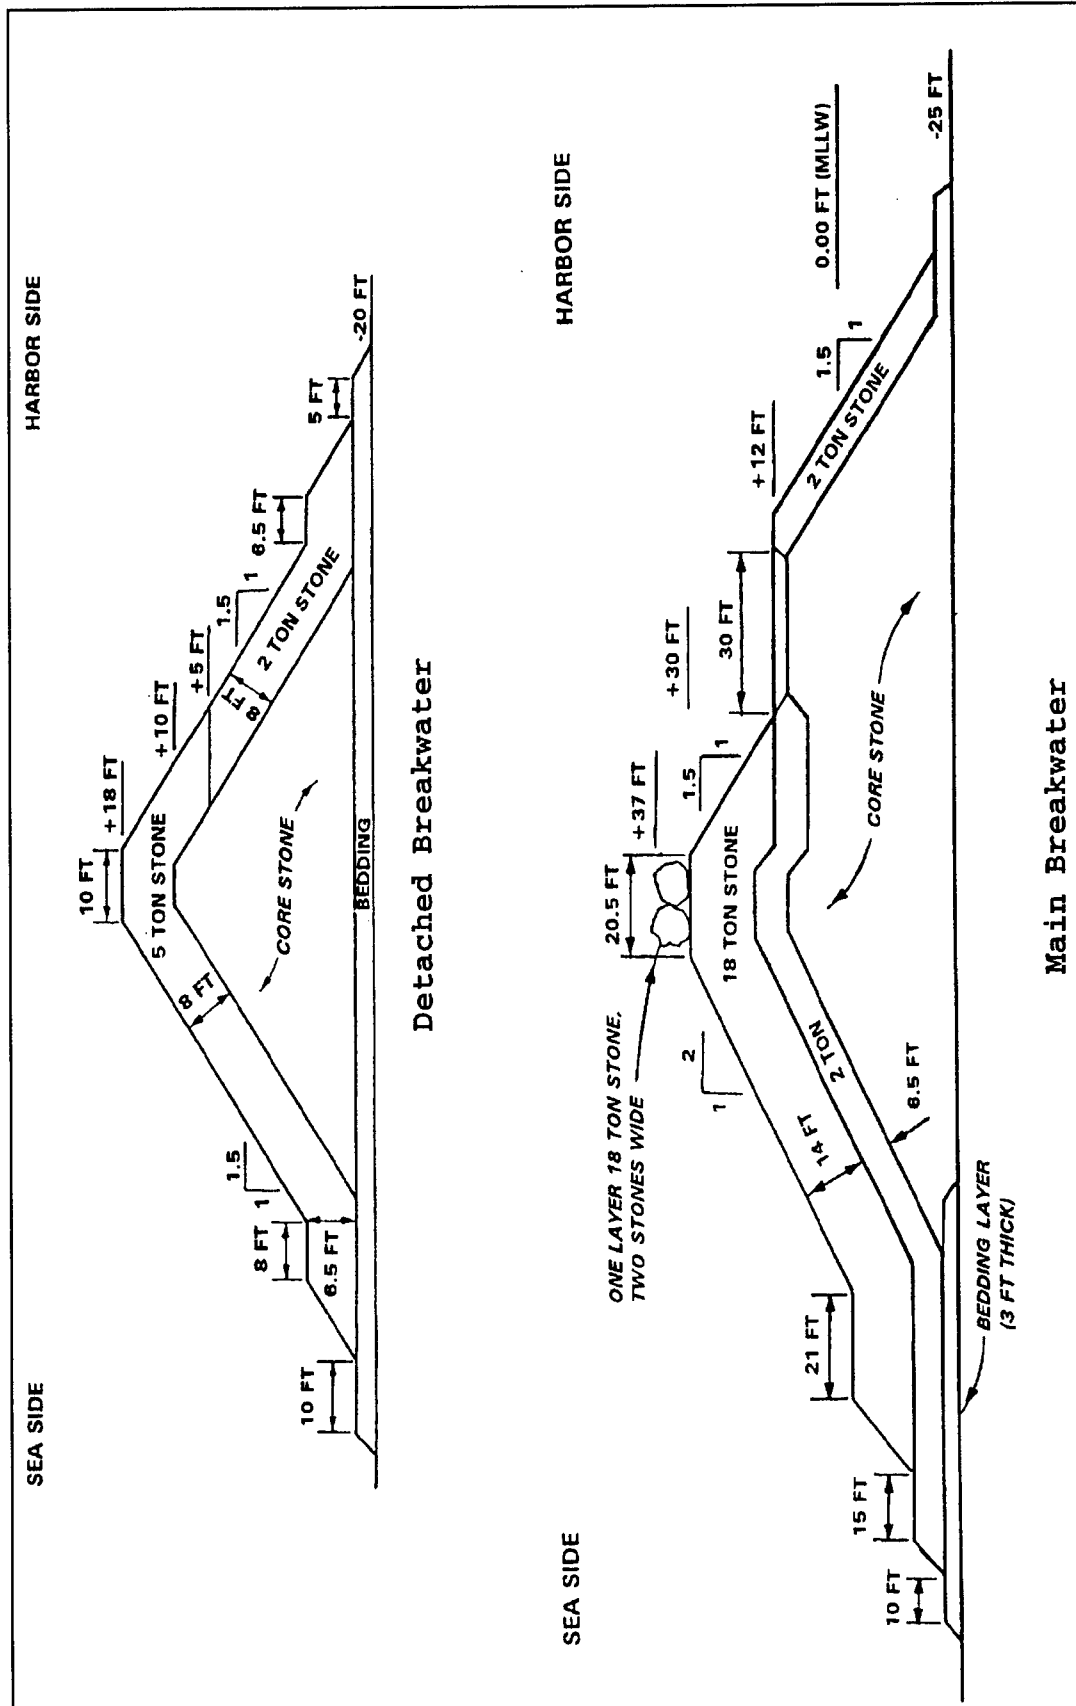
Figure 4. Typical breakwater cross sections (To convert feet to meters, multiply by 0.3048. To convert tons to kilograms, multiply by 907.1847)

After construction of the harbor in 1989, it experienced a rapid growth cycle and quickly became overcrowded. In the mid 1990s St. Paul Harbor served a fleet of 230 transient vessels during the crabbing season. A total of 27 floating processors were located within a 4.8-km (3-mi) limit of the harbor. In addition, three processing plants had permanently located within the harbor complex. Subsequent to harbor construction, significant overtopping of the main breakwater had been experienced during the winter seasons. Overtopping may have been caused by larger than design storm waves and/or still water levels or possible settlement and consolidation of the breakwater stone. Overtopping

caused the roadway in the lee of the breakwater to wash out, and repairs were required frequently during the storm season. Due to these problems and needs, the harbor was again studied at CHL in 1996. The feasibility of deepening the entrance channel and dredging a deeper and larger maneuvering basin was proposed to relieve congestion in the harbor. In addition, a submerged reef breakwater concept was studied as a means of reducing wave overtopping of and wave transmission through the main breakwater. Two- and three-dimensional model investigations were conducted by Ward (1996)<sup>1</sup> and Bottin (1996), respectively, to optimize reef breakwater cross sections and layout as well as wave and current conditions in the expanded harbor.

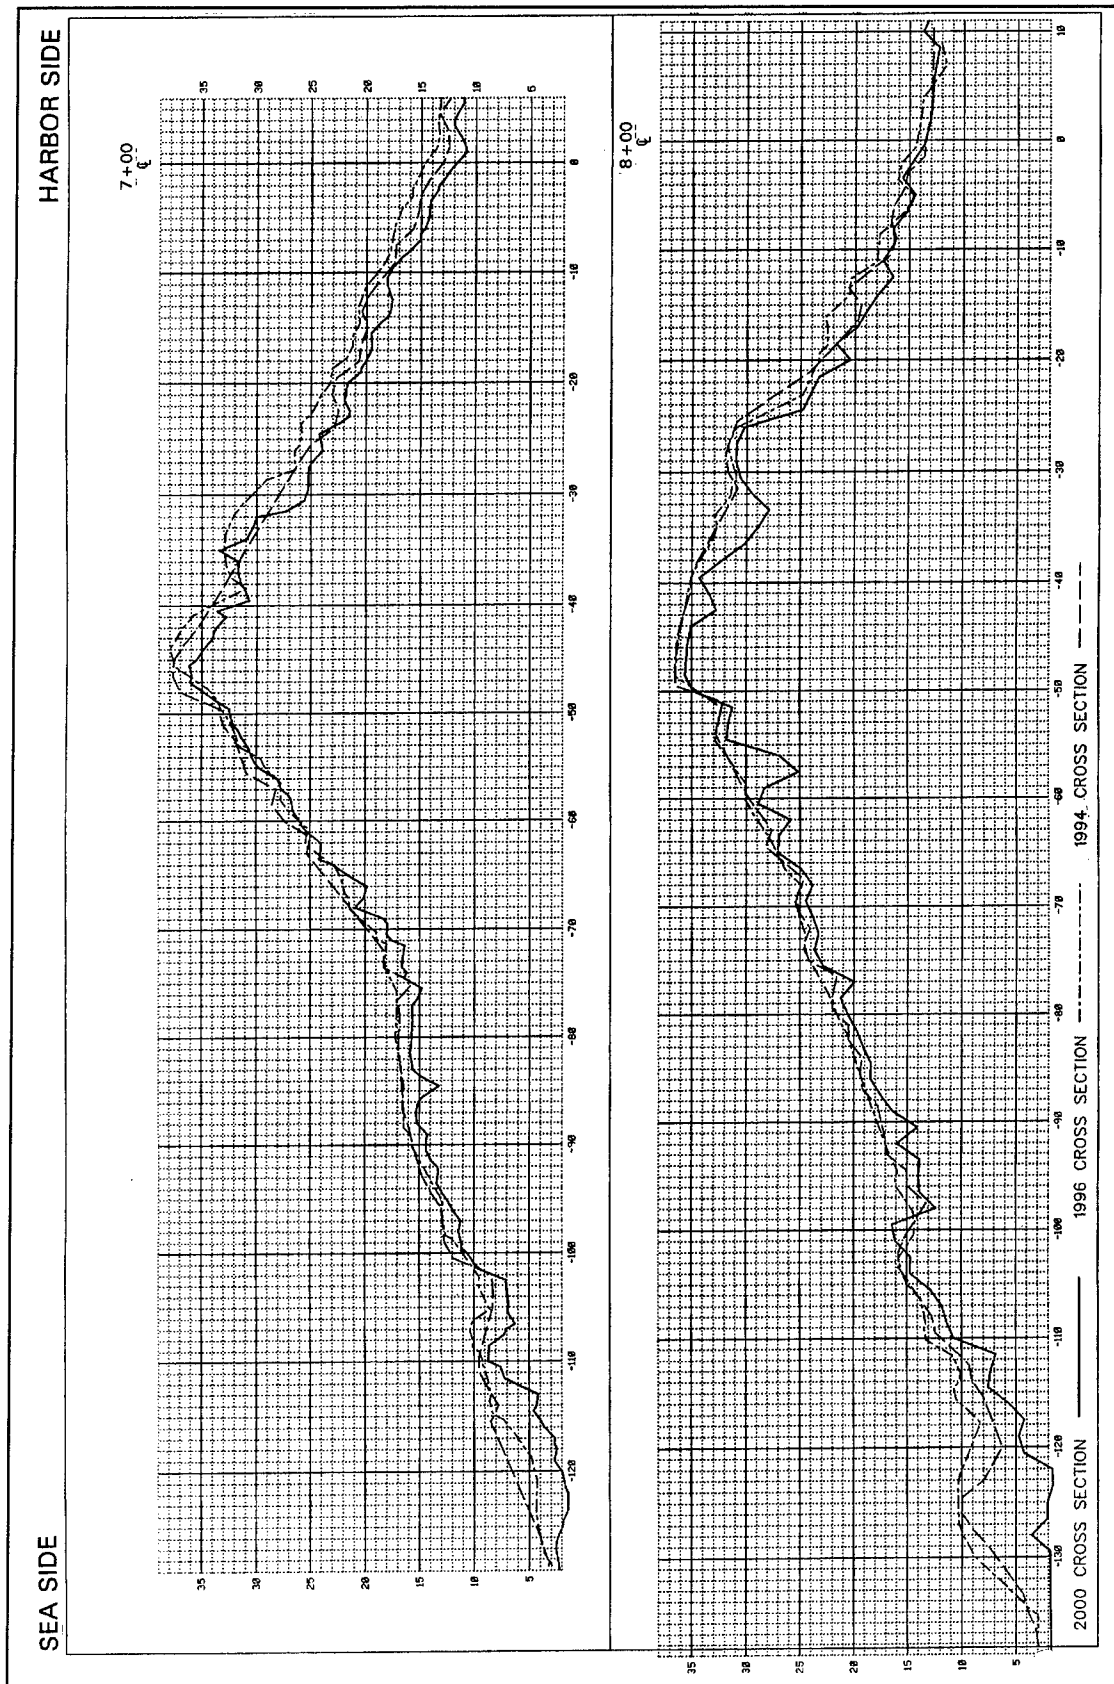
Figure B1. Cross sections of St. Paul Harbor main breakwater, stas 7+00 and 8+00

Examination of breakwater cross sections (Appendix B) reveals low areas in the breakwater based on data obtained in 2000 versus that of 1994 and 1996. The overall shape and elevation of the structure appear to be generally the same, but voids were noted in most cross sections of the current (2000) survey that were not present in the previous ones. Some of these voids were located on the crest of the structure and others along the slopes. The breakwater appears to have lost stones in these low areas.

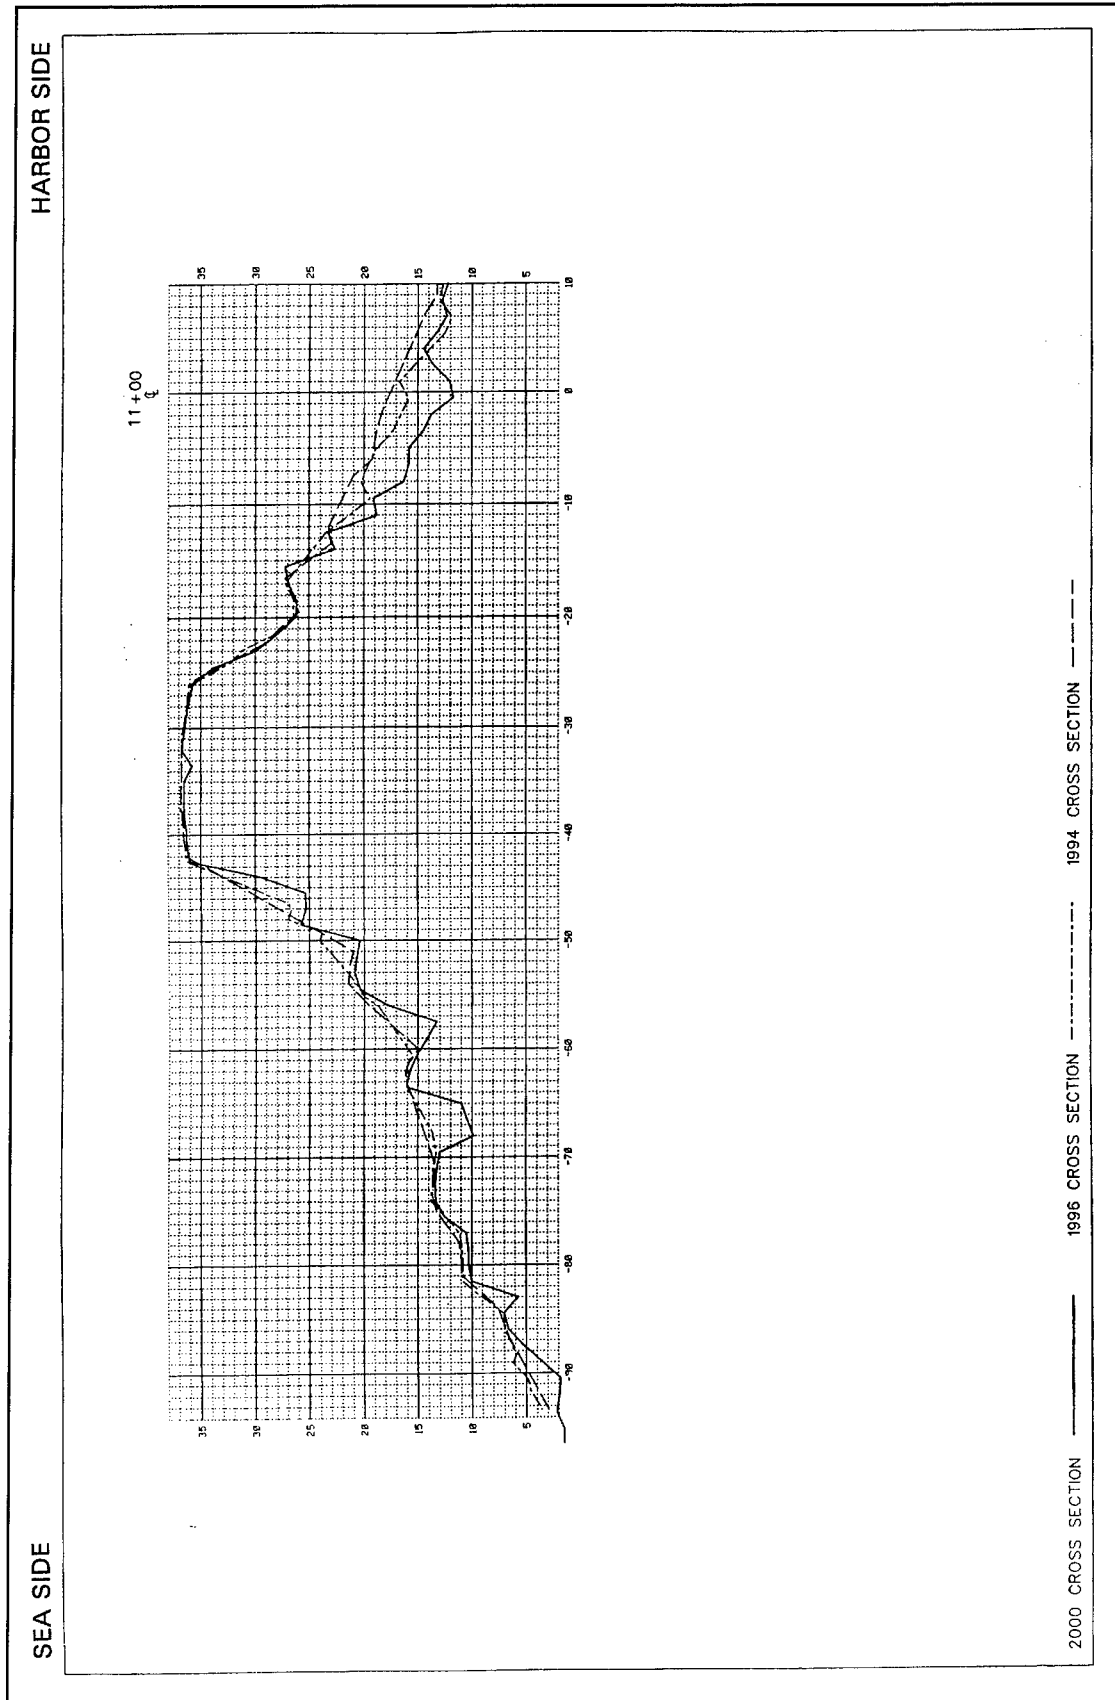
Figure B3. Cross sections of St. Paul Harbor main breakwater, sta 11+00

Examination of cross section data revealed that cross sections of the breakwater were similar in both 1994 and 1996. Accretion of stone along the toe of the harbor side slope of the structure was apparent at stas 11+00, 12+00, and 13+00. This was an accumulation of small stones which was noted during a site visit in 1996. It is not known if this was core stone moving out of the breakwater due to wave action or loose stone moving over and/or through the voids of the structure during storms.
