REPORT NO: NAWCADPAX/RTR-2000/97

S-3B SMALL-SCALE APPLIQUÉ COUPON FLIGHT TEST EVALUATION RESULTS

9 January 2001

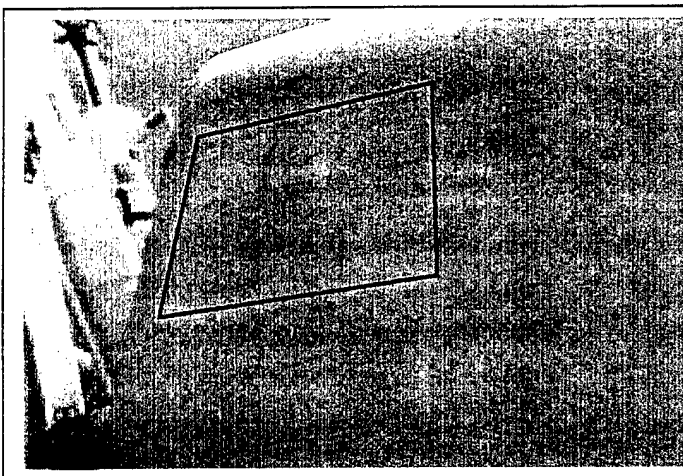
18. Six coupons in a 2 x 3 pattern were applied at site 2, with the FP500 material on the left row and the FP1500 material on the right row (looking forward). Unperforated coupons were applied to the site on the left lower door, and perforated coupons were applied to the site on the right lower door. Figure 3 shows the coupons at site 2 on the left lower door prior to flight, and figure 4 shows the coupons at site 2 on the right lower door prior to flight. Following the initial test flight, both the FP500 and FP1500 coupons remained attached to the surface of the aircraft, and did not show any signs of deformation or failure. The coupons appeared as they did prior to the flight; therefore, no photographs were taken of the coupons at site 2 following the flight.

Figure 3: Coupons at site 2 on the left lower gear door prior to flight. (Test site outlined in black.)

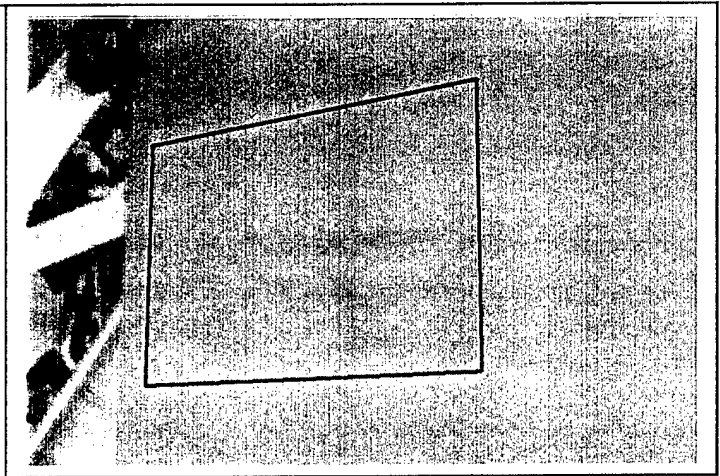
Figure 4: Coupons at site 2 on the right lower gear door prior to flight. (Test site outlined in black.)

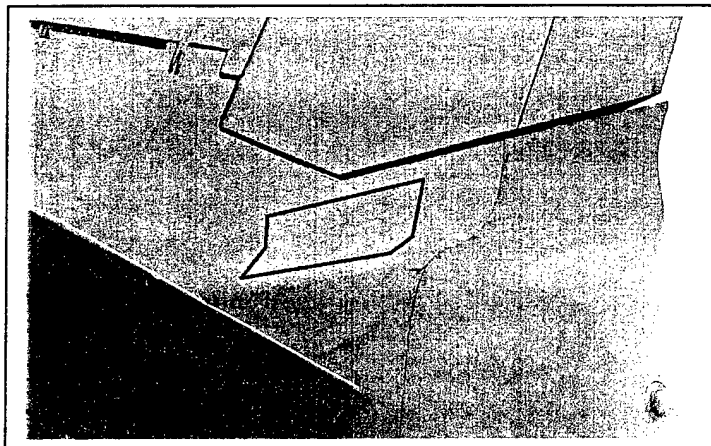
19. Eight coupons in a 2 x 4 pattern were applied at site 3, alternating between the FP500 and FP1500 material in a checkerboard pattern. Only unperforated coupons were applied. Figure 5 shows the coupons at site 3 prior to flight. Following the initial test flight, both the FP500 and FP1500 coupons remained attached to the surface of the aircraft, and did not show any signs of deformation or failure. The coupons appeared as they did prior to the flight; therefore, no photographs were taken of the coupons at site 3 following the flight.

Figure 5: Coupons at site 3 on the vertical tail below the rudder prior to flight. (Test site outlined in black.)
