ERDC/CHL TR-01-12

Beach Erosion and Sediment Processes Study, North East Marina, Erie County, Pennsylvania

Andrew Morang and Jeffrey Melton

June 2001

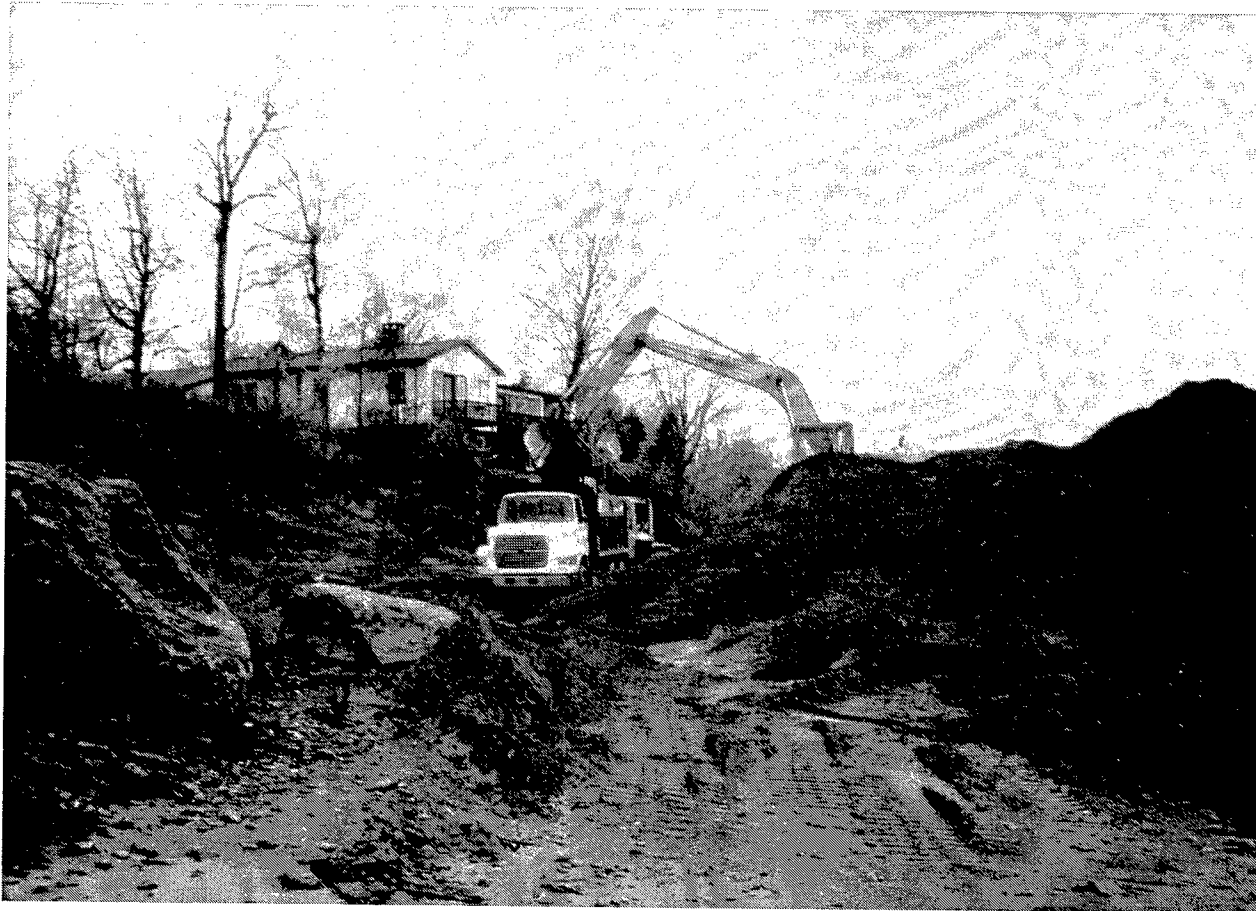
and gravel from the west side fillet into a 5-m-high pile. To obtain as much material as possible from the fillet, the backhoe operator builds a temporary road out into the lake (Figures 25 and 26). Dump trucks are loaded with sand and gravel on the west side, cross the marina, back up along the beach, and deposit their loads. The initial loads are used to build a road at the base of the bluff so that the trucks can proceed east away from the sheltering effects of the marina walls, up to a distance of about 500 m from the east wall (Figure 27). Then sand is spread on the beach and into the water, pushed about by bulldozer. Depending on waves, the road is sometimes partly washed away at night and has to be rebuilt in the morning. During the early 1990s, when lake levels were higher, the road had to be built into the lake to go around the barrels that protrude from one lakefront property.

Figure 25. West fillet sediment being loaded into dump trucks, 17 November 1998

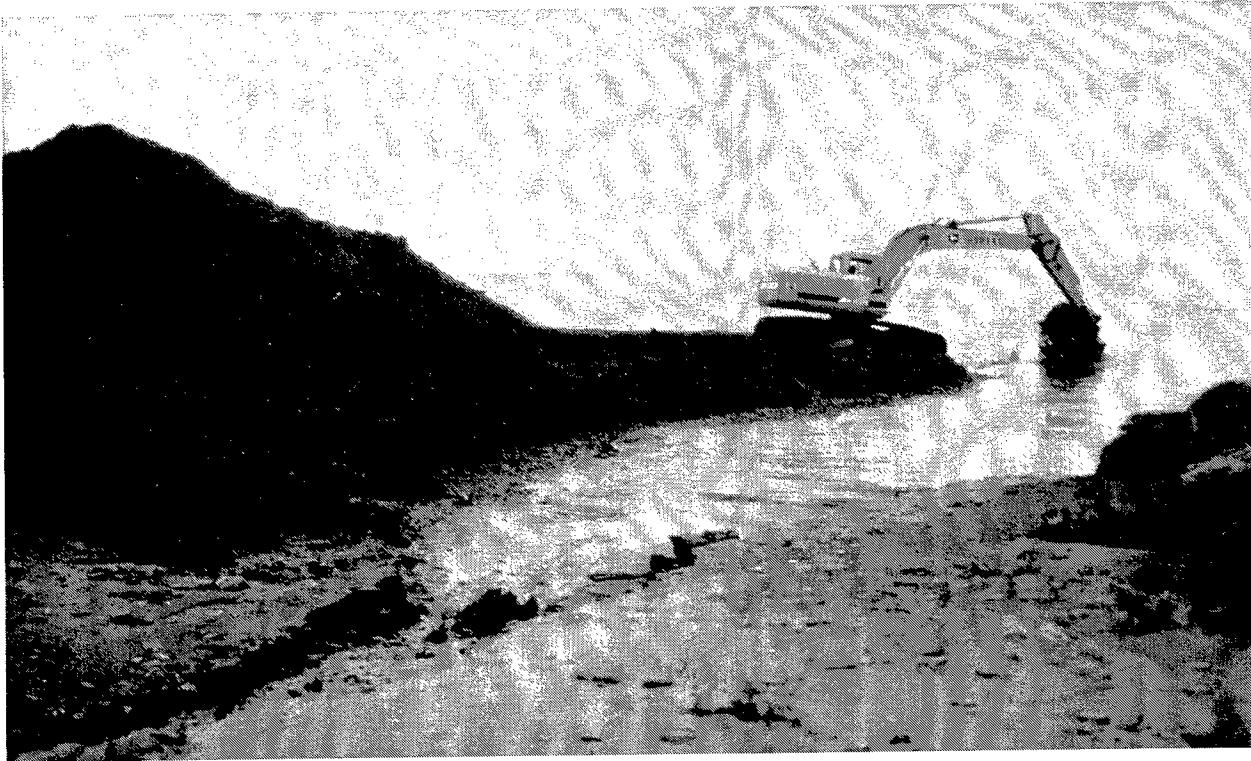
Figure 26. Backhoe removing sand and gravel from updrift fillet, 17 November 1998. A temporary road allows backhoe to proceed out into lake over 30 m

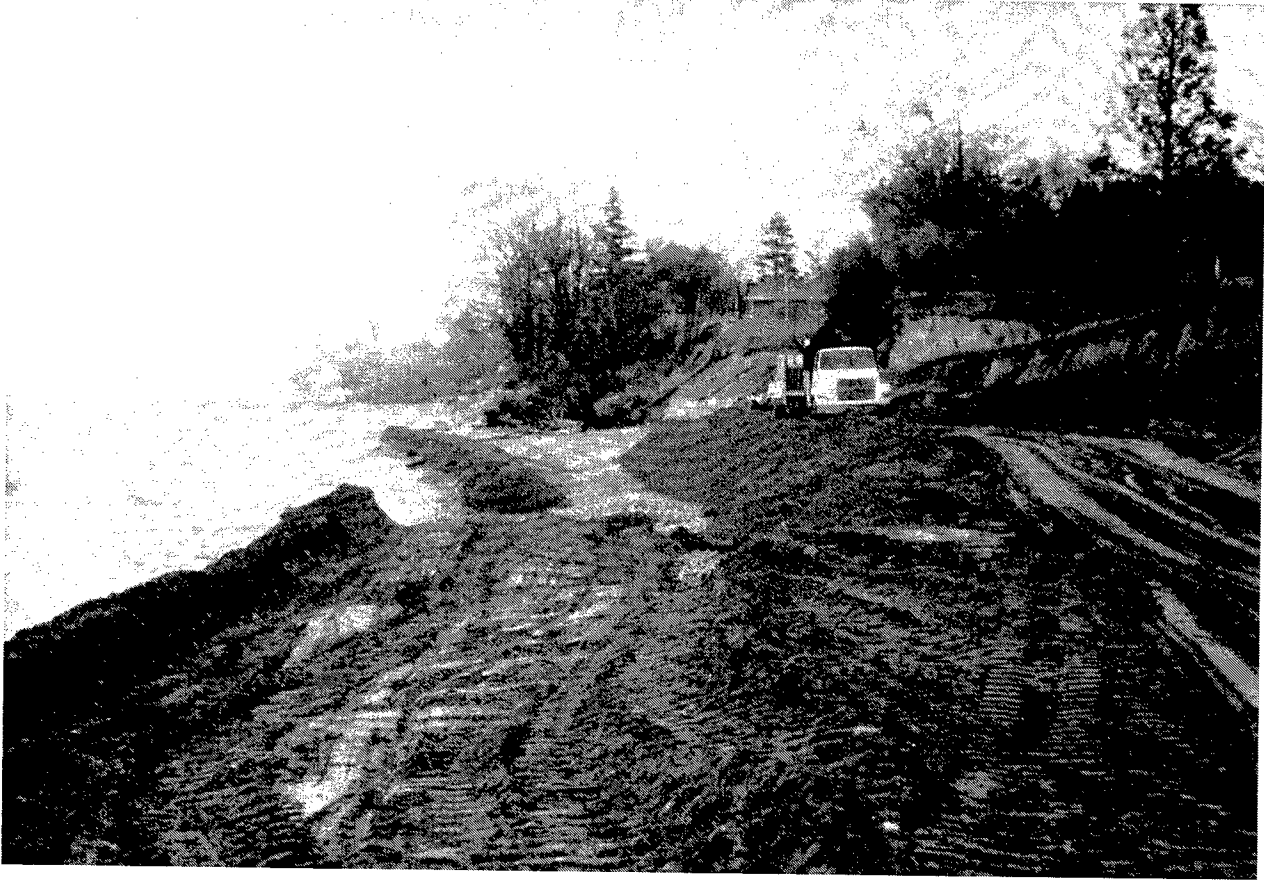
When lake level was high, probably all of the material that was bypassed by truck ended up in the littoral system, with the bulk being mobilized within a few weeks. Since the winter of 1998-99, with lower water level, some of the road has survived, so it has served to protect the base of the bluff. Therefore, this material has been temporarily removed from the littoral drift. Since November of 1993, PFBC has bypassed an annual average of 17,000 yd³ of sediment at North East Marina (Table 4), almost twice the annual volume of fillet growth

Figure 27. Temporary road along base of bluffs east of marina, 17 November 1998. Sediment is spread across beach and into water by a bulldozer

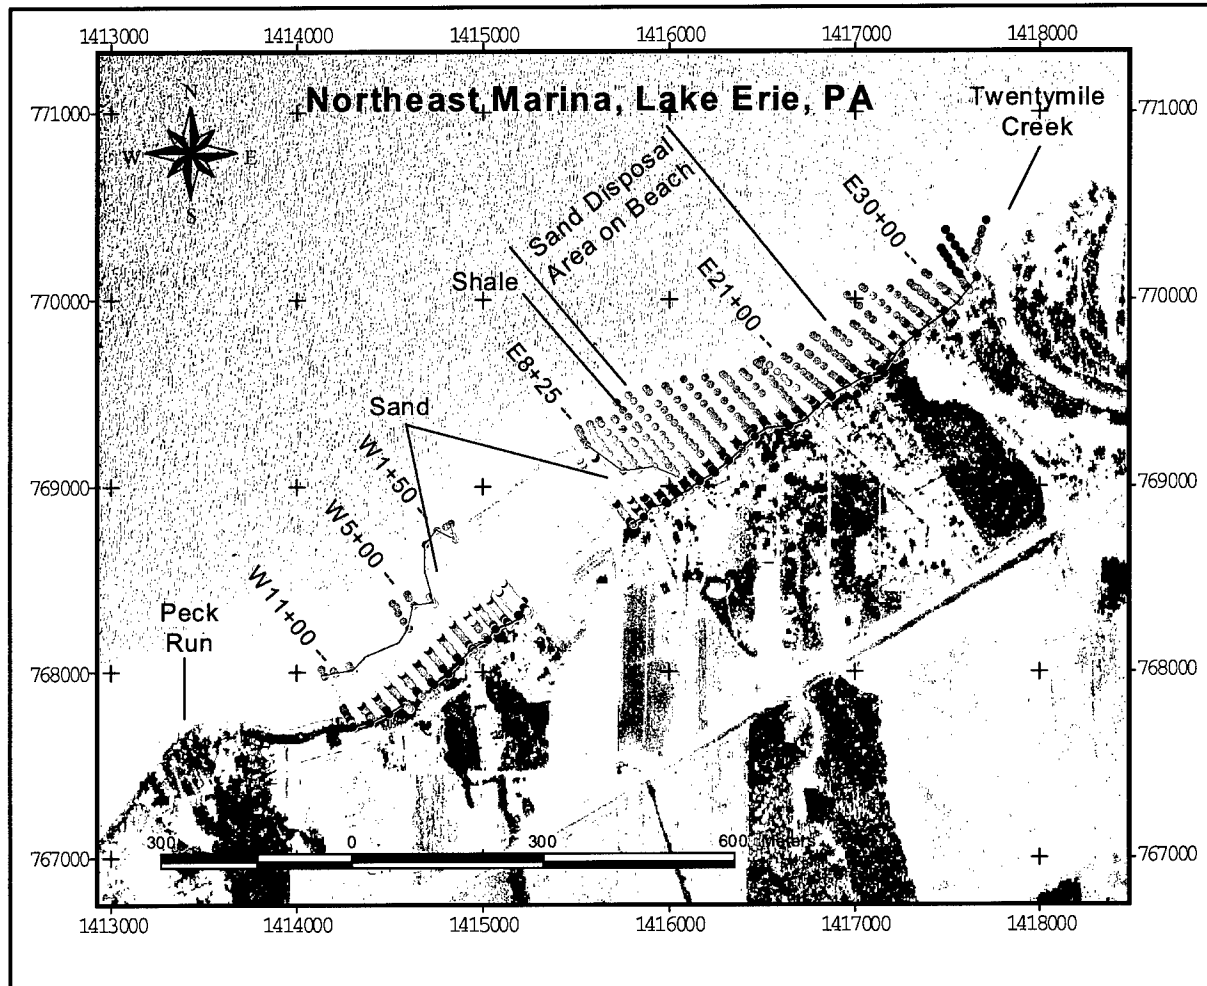
Figure 30. September 1999 profiles. State plane coordinate system, Pennsylvania North Zone, NAD 83, units in feet. Photograph is USGS digital ortho quarter quadrangle, converted from UTM coordinates to PA state plane (To convert feet to meters, multiply by 0.3048)

- c.* The volume of sand east of the marina has approximately doubled since 1992. This sand is found in a fillet that extends about 120 m east of the east wall (Figure 30). Part of this volume is in the upper beach, remnants of the temporary roadway placed by the PFBC.

- h.* Based on the analysis of profile volumes, line E1050 is the easternmost limit where the influence of the marina can be detected with respect to sediment accumulation (or loss) on the beach (Figure 30). This profile is about 120 m (400 ft) east of the east wall. East of E1050, the 1999 profile volume is essentially unchanged compared to 1991 and 1992. The quantity of sand on the beach in this area, east of E1050, is minimal, only about 4 yd³/ft.

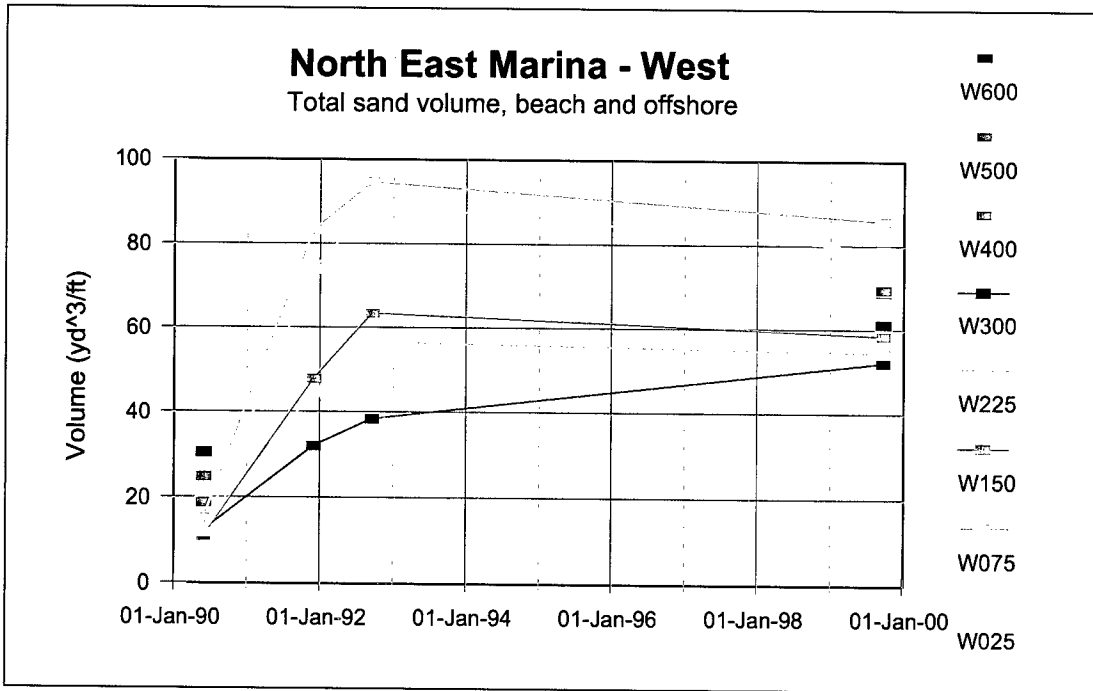
The results are easier to visualize as graphs. Figure 36 shows the volume changes over time for the west profiles. At all locations, volume increased rapidly between 5-30-90 and 9-16-92, during the period of marina construction, especially at lines W025 and W075. These data confirm the visual observations that a large fillet grew on the west side of the marina wall. The recent survey, 9-24-99, shows that the volumes of most of the west lines have stabilized or even slightly decreased. The period of stable overall volume coincides with the years that the PFBC has been bypassing sand from the west to the east side of the project. Only at line W300 did the volume increase from 1992 to 1999, and this is accounted for by the accumulation of sand on the upper part of the beach (see Appendix C). This is private property, west of the area where the PFBC mines the beach during its spring and fall bypassing operations.

Figure 36. Profile volume for lines W025 to W600 west of marina west wall. At W400, W500, and W600, data are only available for 1990 and 1999 and points have not been connected in this plot

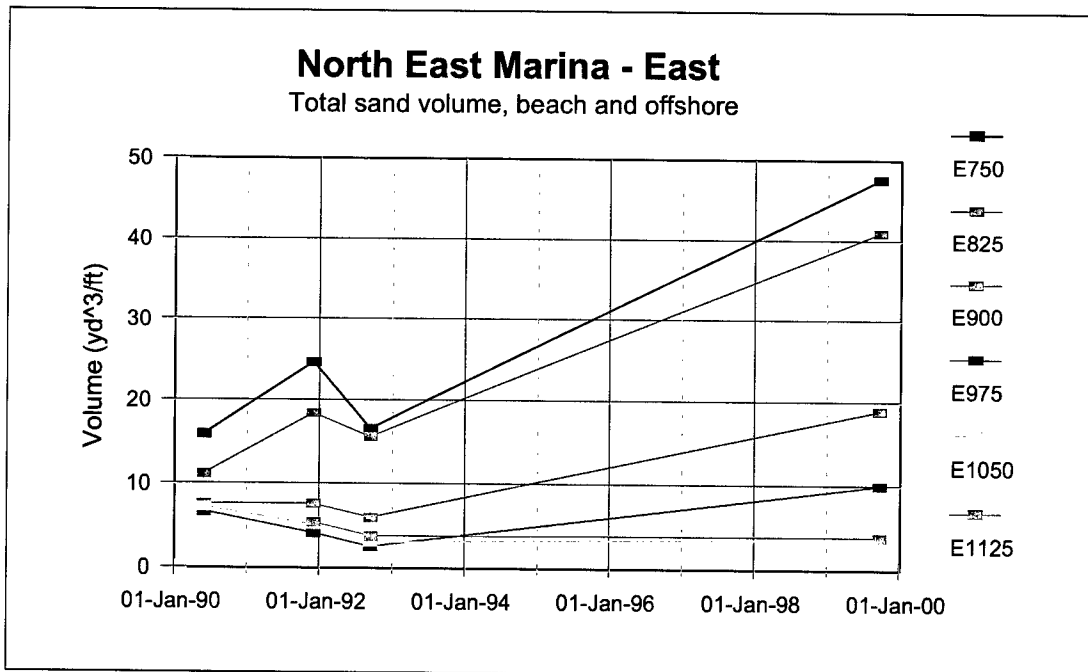
East of the marina, beach volume decreases towards the east (Figure 37). At the two lines closest to the east wall, E750 and E825, volume has more than doubled since 1992. Overall elevation has increased 0.3-0.6 m across the entire

beach, from the bluff toe to about 130 m offshore. Directly in front of the bluff, part of the 1998 fill remains as a raised terrace. Thanks to a mild winter storm season and dropping lake levels, the trucked fill was not completely removed as it had in previous winters. Profiles E900 and E975 also show volume increase, but to a lesser extent than the two lines closer to the marina. Profiles E1050 and E1125 were stable volume over time. These indicate that E1050 is about the easternmost limit where the influence of the marina can be detected with respect to sediment accumulation (or loss) on the beach.

Figure 37. Profile volumes east of marina. Most profiles show an increase in volume since 1992, but E1050 and E1125 are beyond influence of the structure

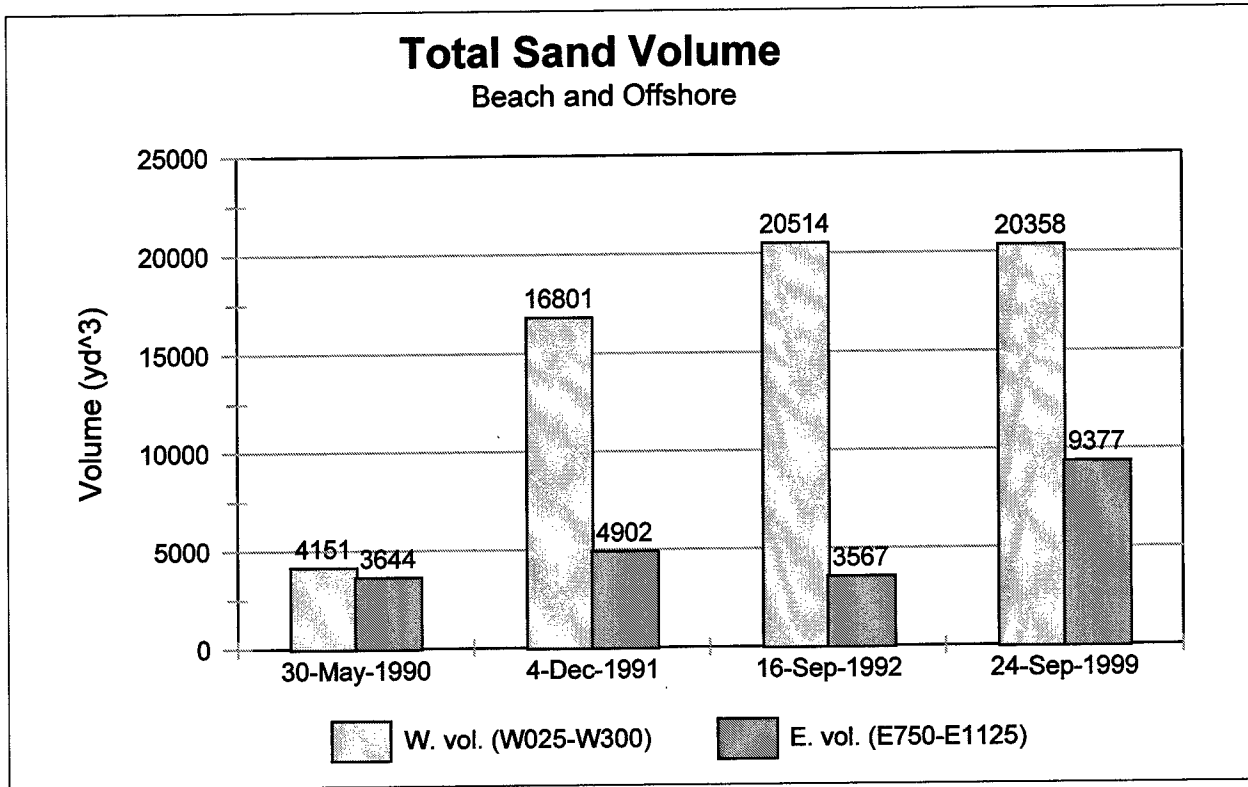
Figure 38 summarizes total volume change over time for the east and the west beaches. The west beach volume between W025 and W300 is almost identical to the 1992 volume, while the east beach has almost doubled. These data indicate that the PFBC has been bypassing a sufficient amount of sand to prevent a volumetric increase on the west side of the marina.

Figure 38. Total volume for west and east beaches. West of marina, volume has been stable since 1992, while to the east, total beach volume has almost doubled

Period 2: Spring 1994 to the present. Pennsylvania Fish & Boat Commission has effectively mitigated the disruption of eastward-directed littoral transport because the volume of sand bypassed during the biannual trucking operations has been approximately the same as the amount of sand brought into the fillet region by littoral processes. In September 1999, the total volume between profiles W025 and W300 remained unchanged at about 20,000 yd³, therefore indicating that the mechanical bypassing has been equal to the input supply (Figure 38).
