## Examination of Suspected Delta II Second-Stage Reentry Debris

15 July 2001

P. M. ADAMS and W. H. KAO  
Space Materials Laboratory  
Laboratory Operations

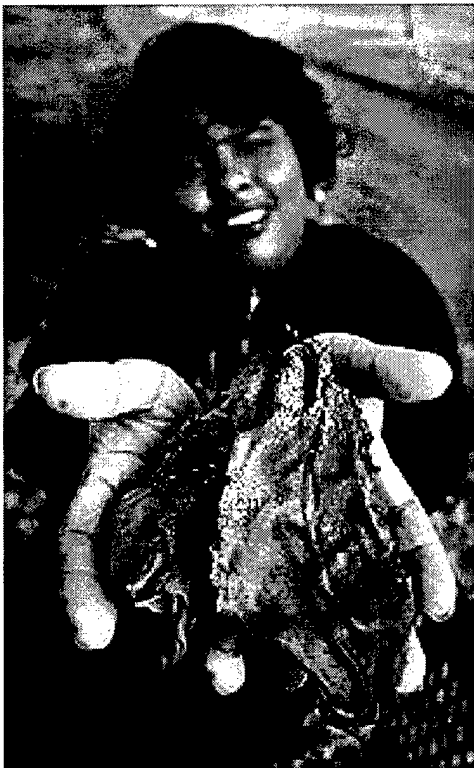
Figure 1. Ms. Lottie Williams holding the debris that struck her.

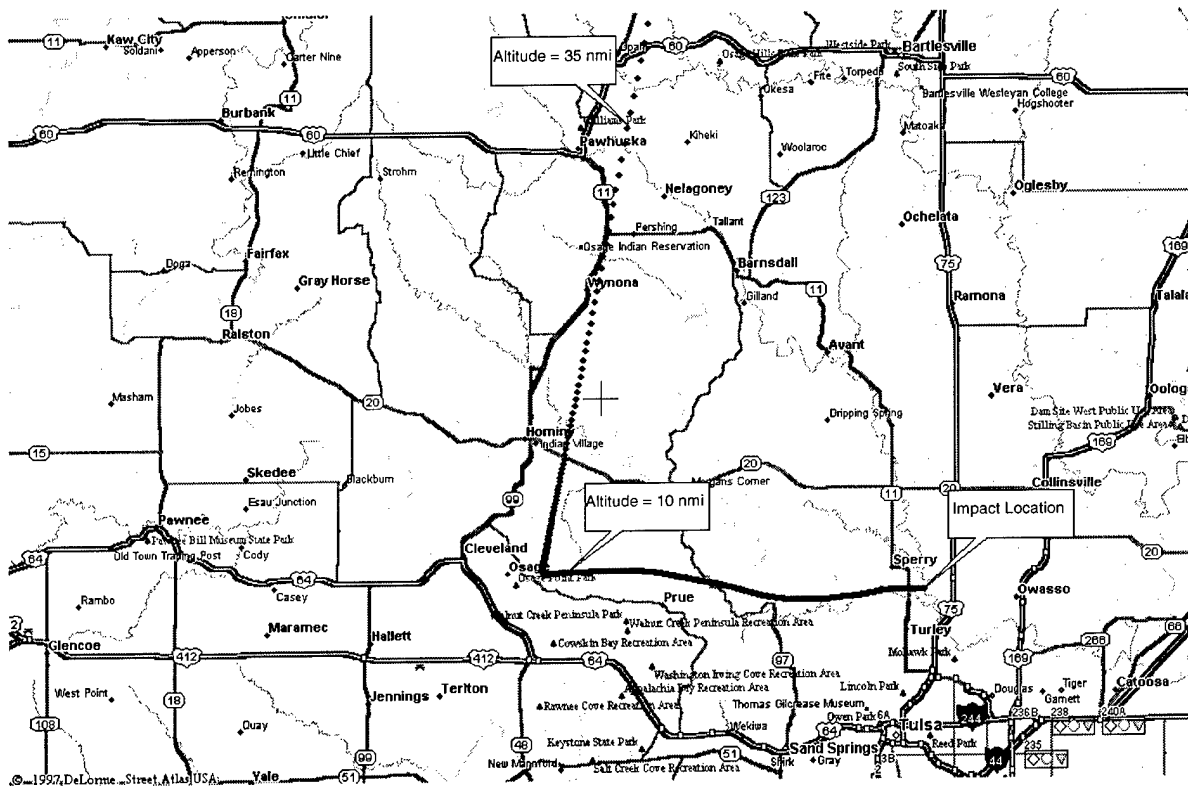
The time and location of the recovery of the debris can be correlated with the reentry of a Delta II second stage. The Delta II was launched from Vandenberg Air Force Base (VAFB) on April 24, 1996, carrying the Ballistic Missile Defense Organization (BMDO) Midcourse Space Experiment satellite. The second stage reentered the atmosphere on January 22, 1997. It was predicted that the vehicle broke up at an altitude of 42 nmi over Topeka, KS at 3:36 AM, local time. The second-stage fuel tank, thrust chamber, and a helium sphere were recovered from several sites in Texas.<sup>1</sup> These areas are about 500 mi. south of Turley, OK, which was along the reentry path. Simulation of the reentry track of a light-weight piece of debris with a low ballistic coefficient, taking into account the presumed breakup altitude, reentry track of the other pieces of the Delta second stage, and the prevailing winds, shows that the debris recovered by Ms. Williams could be from the reentry event (Figure 3).

Figure 3. Simulated reentry track of a light-weight piece of debris with a low ballistic coefficient, taking into account the presumed breakup altitude and reentry track of the other pieces of the Delta II second stage.
