TECHNICAL REPORT

NO. 12776

WINTER TESTING OF VEHICLE
EXHAUST DUST EJECTION SYSTEM, RUBBER
TIRE HUBS, AND PERSONNEL HEATER SYSTEM
ON THE M60 A3 TANK

JUNE 1982

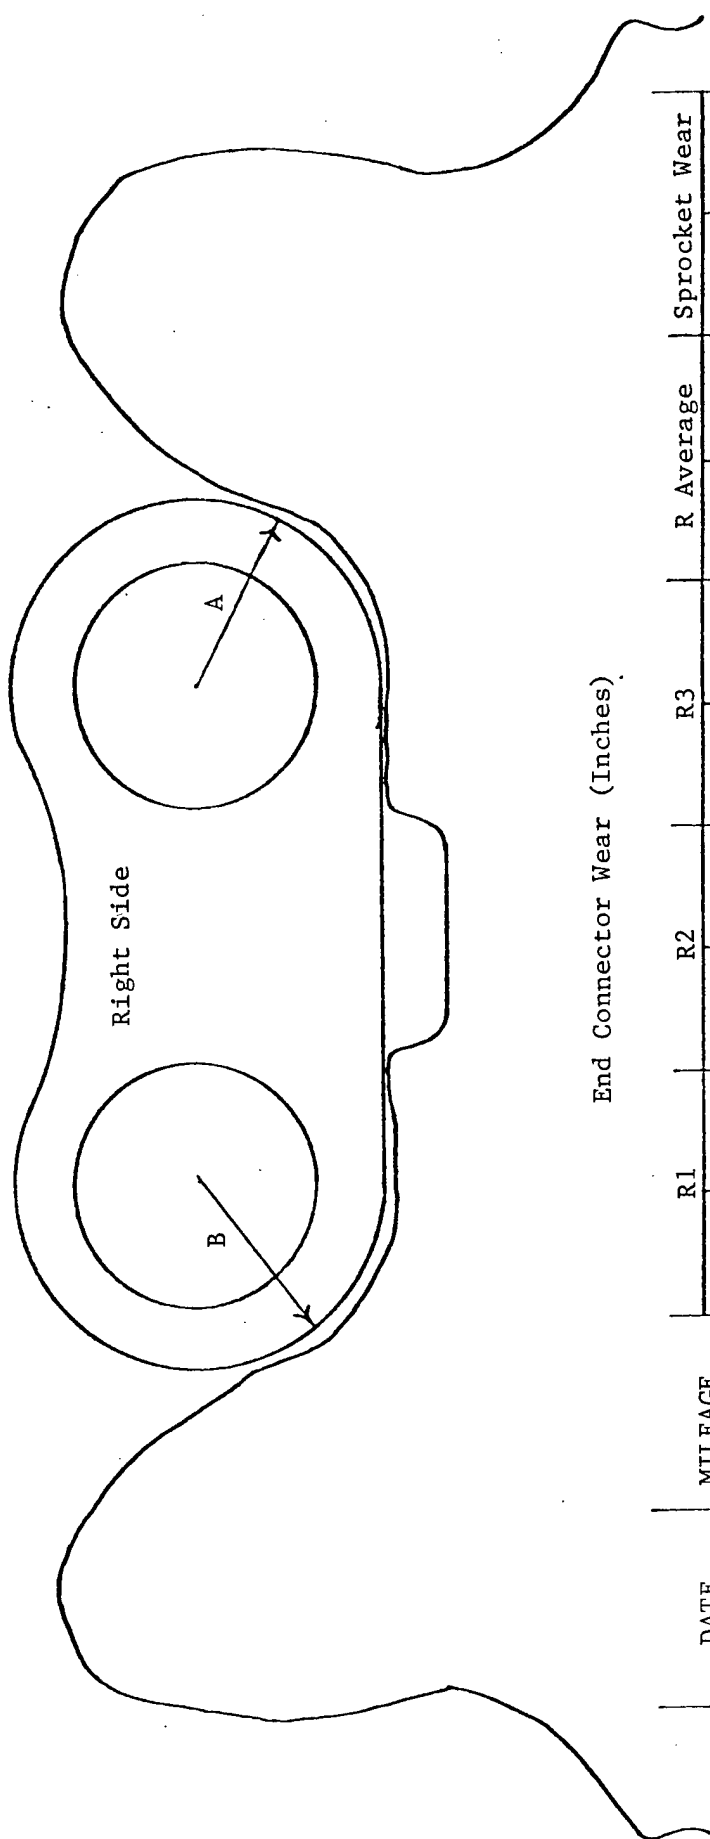
it was noted that there was a mismatch between the RTH sprockets and the track end connectors. This mismatch caused wear to the sprocket teeth and end connectors as seen in Appendix A. Appendix A shows wear to three selected end connectors on both sides of the track as well as the wear to the RTH sprockets.

DATE	MILEAGE	R1		R2		R3		R Average		Sprocket Wear	
		A	B	A	B	A	B	A	B	A	B
03/09/82	2138.6	.429	.425	.480	.400	.452	.445	.454	.423	.384	.329
03/12/82	2186.2	.426	.398	.460	.352	.479	.409	.455	.386	.387	.308
03/17/82	2248.9	.422	.396	.453	.370	.425	.375	.433	.380	.374	.325
03/18/82	2301.0	.455	.410	.462	.353	.424	.374	.447	.379	.380	.317
03/22/82	2361.9	.423	.397	.454	.341	.476	.418	.451	.385	.373	.328

M60 Track End Connector and Sprocket Wear Data
Snow Testing of Rubber Tire Hubs

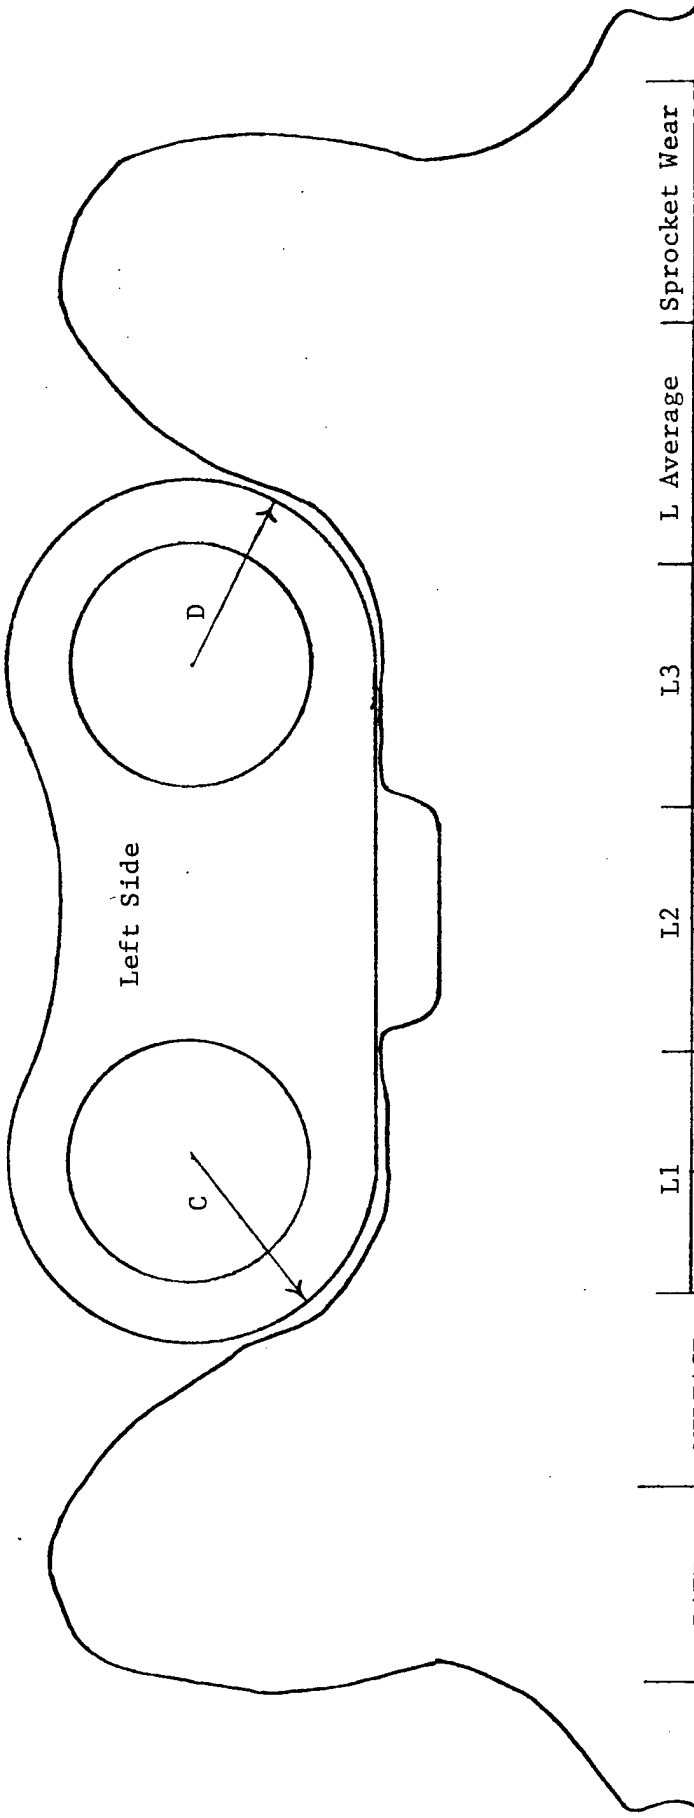
DATE	MILEAGE	L1		L2		L3		L Average		Sprocket Wear	
		C	D	C	D	C	D	C	D	C	D
03/09/82	2138.6	.440	.438	.462	.401	.462	.473	.471	.437	.460	.328
03/12/82	2186.2	.472	.412	.450	.371	.418	.459	.447	.414	.350	.335
03/17/82	2248.9	.468	.406	.453	.340	.421	.453	.447	.400	.352	.317
03/18/82	2301.0	.454	.398	.433	.367	.411	.433	.433	.399	.358	.326
03/22/82	2361.9	.456	.403	.436	.439	.402	.439	.431	.427	.359	.329

M60 Track End Connector and Sprocket Wear Data
Snow Testing of Rubber Tire Hubs
