## Bioengineering as a Tool for Restoring Ecological Integrity to the Carson River

**PURPOSE:** This technical note describes a case study involving the following: (a) use of bioengineering (a combination of vegetation and engineered structures and materials) and rock structures to restore an eroded bank of the Carson River, Nevada, and (b) restoration of ecological amenities that existed prior to disturbances by man and a major flood event.

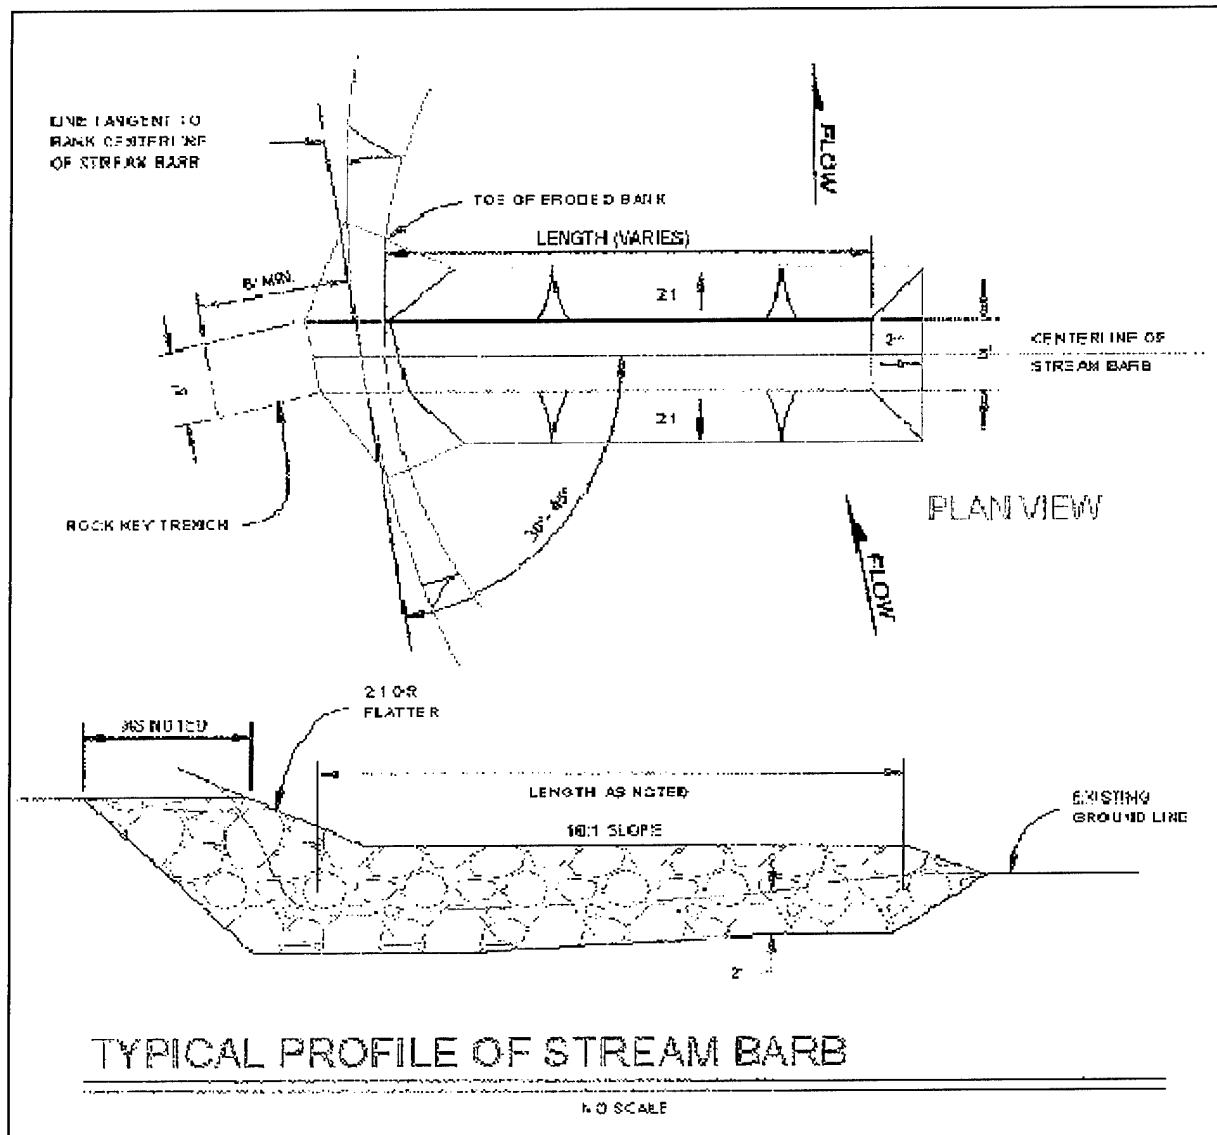
The stream barbs were pointed upstream; specifically, their center line was positioned 30 to 45 deg from a line tangent to the streambank (Figure 4). Their slope was 10H:1V from the top to the toe and they had at least an 8-ft (2.4-m) rock refusal root extending into the bank. Note that the toe of the barb was keyed into the bed of the river for scour protection. Side slopes were 2H:1V. Such a configuration allowed water to be deflected away from the eroded bank at all water levels and also allowed sediment to accumulate behind the barbs.

Figure 4. Plan and profile views of stream barb
