**(CAVITATION DAMAGE OF MECHANICAL  
PUMP IMPELLERS OPERATING IN  
LIQUID METAL SPACE POWER LOOPS)**

*by R. S. Kulp and J. V. Altieri*

Prepared under Contract No. NAS 3-2541 by  
PRATT & WHITNEY AIRCRAFT DIVISION  
UNITED AIRCRAFT CORPORATION  
Middletown, Conn.

CAVITATION DAMAGE OF MECHANICAL PUMP IMPELLERS  
OPERATING IN LIQUID METAL SPACE POWER LOOPS

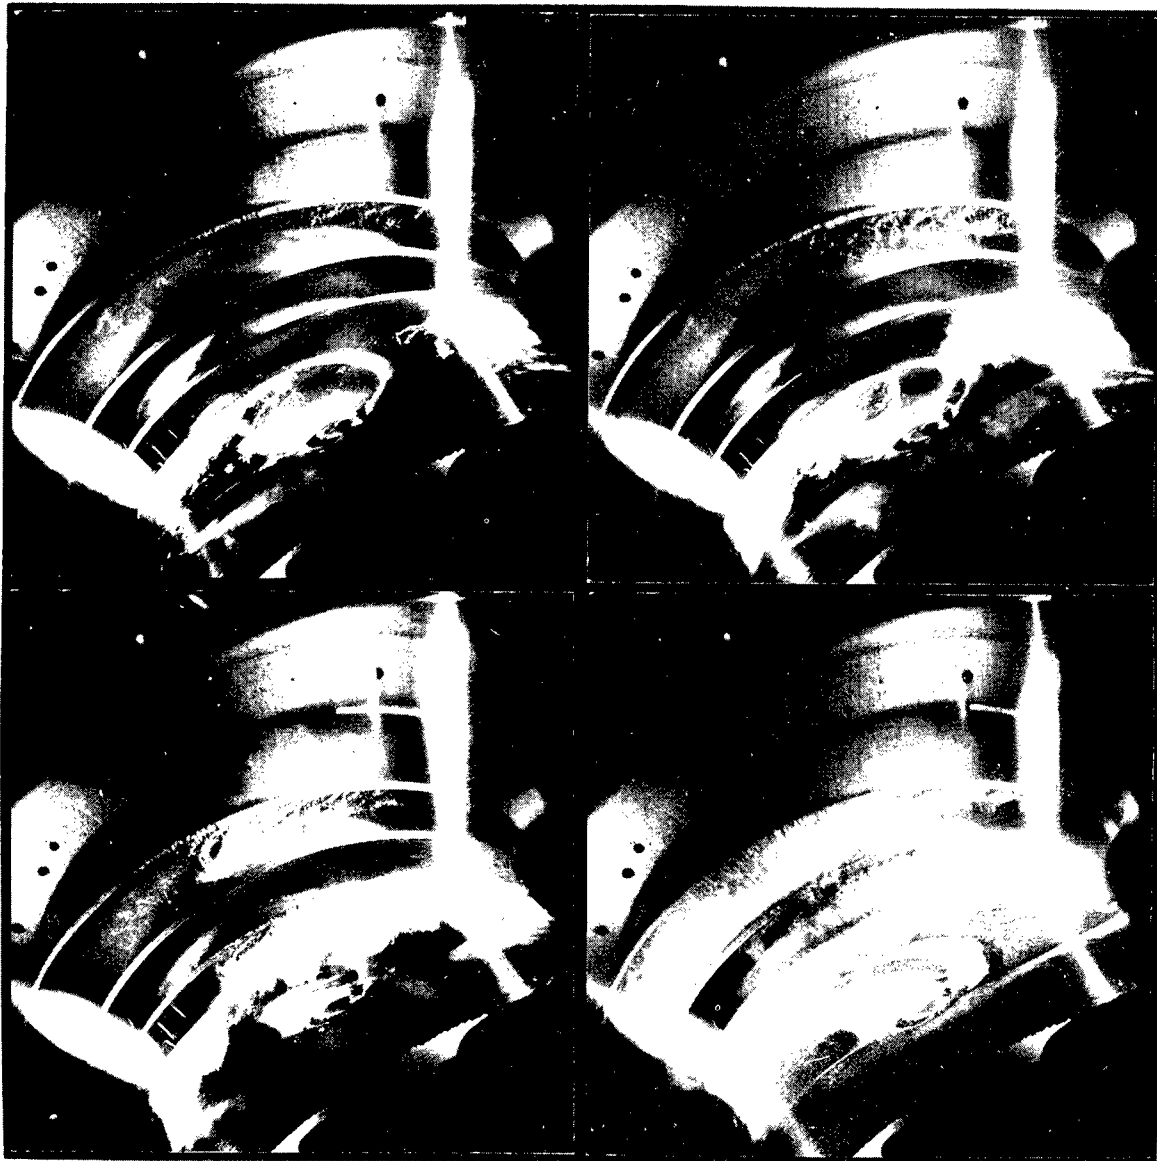
FIG 26

Some of the still photographs taken during this test series are shown in Figs. 26, 27, 28, 29 and 30 for the flows of 660, 680, 700, 720 and 740 gpm, respectively. These photographs clearly show the cavitation patterns on the impeller as a function of NPSH. Fig. 28 shows that cavitation exists on the impeller to NPSH values of 150 feet at a shaft speed of 6375 rpm. Photographs were taken using a 35 mm camera with a 55 mm lens at NPSH values of 150, 100, 60, 35, incipient head loss, 15 and 8 feet for each of the five flows. The incipient head loss point is that point just before a drop in pump head rise is observable as NPSH is decreased.

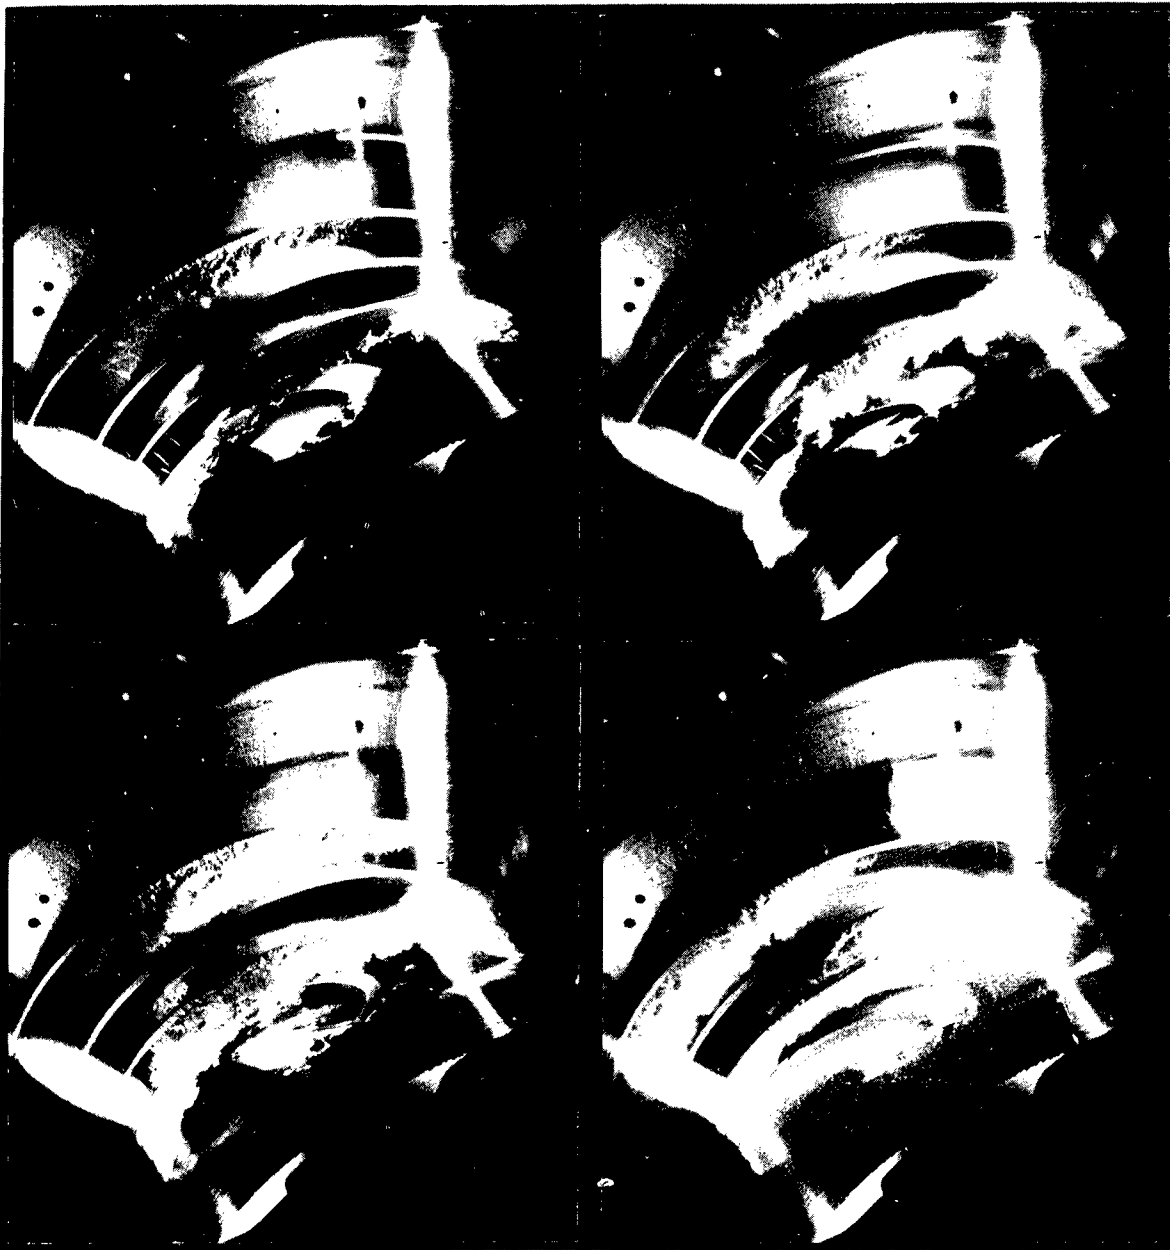
FIG 28

The cavitation pattern selected from the impeller water tests is shown in Fig. 28 corresponding to an NPSH of 17.7 feet and a suction specific speed of 19,500. At this condition, the cavitation bubble implosions in the rear channels of the impeller did not appear to collapse on the vane surfaces. Although bubble implosions were observed to occur on the vane surfaces near the leading edge, they were not judged to be as potentially damaging as cavitation implosions occurring in the rear channel regions where high pressure gradients existed. Also, since no evidence of cavitation pitting attack was found after several hundred hours of accumulated water testing in cavitation, it was decided to test the impeller in potassium at this high value of suction specific speed. A correction of 1.1 feet of NPSH was introduced on the basis of the thermal cavitation criterion derived by Stepanoff (Ref. 11), which accounts for the differing thermal properties of cold water and 1400F potassium as related to cavitation bubble formation. Therefore, the NPSH of 17.7 feet for the water test was adjusted to an NPSH of 16.6 feet for the potassium test to produce an equivalent cavitation pattern in the impeller for both tests. This corresponded to a suction specific speed of about 20,000 for the endurance test with 1400F potassium.

NPSH=17.7 FT  
 $N_{SV}=19,500$

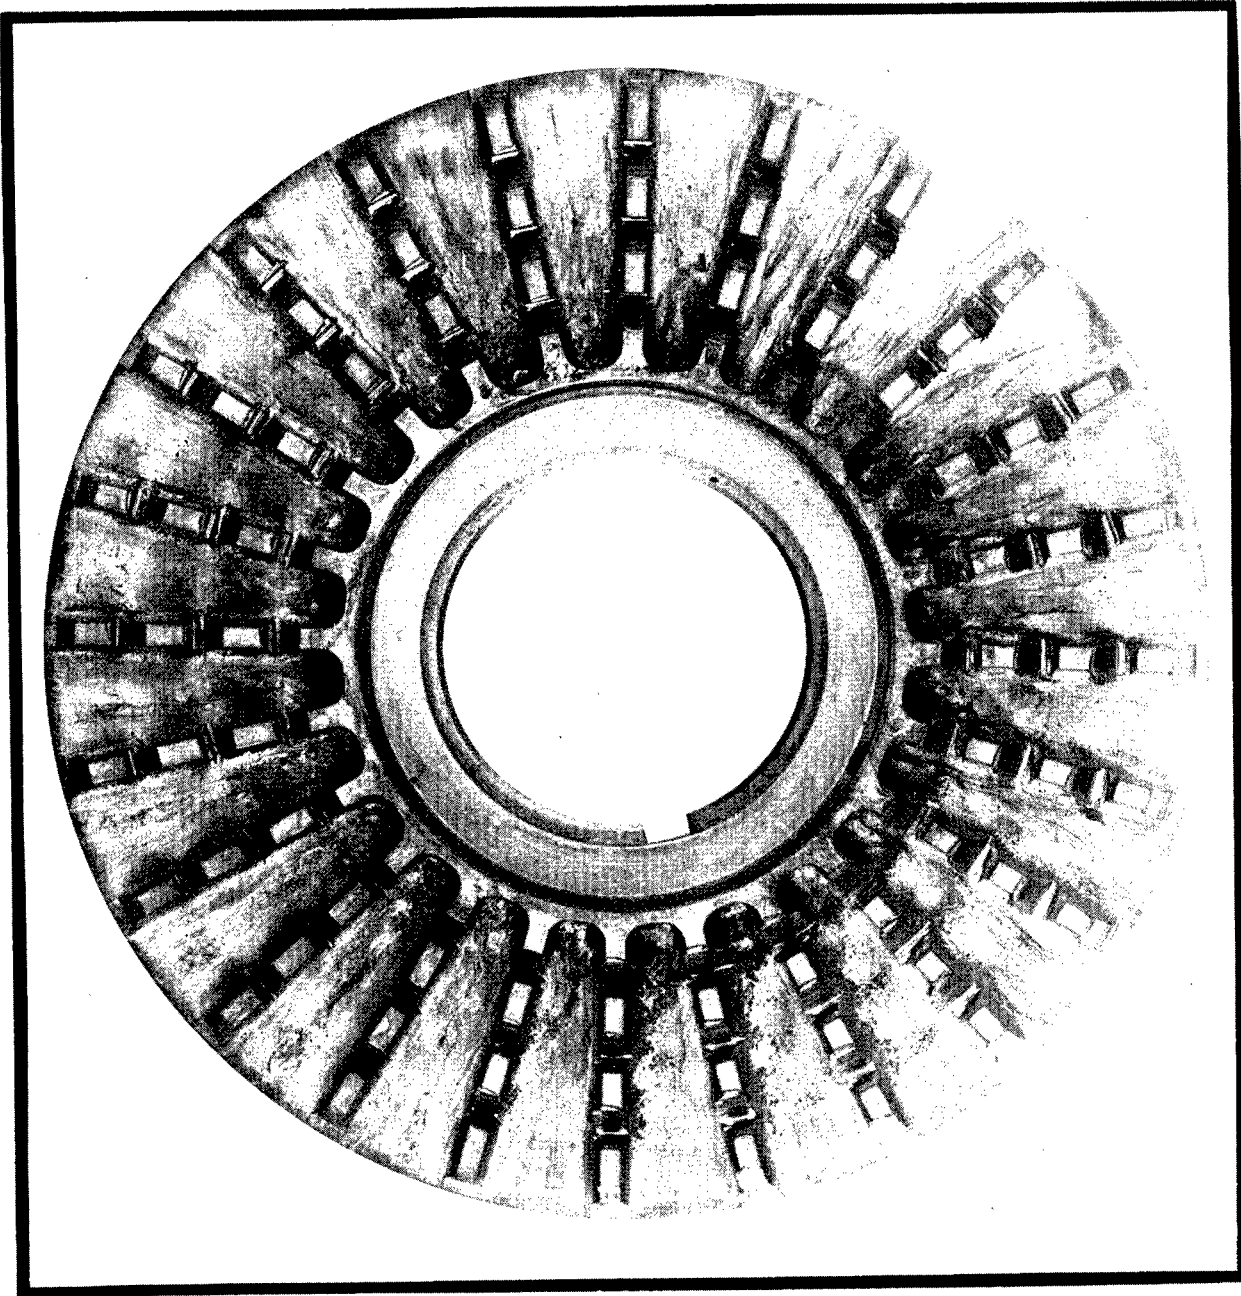
FIG 53

Complete disassembly of the pump revealed additional rubbing damage of the rotating parts. The damage on the impeller is shown more clearly in Fig. 50. It should be noted that the damage is not uniform around the impeller. Very little material was injected into the fluid stream, as evidenced by the apparent flow of metal at the blade tips. Scroll damage from contacting the impeller is shown in Fig. 51. Again, the unsymmetrical pattern of damage should be noted. The cause of the rubbing contact cannot be fully determined from the evidence uncovered, due to the difficulty of separating cause and effect relationships of the damage. However, the unsymmetrical pattern of damage leads to a tentative conclusion that the shaft moved to one side during operation. This is further confirmed by the rubbing damage noted on the dynamic seals shown in Figs. 52 and 53. The cause of this apparent shaft movement has not been satisfactorily determined.

UPPER DYNAMIC SEAL (POSTTEST)

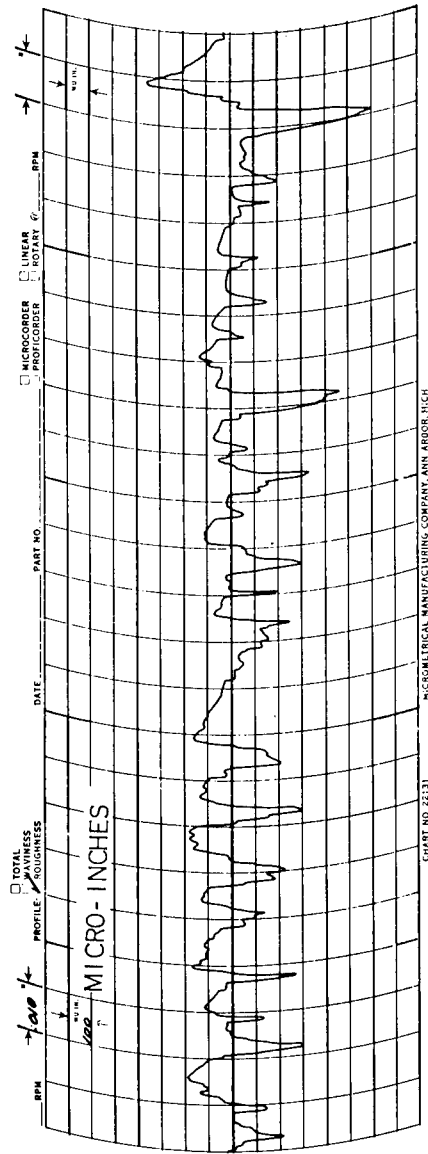
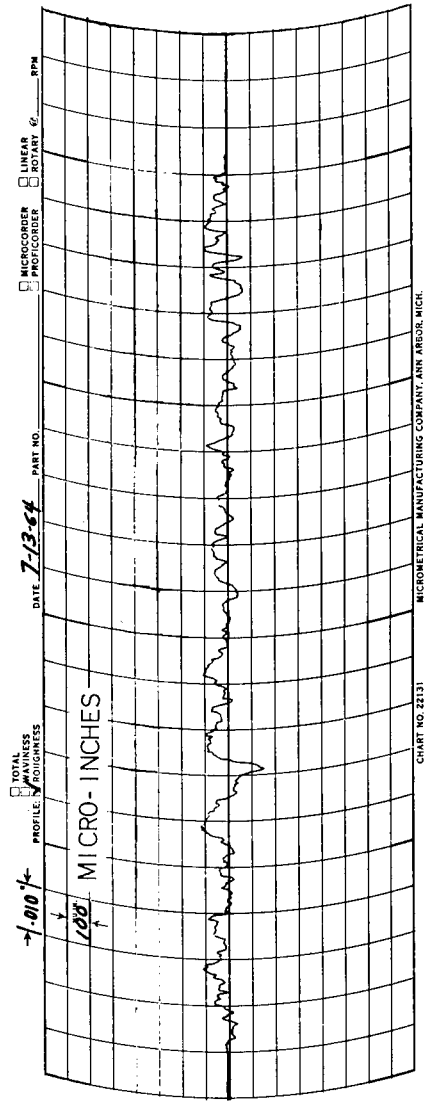
FIG 58

A complete program of inspection was performed on the impeller using all techniques previously noted. The surface roughness measurements made along the same vane stations as those in pretest indicated a slight smoothening of the surface had occurred. This can be seen in the surface roughness traces shown in Fig. 58. This smoothening action was apparently caused by a slight erosive action of the liquid metal.

# SURFACE ROUGHNESS MEASUREMENTS COMPARED AFTER LIQUID METAL TEST BLADE 2, STATION 6, PRESSURE SIDE

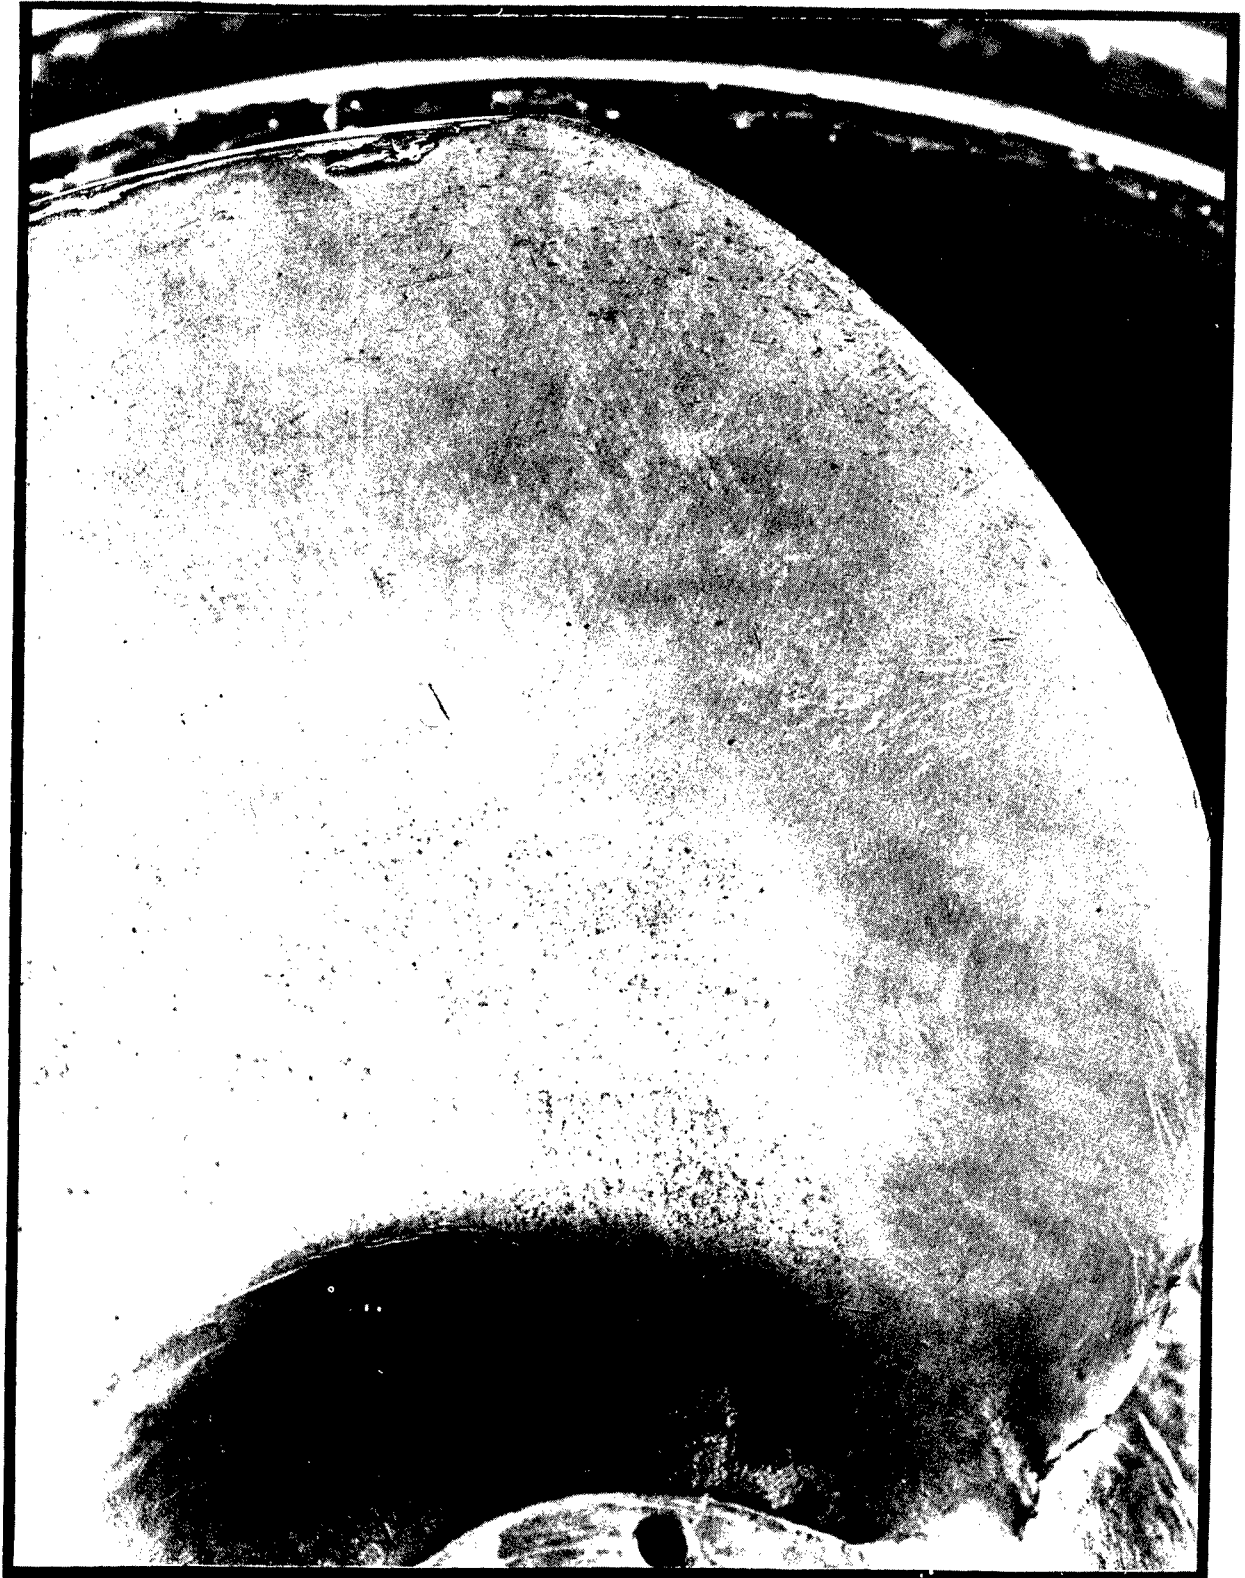
FIG 62

Photographic enlargements were also made of the inlet suction surfaces. A typical photograph is shown in Fig. 62. These photographs were taken at enlargements of two times and four times size and have the potential of enlargement to 20 times size.

POSTTEST VIEW OF RI-7C3 IMPELLER VANE 2 SURFACE

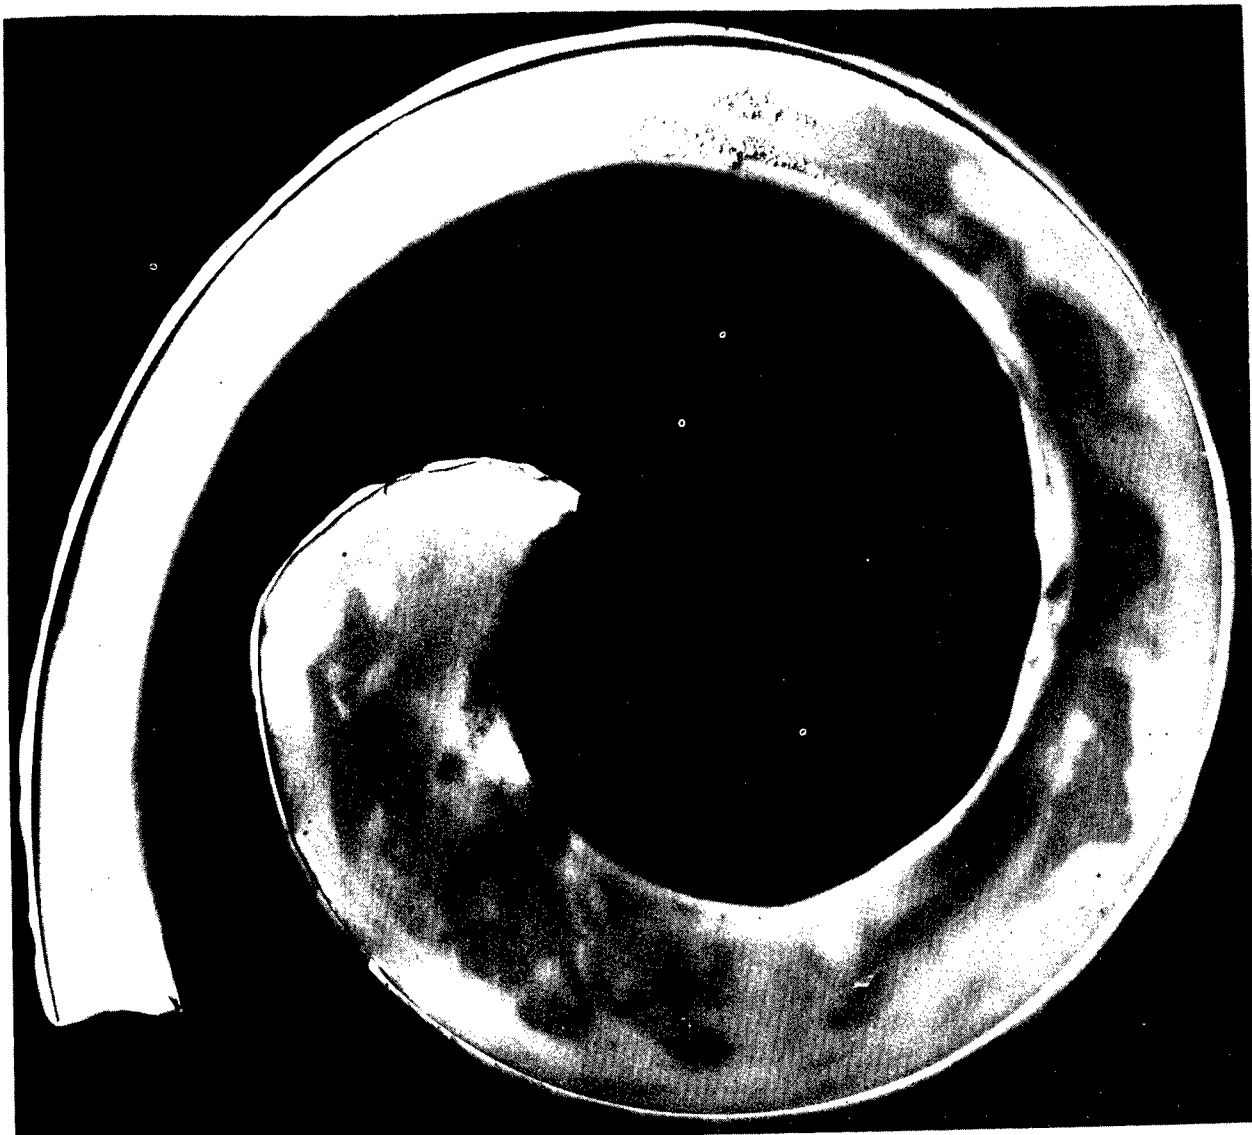
FIG 63

A typical rubber mold is shown in Fig. 63 of the entire pressure surface of vane 2. Fig. 63A is the heavy cavitation damage area of vane 2 photographed at 11X with the mold laid over a sharp edge. Fig. 63B is the rear channel damage of vane 1, photographed by the same technique but at higher magnification (23X). The partial translucence of the rubber material does not allow surface features to stand out in sharp contrast when looking directly at the surface, even under high magnification. The best method of interpreting the rubber molds appears to be the technique employed in photographing.

RUBBER MOLD OF IMPELLER VANE SURFACE AFTER POTASSIUM TEST  
PRESSURE SURFACE OF VANE 2

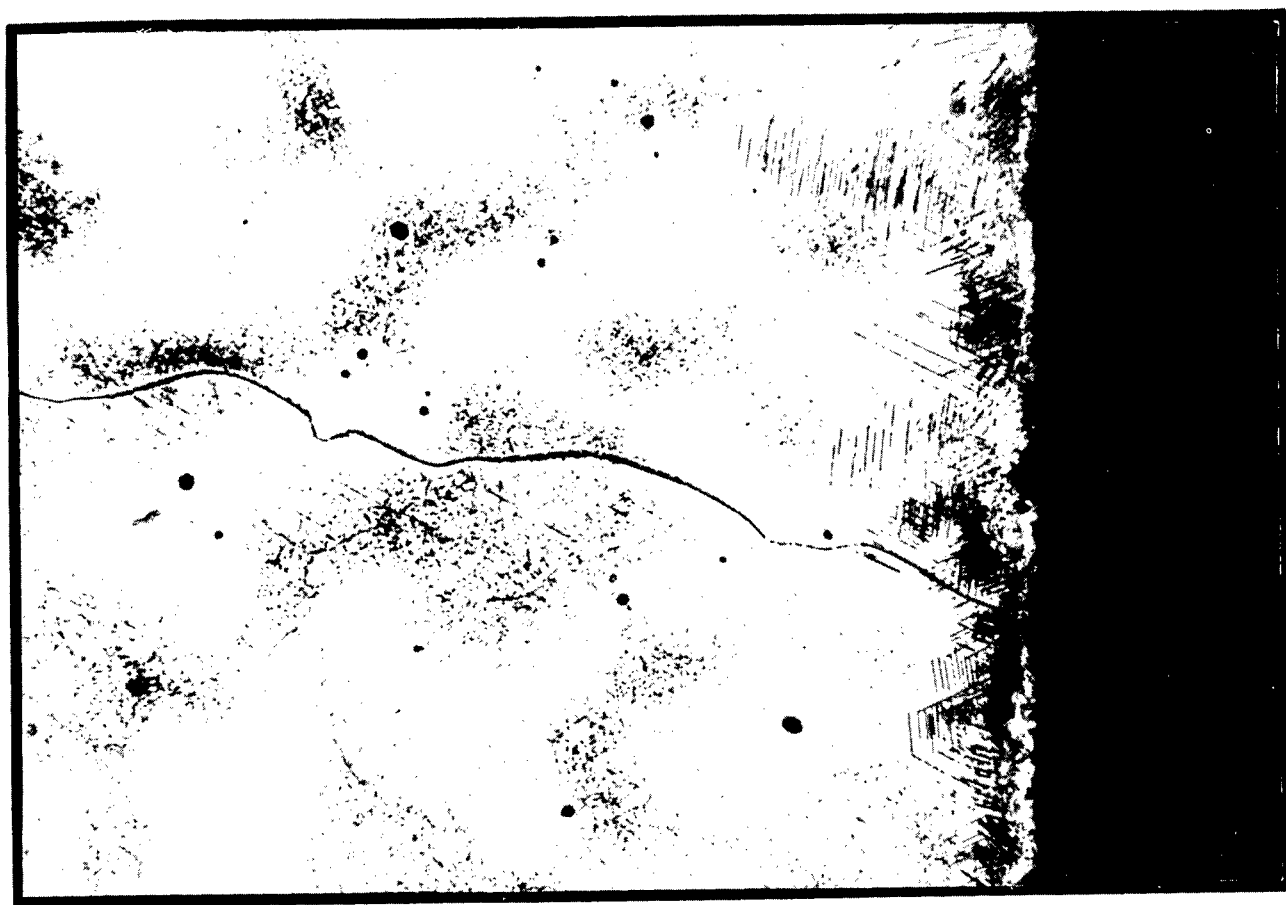
FIG 69

PHOTOMICROGRAPH OF POSTTEST UNDAMAGED MATERIAL
