AIRCRAFT ACCIDENT REPORT

RUNWAY OVERRUN DURING LANDING
AMERICAN AIRLINES FLIGHT 1420
MCDONNELL DOUGLAS MD-82, N215AA
LITTLE ROCK, ARKANSAS
JUNE 1, 1999

**NTSB/AAR-01/02
PB2001-910402
Notation 7195A
Adopted October 23, 2001**

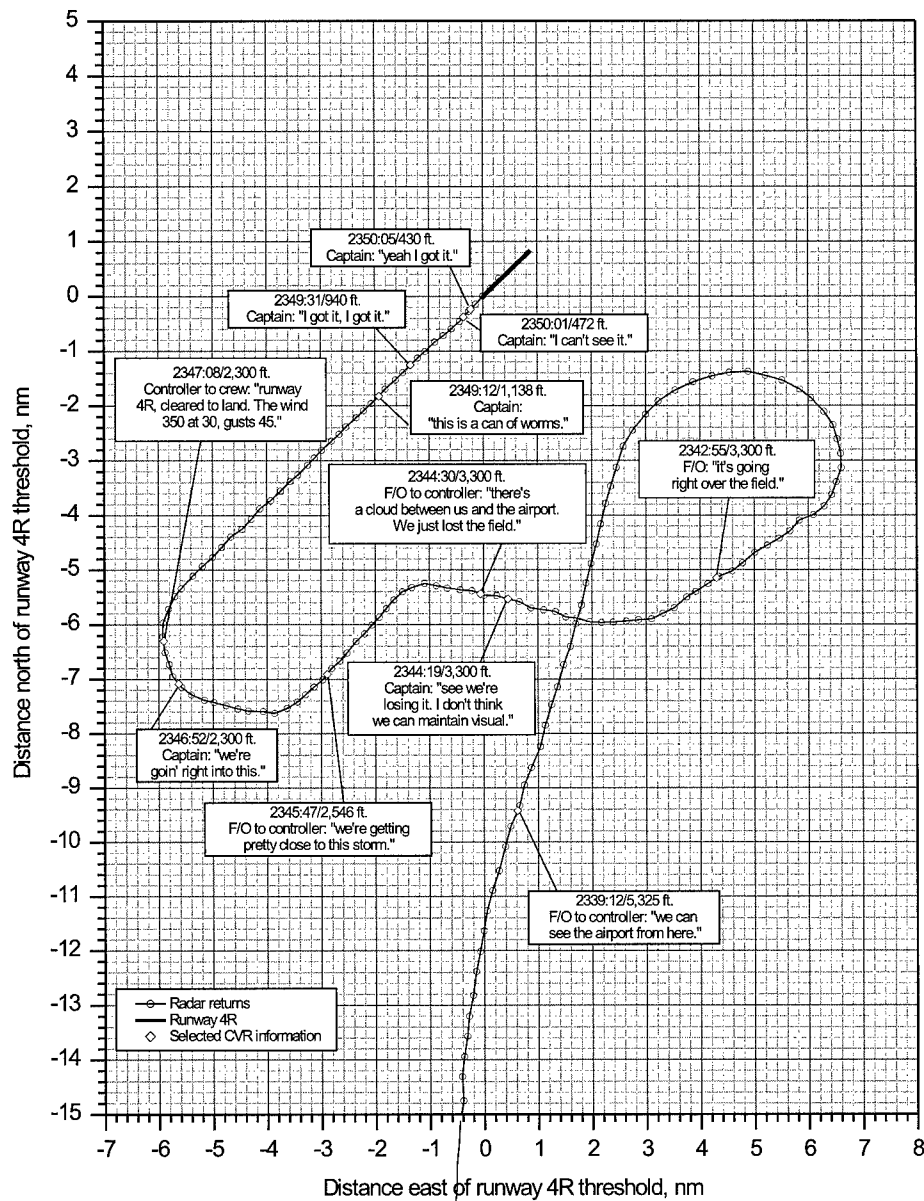
Figure 1. Flight 1420's Approach Path to the Airport and Key CVR Comments

The CVR indicated that, at 2350:00, the first officer said, "we're way off." Flight data recorder (FDR) information indicated that the localizer deviation value was about one dot to the right at that point.¹⁸ About 1 second later, the captain stated, "I can't see it." About 3 seconds afterward, the first officer asked, "got it?" to which the captain replied, "yeah I got it." At 2350:13 and :14, the CVR recorded the sound of the ground proximity warning system (GPWS) radio altitude callout "sink rate."¹⁹ Calculations based on FDR data indicated that the airplane was descending through an altitude of about 70 feet afl at the time of the first sink rate warning and about 50 feet afl at the time of the second warning. Figure 1 shows flight 1420's flightpath to Little Rock and runway 4R along with key CVR comments and the airplane's location when the comments were made.

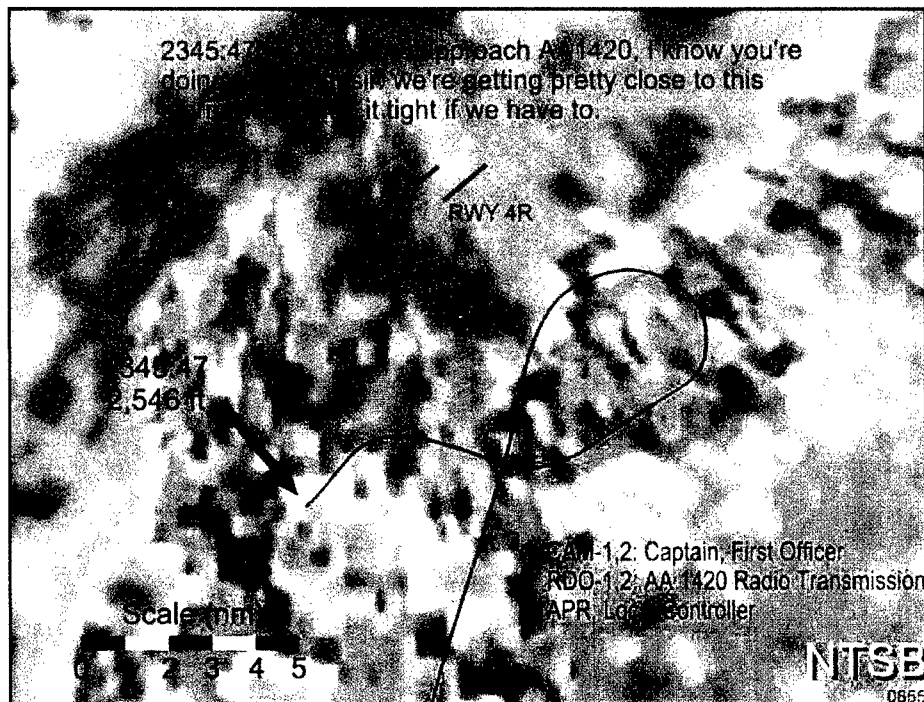
Figure 22. Weather and Flight Information for 2345:47

The weather south of the airport became the next focus of the flight crew's attention. NWS radar data indicated that, in the 6 minutes before the accident, a line of thunderstorms, with several large areas of intense and extreme activity, was encompassing the Little Rock airport area and runway 4R approach path. At 2345:47, the first officer told the controller "we're getting pretty close to this storm. we'll keep it tight if we have to." The controller indicated to the flight crew that, "when you join the final, you're going to be right at just a little bit outside the marker if that's gonna be okay for ya." The captain stated, "that's great," and the first officer told the controller, "that's great with us." Figure 22 shows a map of the weather conditions at 2345:47 and flight 1420's location.
