**NBS CIRCULAR 550**

**Mechanical Failures  
of Metals in Service**

For many years the National Bureau of Standards has made examinations of metal parts that have failed in service for evidence bearing on the causes of failure. Thirty-five such cases, representing the most frequently observed types of failures are described, and the factors of design, fabrication, or use contributing to these failures are presented. The characteristics by which the various types of fractures can be recognized are discussed, and recommended precautions that should be observed to reduce mechanical failures of metals in service are included.

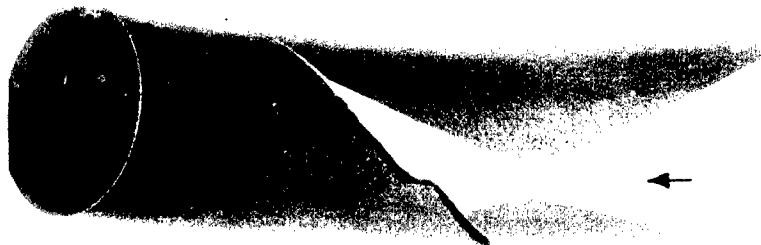
FIGURE 25.3. *The two parts of the fracture fitted together.*

The piece on the right has been ground to show the extent of the longitudinal crack (arrow) away from the fracture.  $\times 2$ .

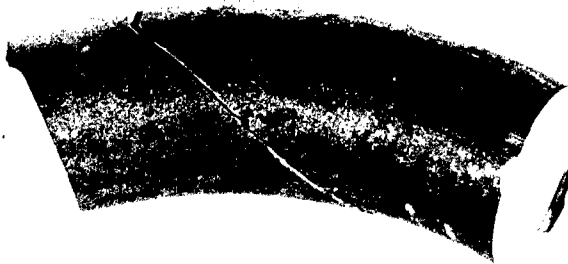
FIGURE 26.1. *Fractured pieces of spring fitted together to show surface pit at nucleus of fatigue fracture, arrow O.*  $\times 2$ .

**Case 26:** Helical spring (steel). In contrast to case 25, the fatigue fracture in this spring started on a plane normal to the tensile stress. The surface of the spring was somewhat pitted, and the stress concentration at one of these pits was sufficient to cause the initiation of the fatigue crack. The fatigue crack progressed over nearly half of the cross section of the rod before final fracture

occurred, indicating that the applied stress was relatively low and showing the severe decrease in fatigue strength caused by a surface defect.

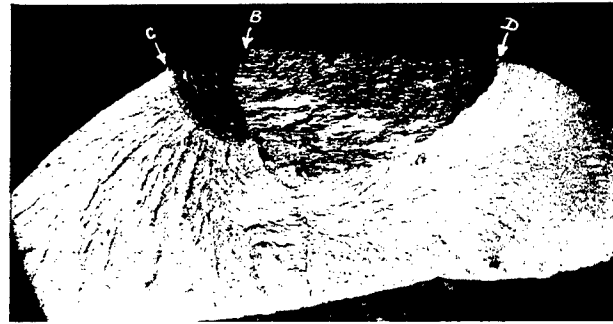
FIGURE 27.2. *Surface of the fracture.*

The dark fatigue crack areas at the top are easily distinguished from the lighter overload portion. The tensile fatigue crack from B to C is on a plane making an angle of approximately  $45^\circ$  to the plane of the paper.  $\times 1$ .

of the area fractured from overload. Torsion bars of this type are among the most highly stressed members in common use, and this failure emphasizes the importance of having material free from large inclusions for such service.

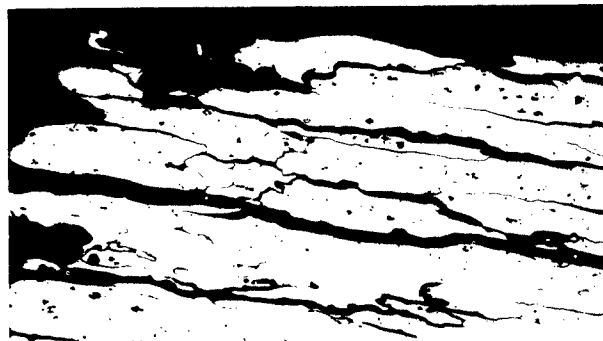
FIGURE 33.2. *Typical intercrystalline corrosion in one of the fittings. Unetched.  $\times 100$ .*
