**Degradation of Peel and Tensile
Strength of Bonded Panels
Exposed to High Humidity**

DSTO-TR-1272

**Airframes and Engines Division
Aeronautical and Maritime Research Laboratory**

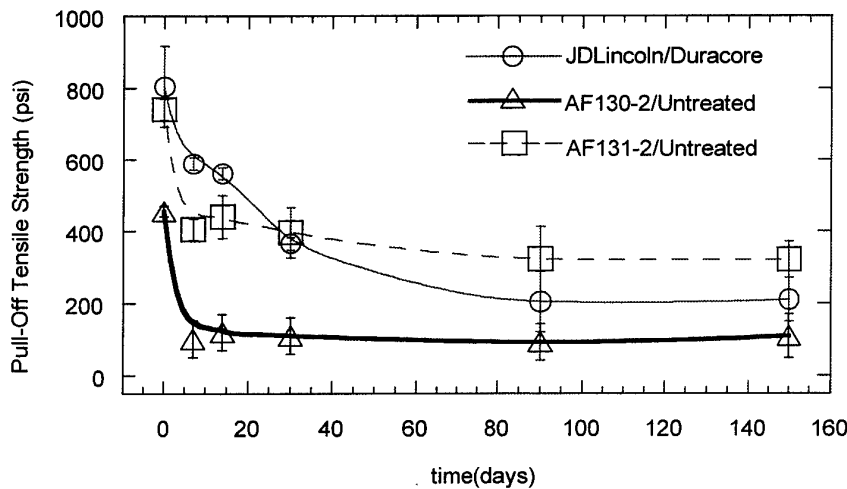
Figure 1 and Figure 2 indicate the change in Tensile and Peel strength of the bonded panels exposed to a 70°C and condensing humidity environment. The tensile strength of all the samples reduces by 400-600psi over a 150 day period. The JD Lincoln and Duracore sample tensile strength degrades gradually over the first 30 days, whereas the untreated honeycomb and AF130-2 and AF131-2 samples both degrade very rapidly in the first 7 days. The peel strength of the JD Lincoln/Duracore sample shows a more rapid decrease than the tensile strength, although the overall reduction does not appear to be as great as the tensile strength reduction. The change in peel strength of untreated honeycomb and AF130-2 and AF131-2 samples is not as marked. Both these adhesives are very brittle and their peel strengths are very low in the control samples. The major information to be established for the exposure of the AF130-2 and AF131-2 samples is the change in failure modes resulting from humid exposure.

Figure 1 Honeycomb panel tensile strength as a function of exposure to a 70°C/100% R.H. environment.

The data in Figure 1 indicates that direct exposure of the fillet bonds to moisture results in a significant reduction in the tensile strength of the honeycomb sandwich panel bonds and a significant increase in adhesion failure. In all cases the majority of the strength reduction and adhesion failure occurs within 30 days. This suggests that should moisture gain access to the bonded honeycomb panel on an aircraft that the reduction in panel tensile strength would be quite rapid. In the case of the AF131-2, the reduction in strength wasn't as marked as the other two systems examined and the percentage of adhesion failure was not as marked. AF-131-2 is used in higher temperature applications on the aircraft and subtle differences in epoxy resin chemistry may improve the adhesive bond formation process during panel fabrication. Generally, the bonded panel tensile strength appears to be inversely proportional to the percentage of adhesion failure and is directly related to moisture diffusing to the adhesive and honeycomb interfacial region and displacing the adhesive bonds from the aluminium honeycomb core surface.

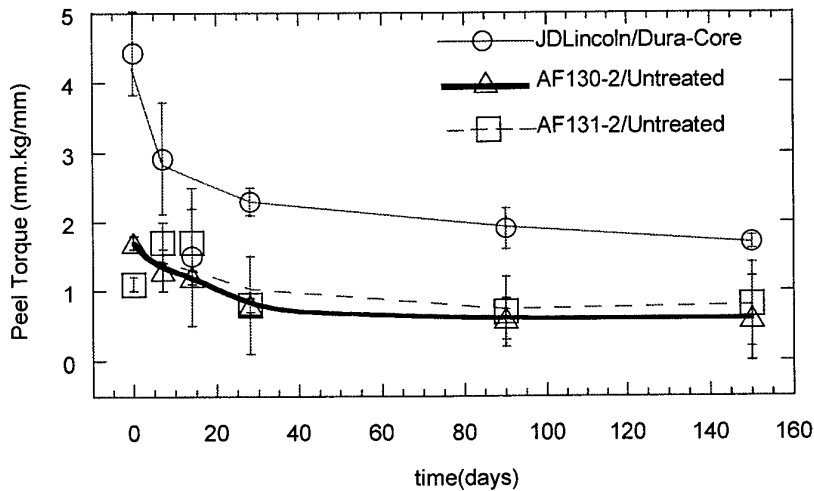
Figure 2 Honeycomb panel peel strength as a function of exposure to a 70°C/100% R.H. environment.

The data in Figure 2 indicates that the change in peel strength for the different honeycomb-adhesive combinations is not as marked as in the tensile strength case. The adhesives tested, particularly the AF-130-2 and AF131-2 adhesives, are brittle and the lack of fracture toughness is shown by the low peel strength values. The newer JD-Lincoln adhesive, shows higher peel resistance, but degrades rapidly in strength once exposed to the moist environment. Both the AF130-2 and JD Lincoln samples indicated that peel strength reduction was associated with a significant increase in adhesion failure either at the skin to adhesive interface or the honeycomb core to adhesive interface. The AF131-2, in contrast, showed a percentage of cohesive fracture of the fillet bond adhesive even after extended exposure, without significant changes in peel strength being observed. The recorded failure modes will provide an important reference for the type of fracture surfaces that will indicate adhesive bond degradation in bonded panels being inspected on the F-111 teardown article in Task Air 00/140.

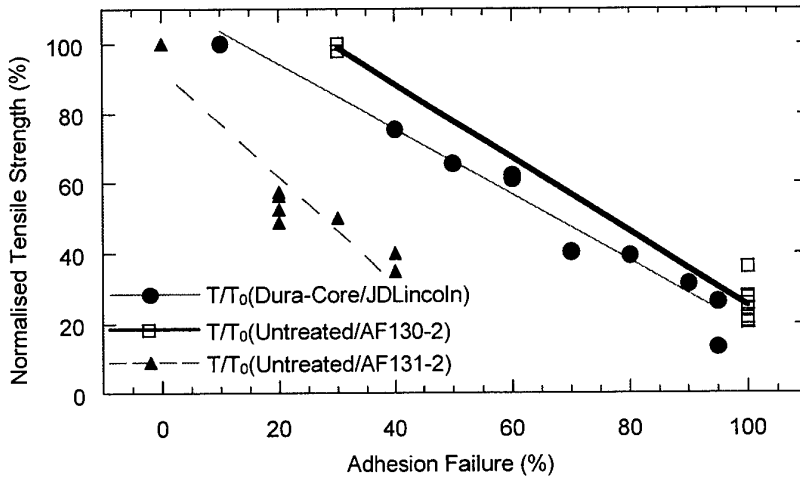
Figure 21 and Figure 22 indicate the measured tensile and peel strength as a function of adhesion failure for the three different honeycomb/adhesive systems. The results suggest that there is an inverse linear relationship between the mechanical strength and the percentage of adhesion failure. Surprisingly, both figures indicate that residual strength remains even when there is 100% adhesion failure. This result may suggest that the mode of failure is caused by moisture diffusion between the adhesive and metal surface of the core or skin material displacing adhesive bonds. The residual strength may indicate that there are still some adhesive bonds that are not disrupted by the interfacial water.

Figure 21 Normalised tensile strength as a function of adhesion failure

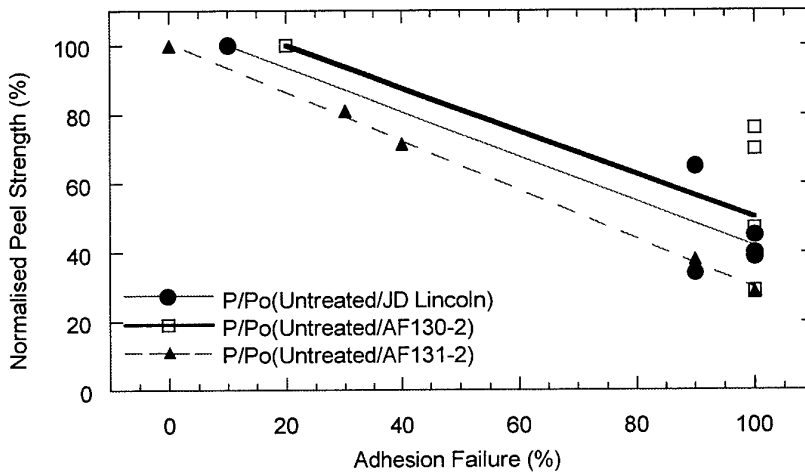
Figure 22 Normalised peel strength as a function of adhesion failure

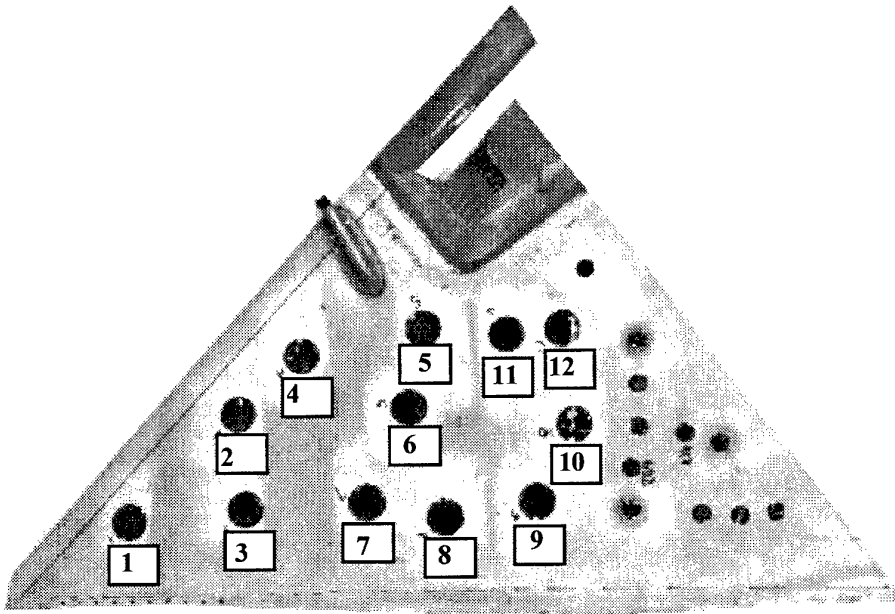
Figure 23 indicates the locations of tensile strength measurements taken on a retired Horizontal Stabiliser Tip (Stab-Tip) from Amberley Air Base. The values for the tensile strength measurements acquired using the portable adhesion tester, refer section 2.2, are provided in Table 2. The average tensile strength value is 590 psi with a standard deviation of 100psi. All the samples either failed as a result of core fracture or cohesive fillet bond failure or a combination of both of these failure modes. The honeycomb had a cell size was 0.25" and the foil gauge was 3.4pcf. Typically, the core fracture is seen for honeycomb with these dimensions and the values around 600psi are acceptable values for undegraded honeycomb structure

Figure 23 Locations of tensile test measurements taken from the Stab-Tip, prior to conditioning.

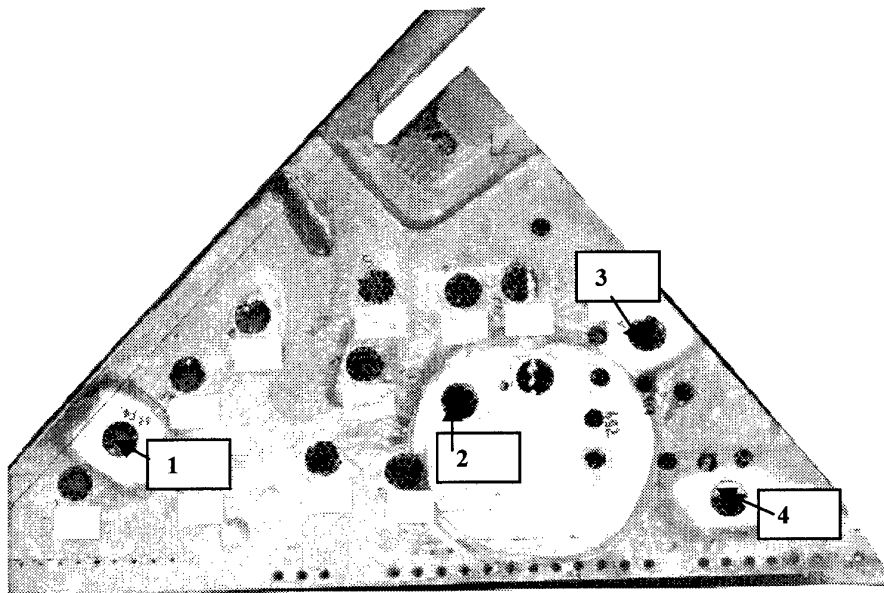
Table 2 also indicates tensile values for samples taken from the Stab-Tip after 20 days and 13 months of immersion in 50°C water. The location of the tensile test measurements are provided in Figure 24 to Figure 26. The data suggests that after 20 days little effect in bond strength results, although a low value of 320psi was recorded for a cohesive failure of the fillet bond adhesive. A similar value and failure mode was observed for a test taken after the Stab-Tip was immersed for 13 months in the 50°C water. It is not clear whether this strength reduction is due to adhesive degradation or not. After 13 months of immersion the Stab-Tip indicated two samples with low values between 200-300psi that failed as a result of core corrosion. Two samples that indicated the onset of fillet bond pull-out did not indicate significant decreases in bond strength. This data suggests that an important factor that may lead to degradation of panel mechanical properties will be due to core corrosion. There is also some suggestion that fillet bond pull-out may occur for extended exposure of bonded panels to humid conditions. Failure surface images of core fracture, core corrosion and fillet bond pull-out are shown in Figure 27 to Figure 29. Generally, the results from the Stab-Tip immersion experiments suggest that in cases of well sealed panels, moisture diffusion into the panel is very slow.

Figure 24 Locations of tensile Test measurements taken from the Stab-Tip after conditioning in 50°C ionised water for 20 days.

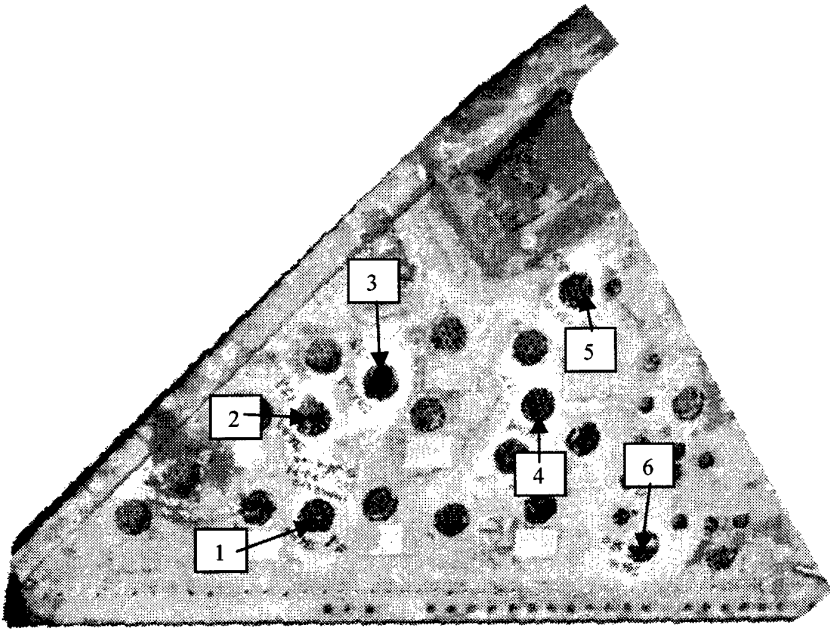
Figure 25 Locations of tensile test measurements taken from side 1 of the Stab-Tip after conditioning for 13 months in 50°C ionised water.

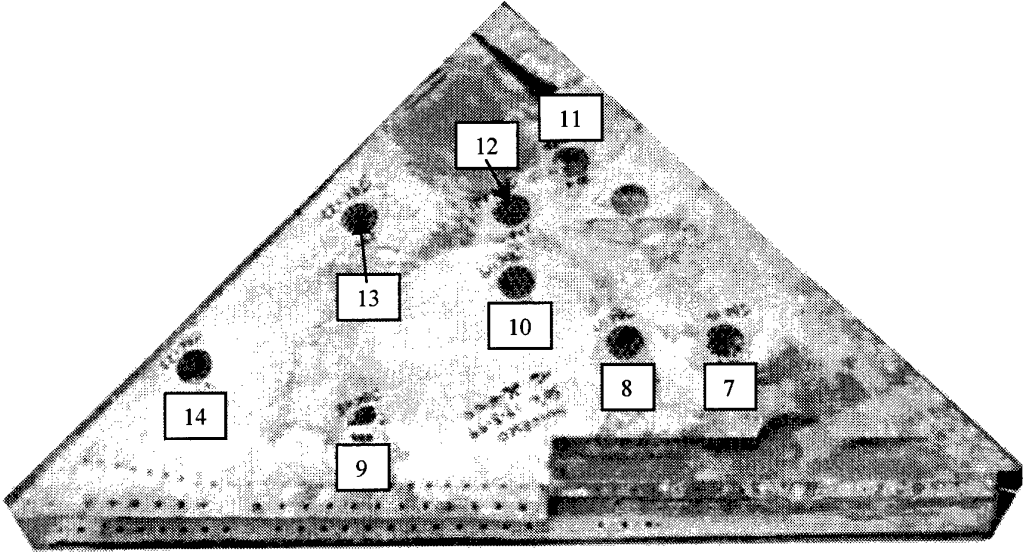
Figure 26 Locations of tensile test measurements taken from side 2 of the Stab-Tip after conditioning for 13 months in 50°C ionised water.
