**AFRL-PR-WP-TR-2002-2061**

**JP-8+100 ENGINE DEMONSTRATION  
Industry Version**

**MARCH 2002**

**Final Report for 23 June 1995 – 30 July 2000**

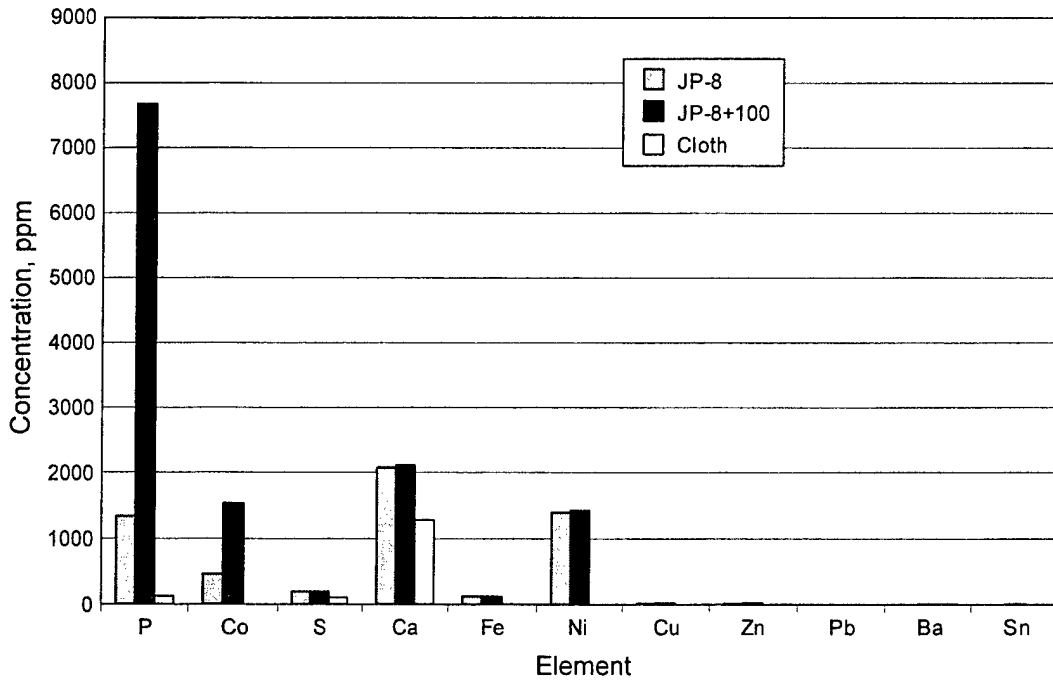
**Figure 26** Elemental Analysis of Surface Coating From 1st Stage Turbine Blades of TF34 Engines Operated on JP-8 and JP-8+100

Figures 26 and 27 summarize the results of these analyses from the blade deposits as well as the paper towel itself. The only significant contribution from the paper towel was Ca; small quantities of S and P were also found. The major differences between the blade analyses are the increases in P and Co in deposits from the engine operated on JP-8+100. Concentrations of the other constituents were essentially the same.
