## **Aircraft Accident Brief**

**EgyptAir Flight 990  
Boeing 767-366ER, SU-GAP  
60 Miles South of Nantucket, Massachusetts  
October 31, 1999**

**NTSB/AAB-02/01  
PB2002-910401  
Adopted March 13, 2002**

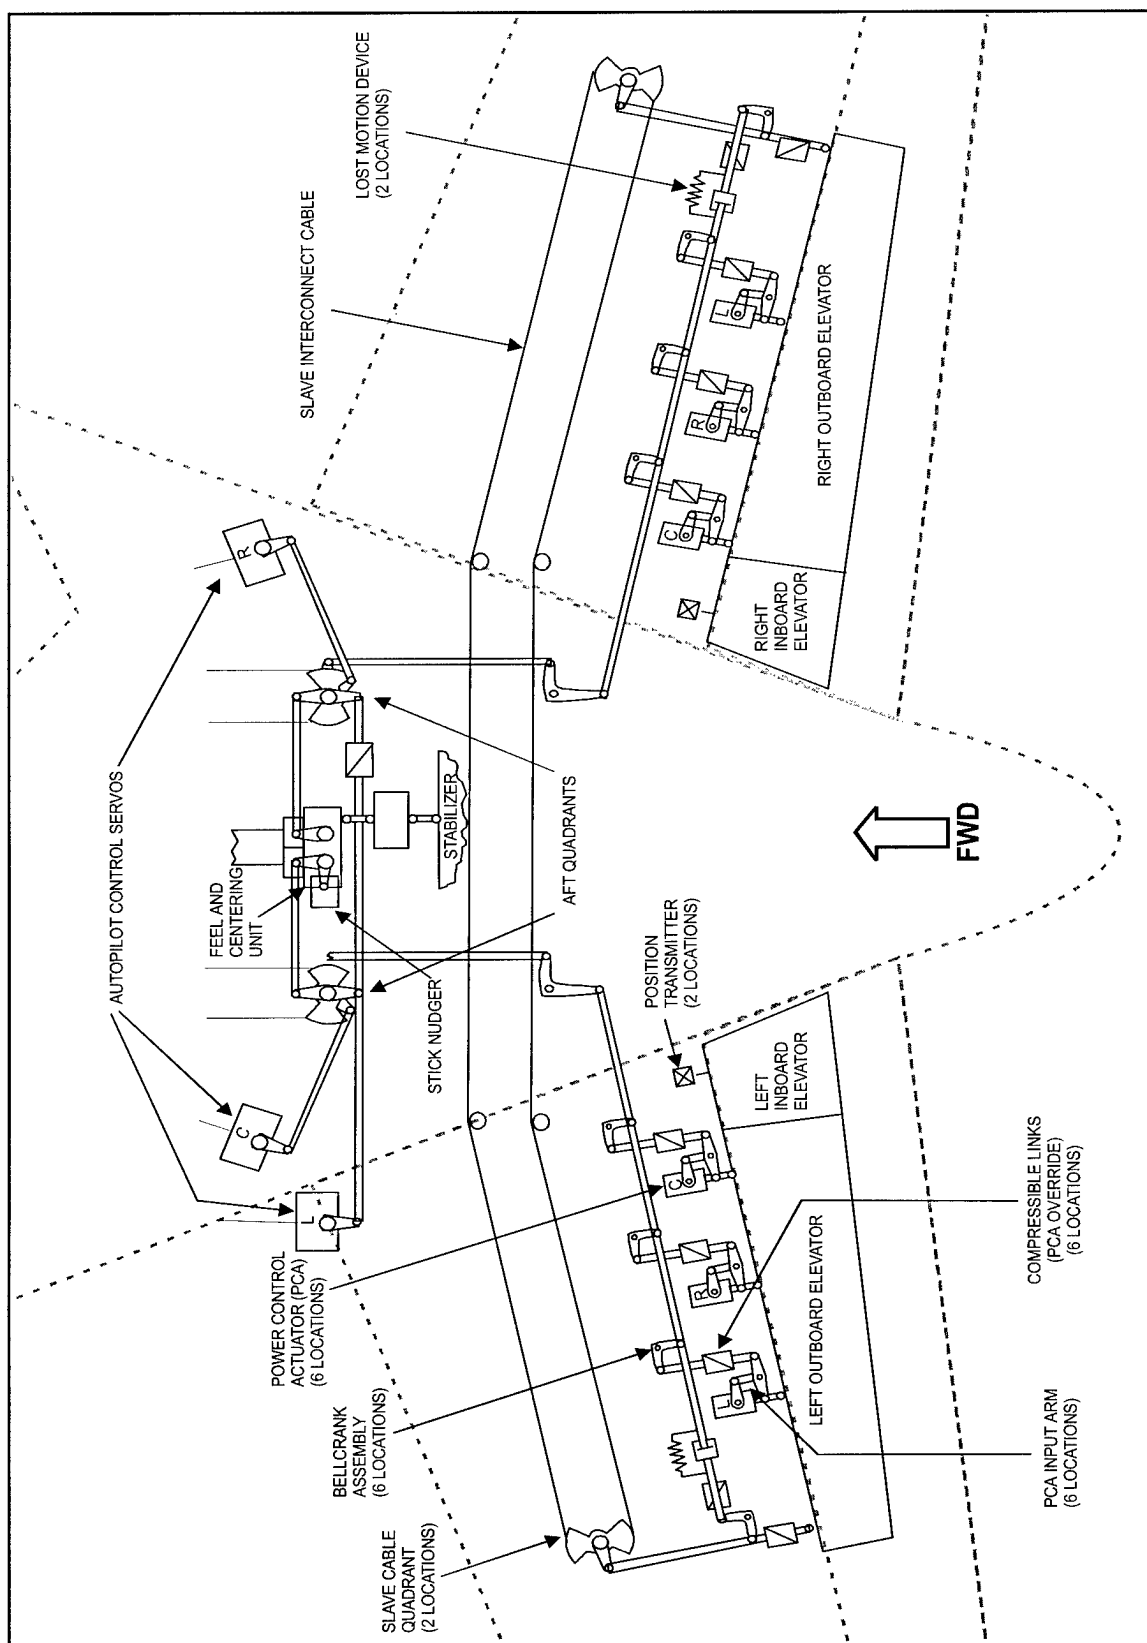
**Figure 1b.** Diagram of the aft 767 elevator control system components.
