**AFRL-VA-WP-TR-2002-3032**

**CORROSION MORPHOLOGY IN  
LAP JOINTS**

**JUNE 2000**

**Final Report for 01 April 1999 – 31 May 2000**

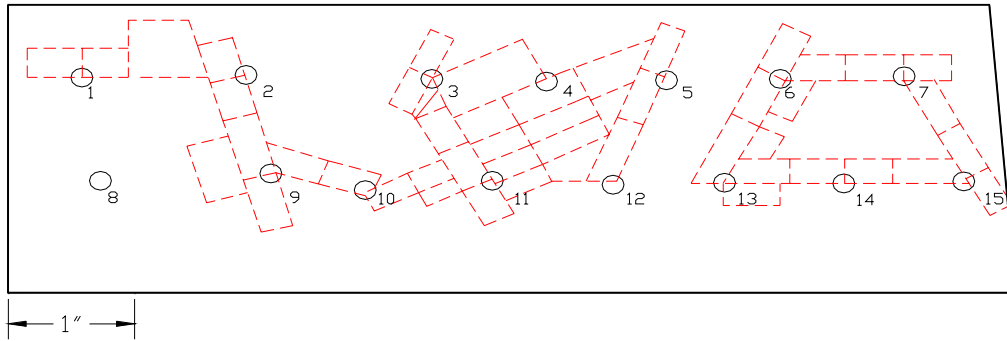
**Figure 4. Schematic Diagram of Panel from Outboard Wing Section (see Figure 1, c and d), Showing Metallographic Cuts**

microscope. In some cases, metallographic cross sections were made perpendicular to the original cross section in order to produce three-dimensional montages of the corrosion damage.

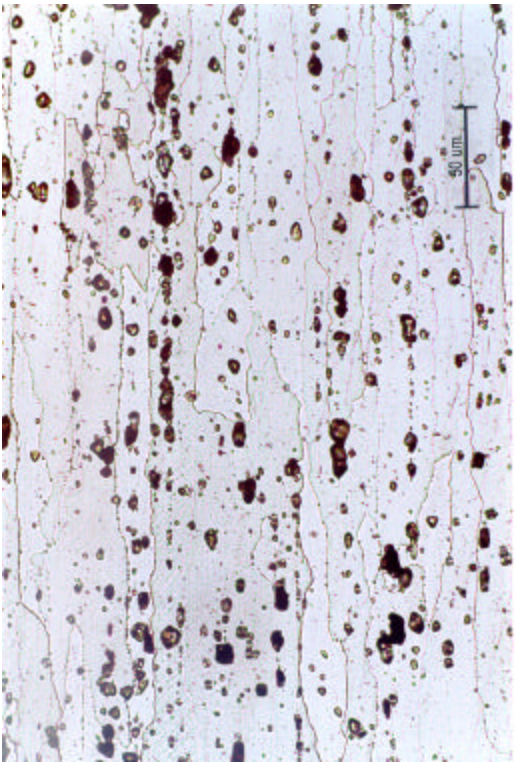
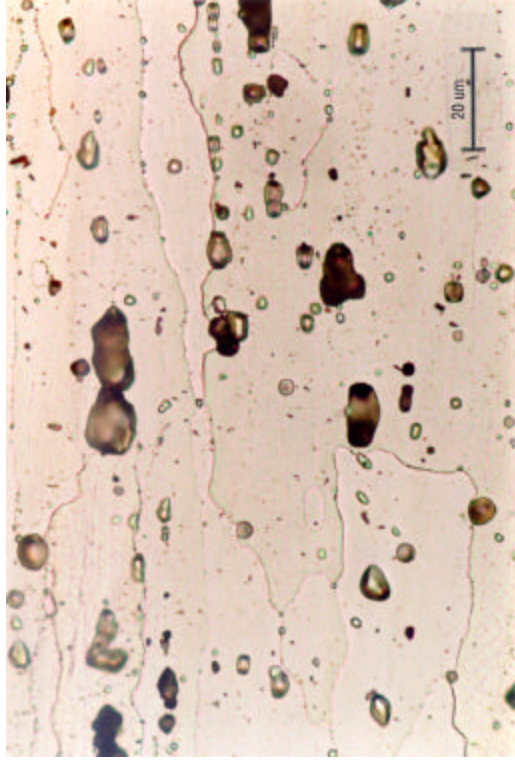
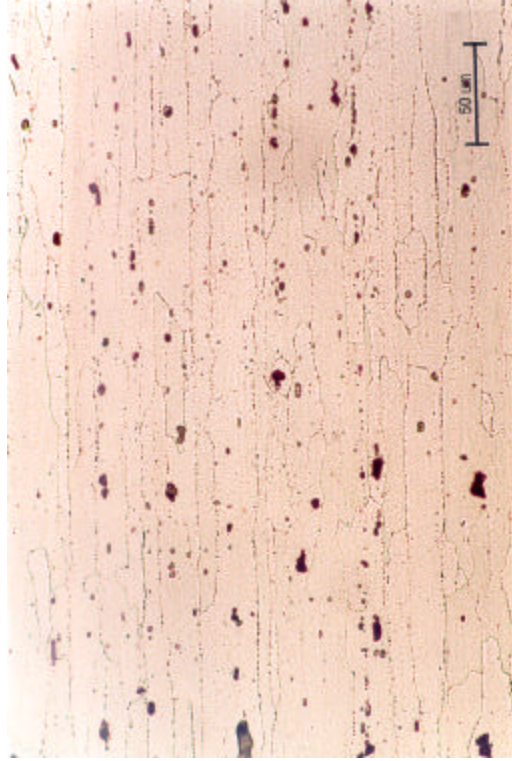
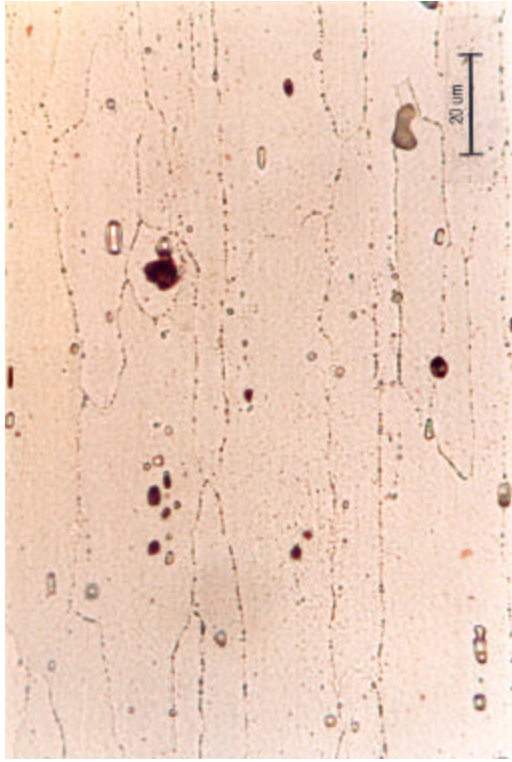
**Figure 17. Optical Micrographs of Aluminum Alloy 7075-T6 from the KC-135 Fuselage Crown Section (a, b) and of Recently Fabricated Material (c, d)**

The microstructures of aluminum alloys 7075-T6, 7178-T6, and 2024-T6 that were removed from different wing and fuselage lap joints were examined and compared with similar, but recently produced alloys. The photomicrographs in Figure 17 show the microstructures of aluminum alloy 7075-T6 removed from the fuselage crown lap joint (a and b) and the recently produced alloy 7075-T6. From the micrographs, it becomes immediately obvious that the older alloy removed from the lap joints has a microstructure containing several relatively large intermetallic particles distributed throughout the microstructure. Some stringer formation as a result of processing can be seen on the lower magnification micrograph (see Figure 17b). The photomicrographs further show distinct grain boundary precipitates in the new alloy, whereas in the lap joint alloy such precipitation is not clearly marked.

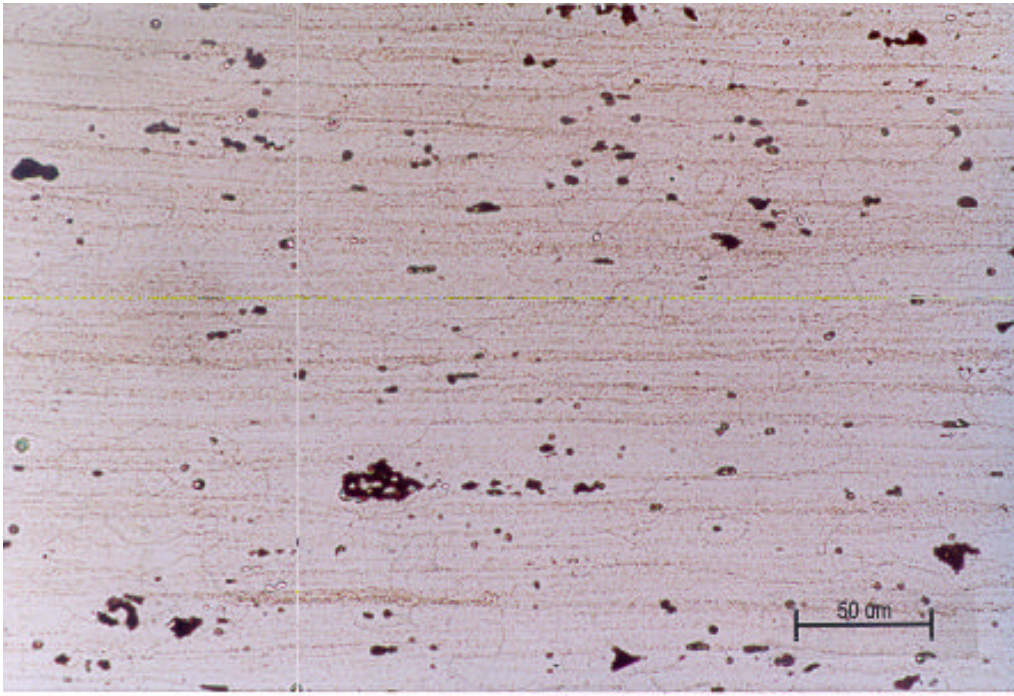
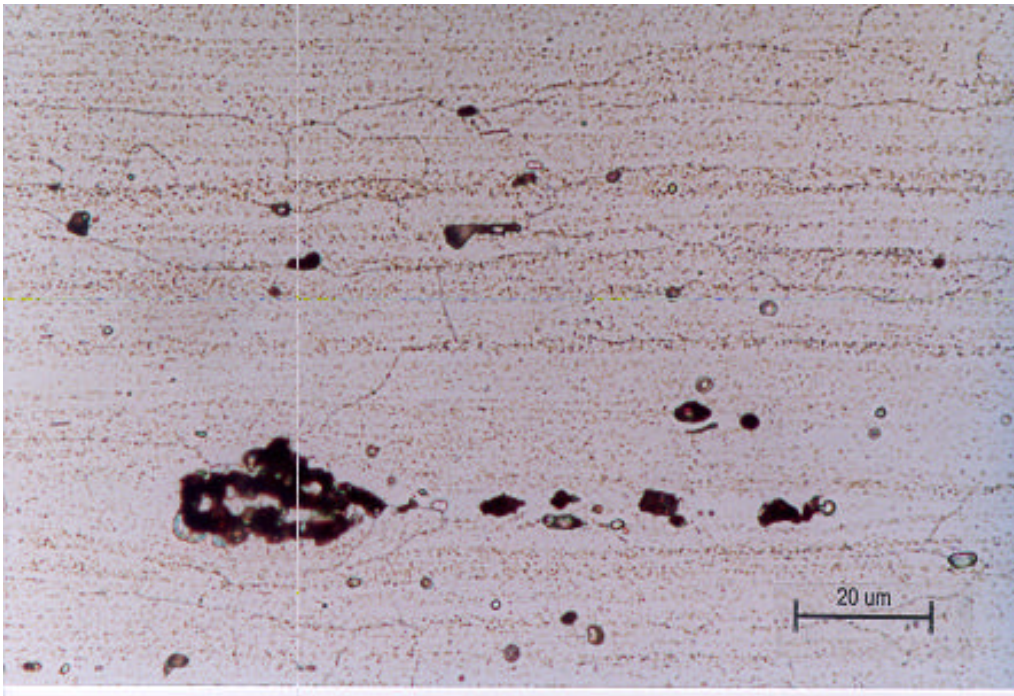
**Figure 18. Optical Micrographs of Aluminum Alloy 7178-T6 from the KC-135 Upper Wing Skin**

Figure 18 shows optical micrographs of aluminum alloy 7178-T6 removed from the upper wing section lap joint. Although this alloy is similar to alloy 7075-T6, its microstructure appears to be different. Particularly, the grain boundaries are not clearly marked and fine precipitates occur in bands in the rolling direction. Like the 7075-T6 alloy, the alloy shows a high density of coarse intermetallic precipitates distributed throughout the alloy.

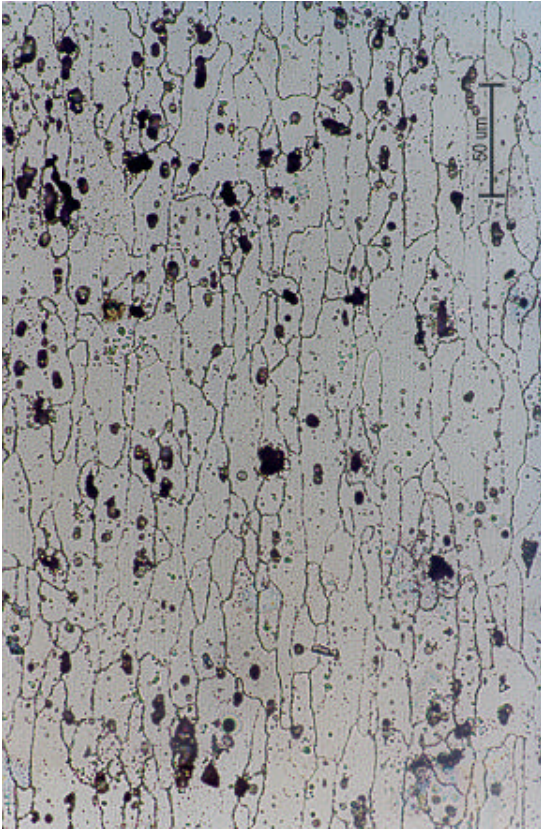
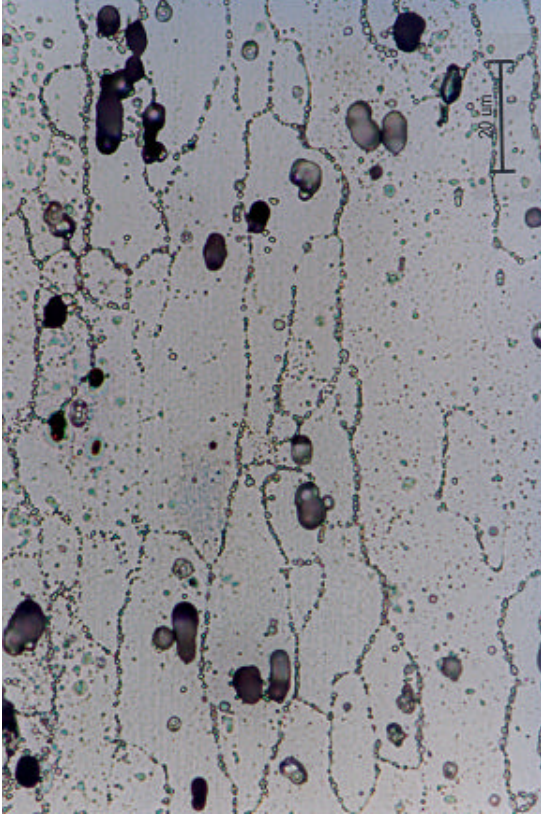
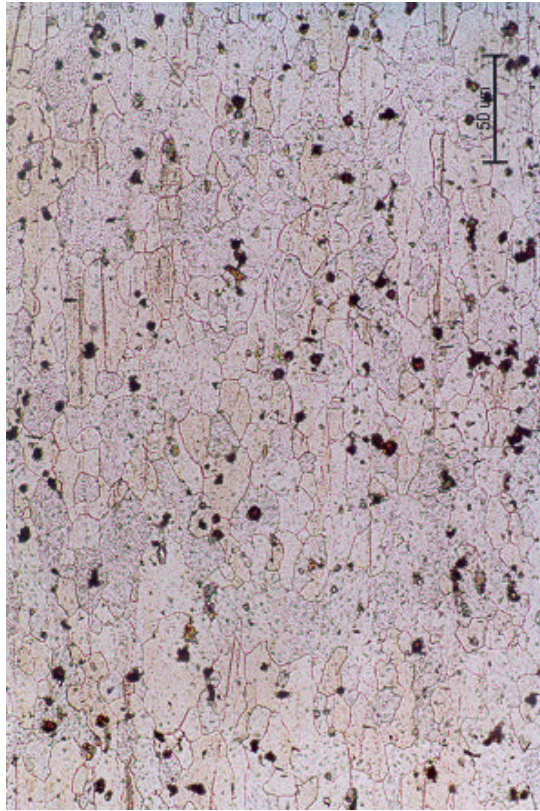
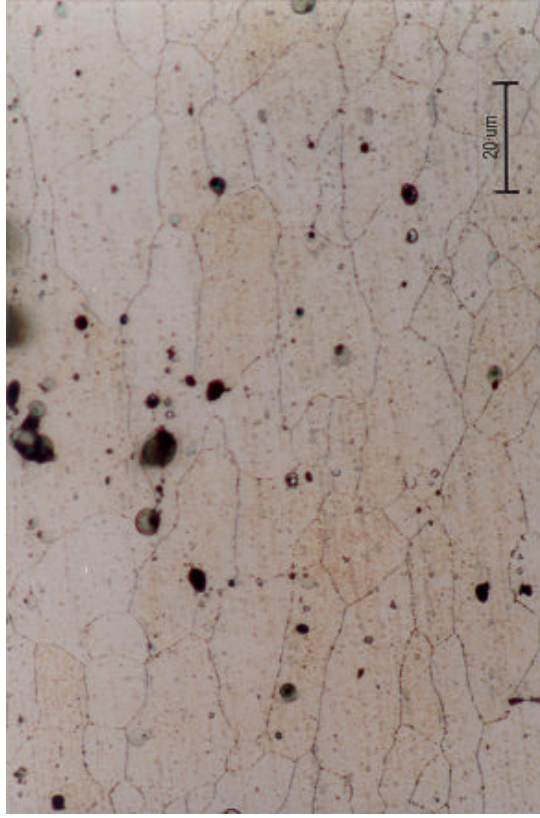
**Figure 19. Optical Micrographs of Aluminum Alloy 2024-T3 from the KC-135 Fuselage Skin (a, b) and of Recently Fabricated Material (c, d)**

When comparing the microstructure of the aluminum alloy 2024-T3 skin with newly fabricated alloy 2024-T3, a number of differences are found. Figure 19 shows that the older skin alloy has clearly defined continuous grain boundaries, whereas the newer alloy has distinct particles marking the grain boundaries. Also, the grains of the skin alloy appear to be more equiaxed than those of the newer alloy.

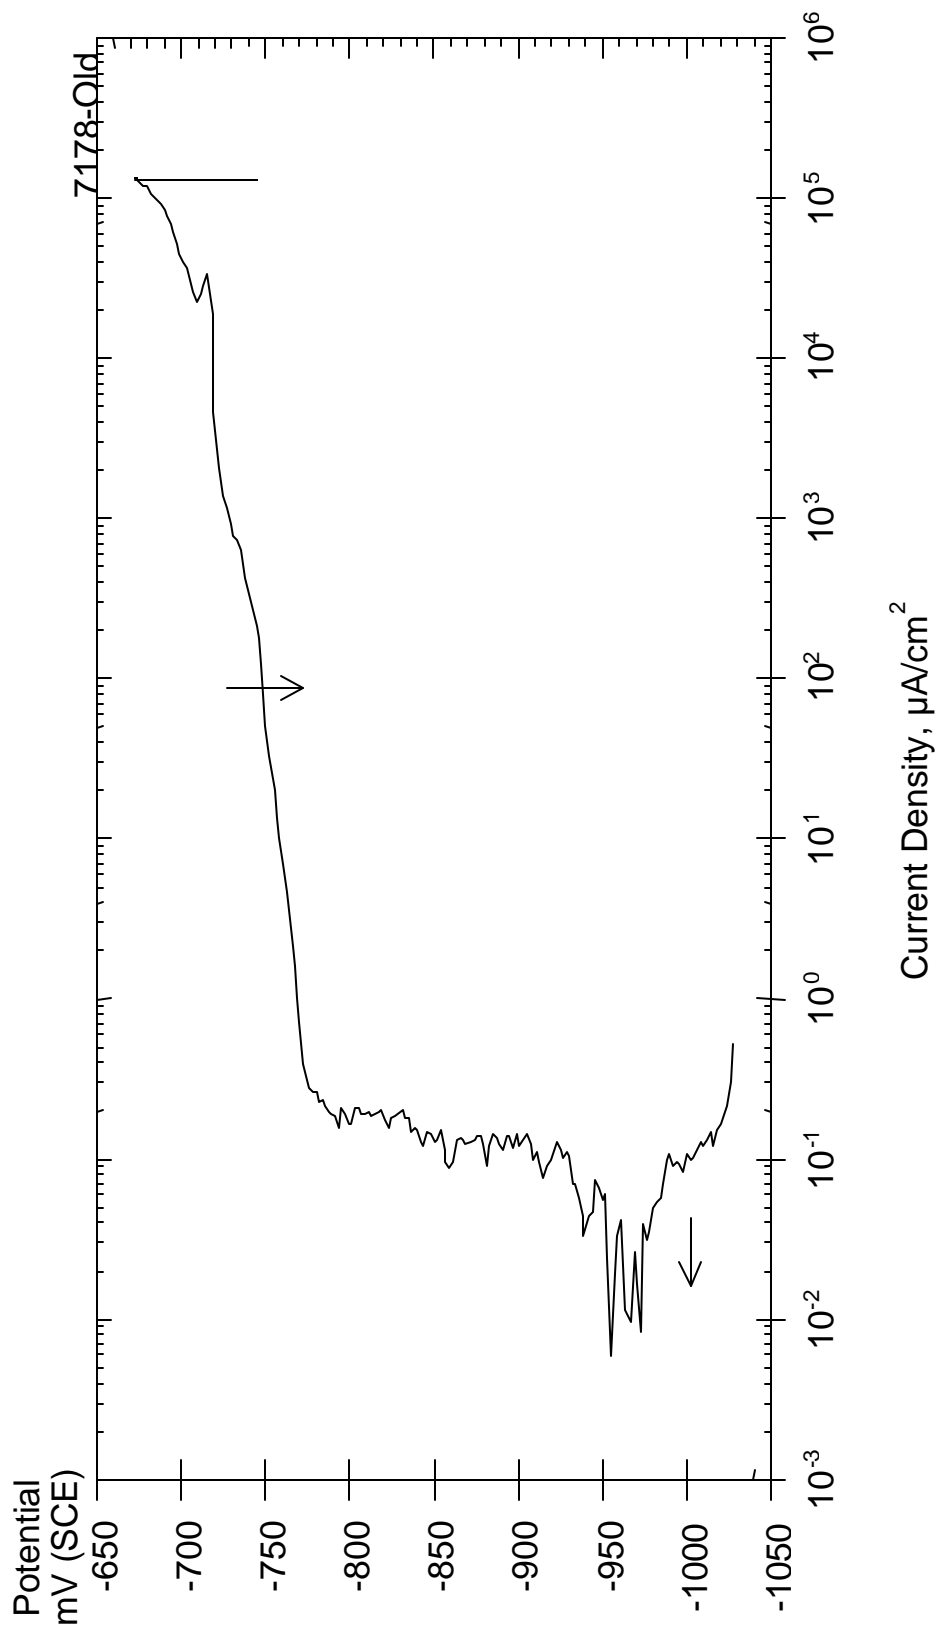
Figure 20. CPP Curve for Alloy 7178 Aluminum in Deaerated 3% (Wt) NaCl at 20°C

The anodic polarization curve for 7178T6 from the fuselage crown section is shown in Figure 20. The polarization curve indicates a corrosion potential ( $E_{cor}$ ) of  $-850$  mV versus SCE. Also on this curve, two different breakdown potentials are observed, at  $-780$  mV versus SCE and  $-700$  mV versus SCE. Each of these breakdown potentials is characterized by a rapid increase in current density. Based on the potentiodynamic scan, alloy 7178-T6 samples were potentiostatically polarized at the two breakdown potentials for a period of 4 days. After exposure, the specimens were cross-sectioned, polished, and etched with Kellers etchant. The results of the potentiostatic tests are shown in the optical micrographs in Figures 21 and 22. The micrographs in Figure 21 show that at the first breakdown potential ( $-780$  mV versus SCE), pitting corrosion occurred, whereas Figure 22 shows that at the second breakdown potential ( $-700$  mV versus SCE), intergranular corrosion is the prevalent mode of attack.

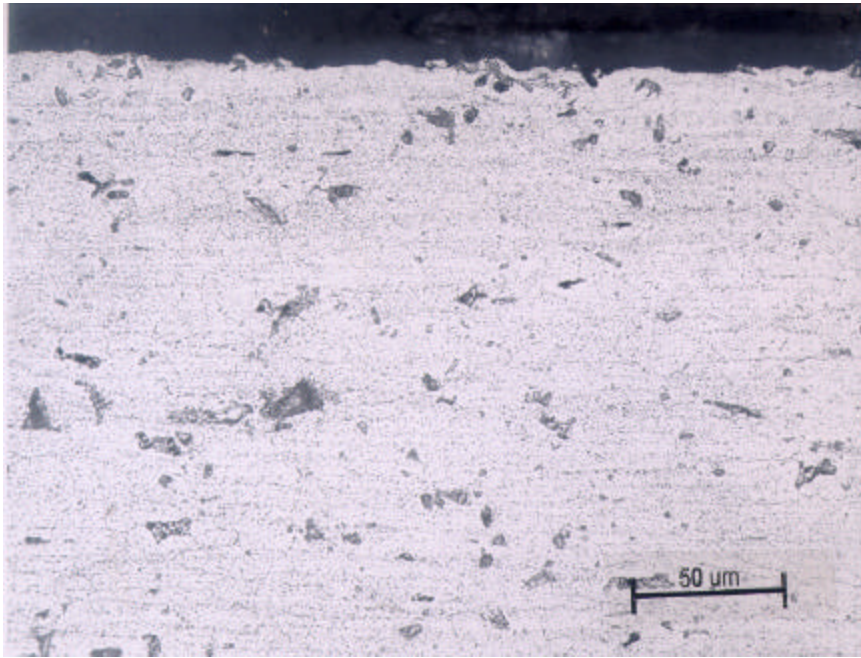
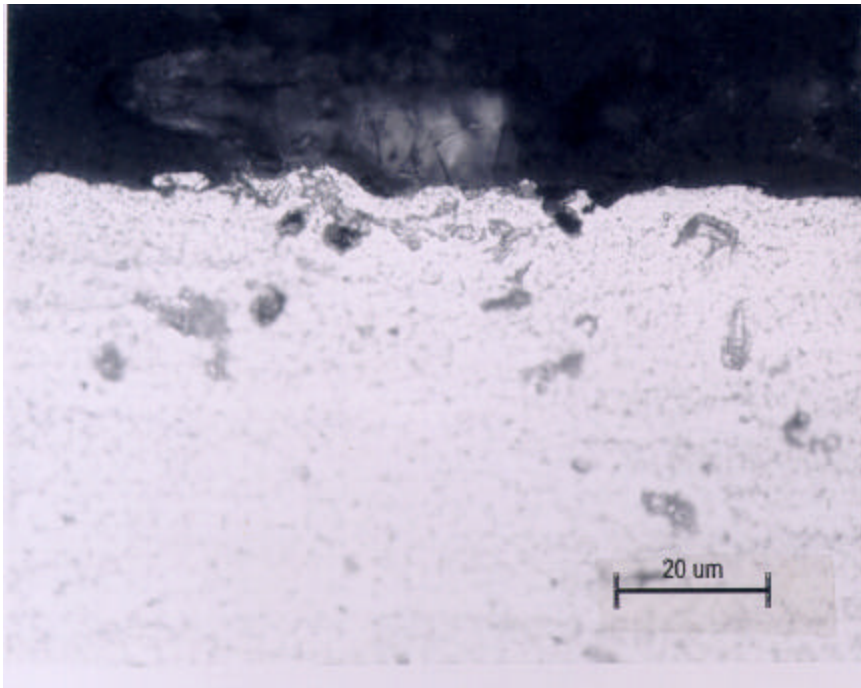
**Figure 21. Optical Micrographs of Cross Section Through Alloy 7178-T6 after Potentiostatic Polarization at  $-780$  mV Versus SCE, Showing Small Pits on the Surface**

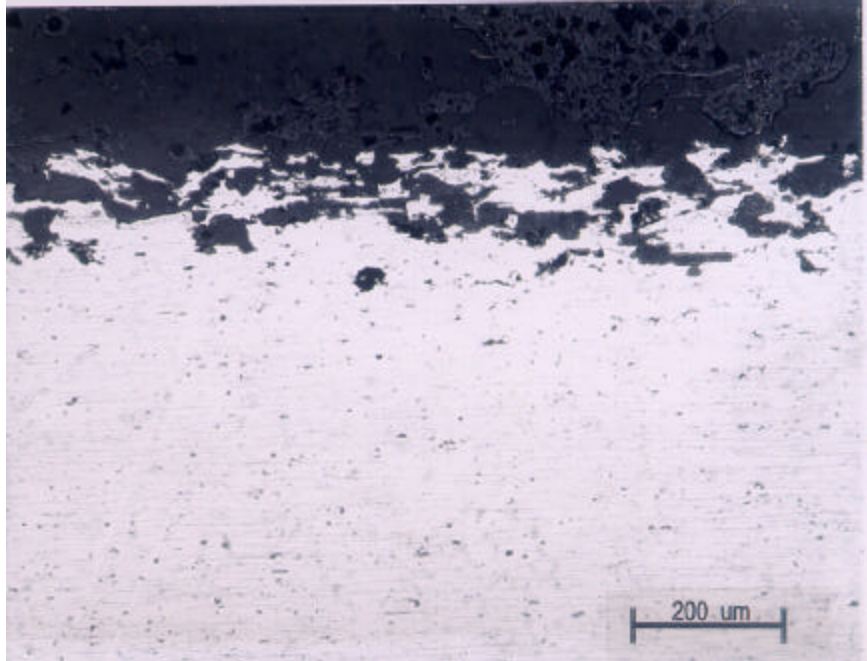
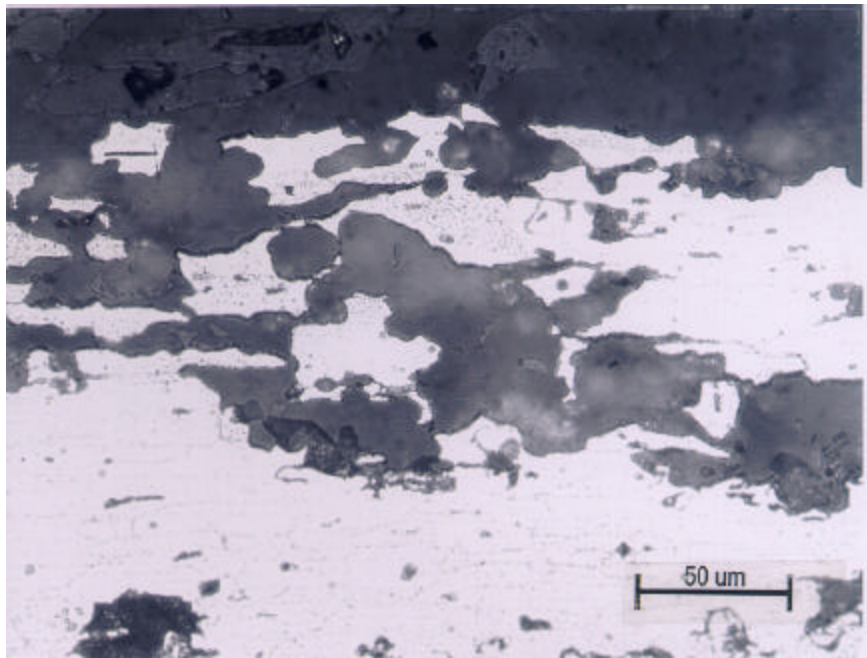
**Figure 22. Optical Micrographs of Cross Section Through Alloy 7178-T6 after Potentiostatic Polarization at  $-700$  mV Versus SCE, Showing Intergranular Corrosion at the Surface**
