**Failure Analysis, Cadmium Brush Plate Qualification and
Salt Fog Testing of the AH-64 Shock Strut Mount,
P/N 7-311113409**

ARL-TR-2870

November 2002

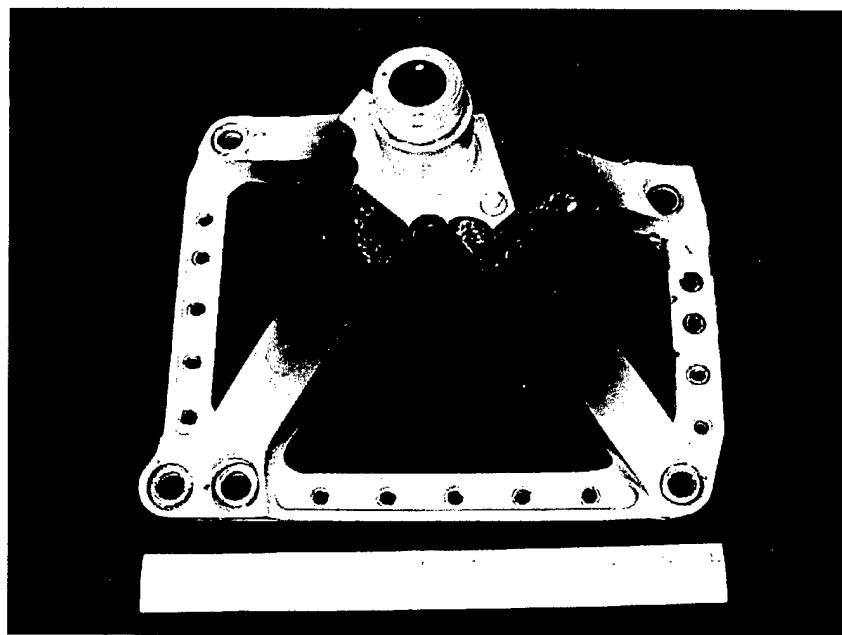
Figure C-1. Intact shock strut mount shown in the as-received condition (reduced 75%).

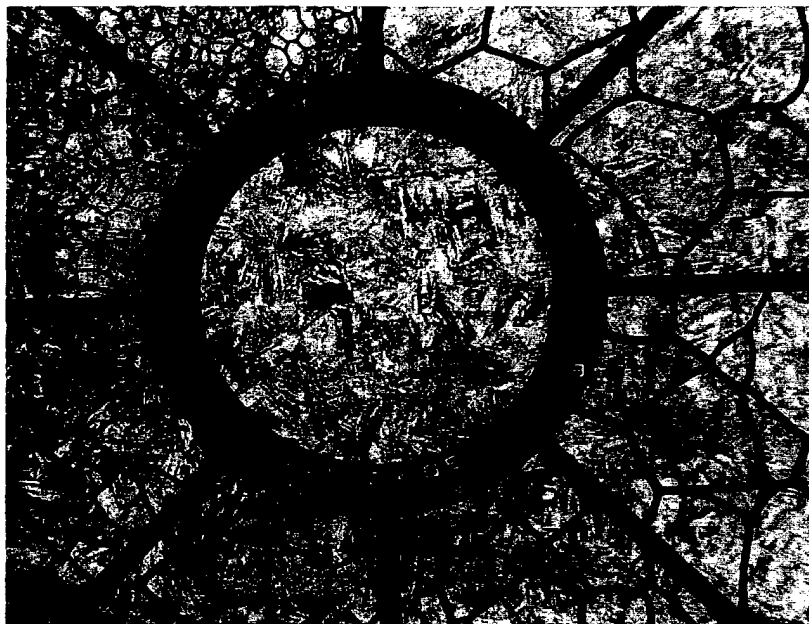
Representative SCC specimens coated by HAAF and Ft. Lewis were sectioned in order that a metallographic examination could be performed. Transverse and longitudinal samples were polished then etched with Marble's Reagent (4-g CuSO₄, 20-mL HCl, and 20-mL deionized water). The structure was similar in both orientations, consisting of an aged, low-carbon martensite. In addition, the material was fairly clean, exhibiting no gross defects or inclusions. Paragraph 3.4.1.3 of specification HMS 6-1081 requires a grain size of no. 7 or finer with an occasional no. 5 unless otherwise specified for material up to 3-inches in diameter or square. The grain size was determined using a metallograph with grain size reticle conforming to ASTM E112.³ It was determined that the grain size was between ASTM nos. 6 and 7 at 100× magnification for both the HAAF and the Ft. Lewis specimens (Figures C-3 and C-4), and no appreciable difference existed between the two.

Figure C-3. Grain size of a representative HAAF specimen (mag. 100×).

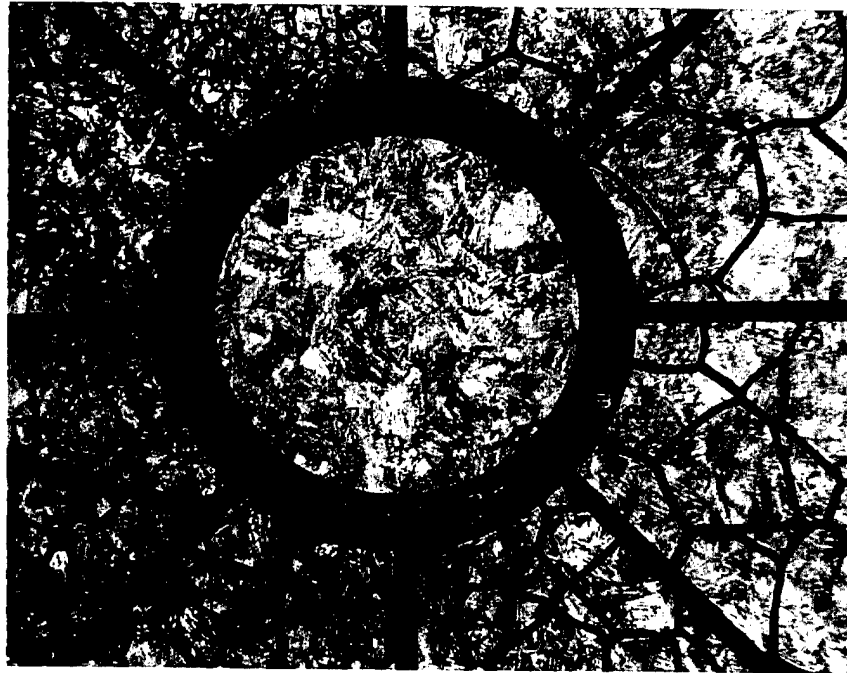
Figure C-4. Grain size of a representative Ft. Lewis specimen (mag. 100 \times).

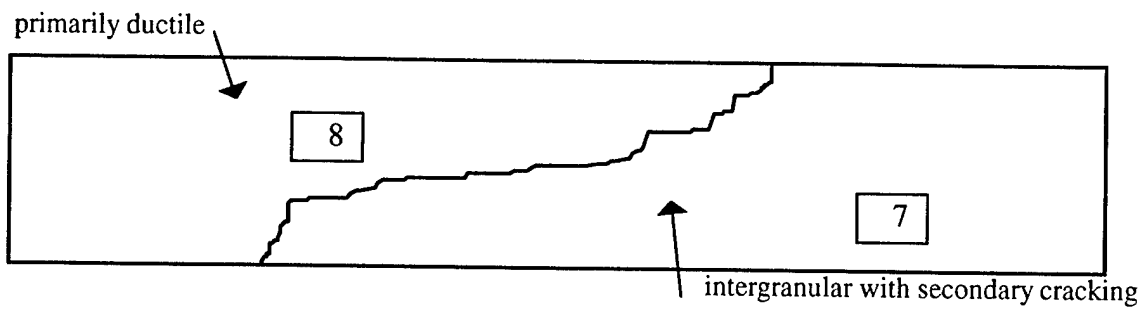
Figure C-6. Schematic illustrating a mapping of the fractographic features of the surface shown in Figure C-5. Boxes show locations of Figures C-7 and C-8.

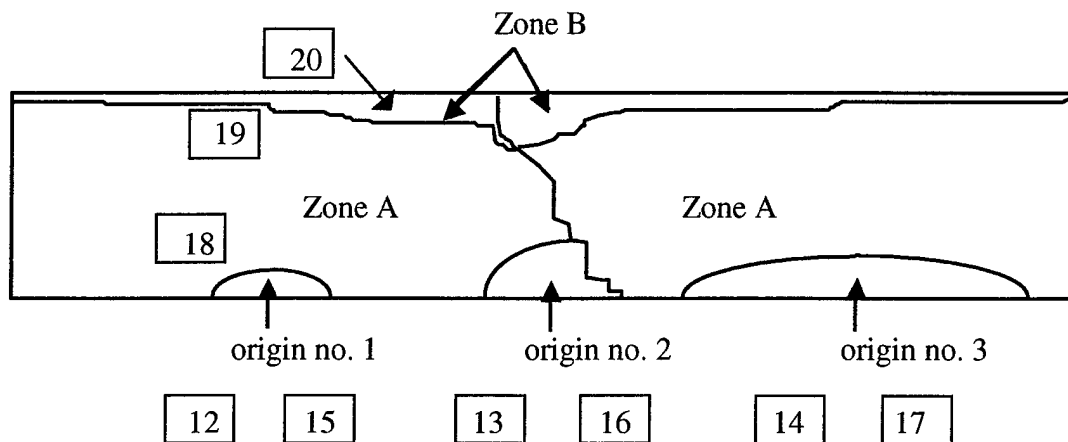
Figure C-9 contains a montage of a typical Ft. Lewis failure, while Figure C-10 contains the accompanying schematic map. The fracture surfaces of the broken Ft. Lewis specimens consisted primarily of a transgranular, quasi-cleavage morphology (Figure C-11). The fracture of one of the specimens consisted of two planes with three distinct origins on the tensile side of the specimen and had the appearance of a ductile fracture. The surface was predominantly transgranular with evidence of intergranular attack and secondary cracking only at each of the three origins. Ductile dimples were noted on the compressive side of the specimen, which was the last to fail. Figures C-12 through C-14 represent the three origins at 100 \times magnification, while Figures C-15 through C-17 show the origins at higher magnification (200 \times). Figure C-18 represents the morphology noted within the center of the specimen (mixed mode; ductile and transgranular) as illustrated in Figure C-10, while Figure C-19 represents the morphology of near the compressive side of the specimen. Figure C-20 is a high-magnification scanning electron micrograph representing the ductile region (final fast fracture) on the fracture surface.

Figure C-10. Schematic illustrating a mapping of the fractographic features of the surface shown in Figure C-9. Boxes represent location of figures.

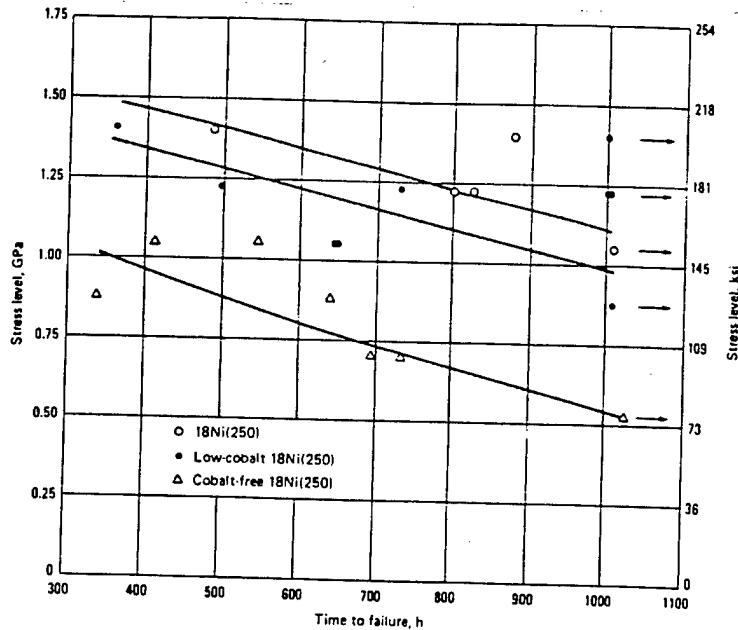
Figure C-21. Chart showing the effect of increased cobalt composition on the time-to-failure of maraging 250 steel. Plot compares 8% cobalt, 2% cobalt, and cobalt-free maraging 250 steel. Tests were conducted in stagnant 3.5% NaCl solution for 1000 hr using proof-ring specimens.

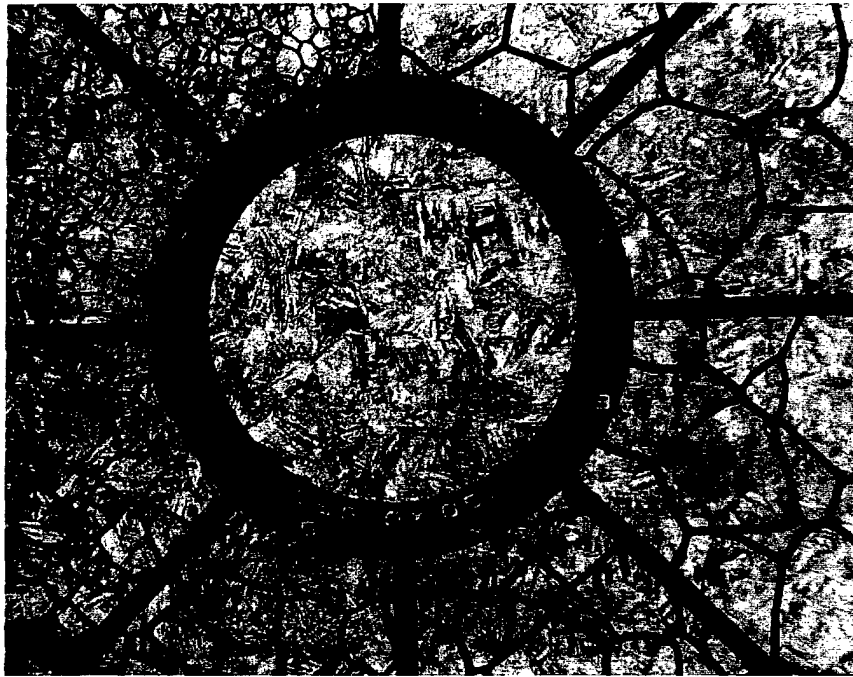
Figure D-3. Grain size of the HAAF specimen with reticle overlay.
Compare to Figure D-1 (mag. 100 \times).

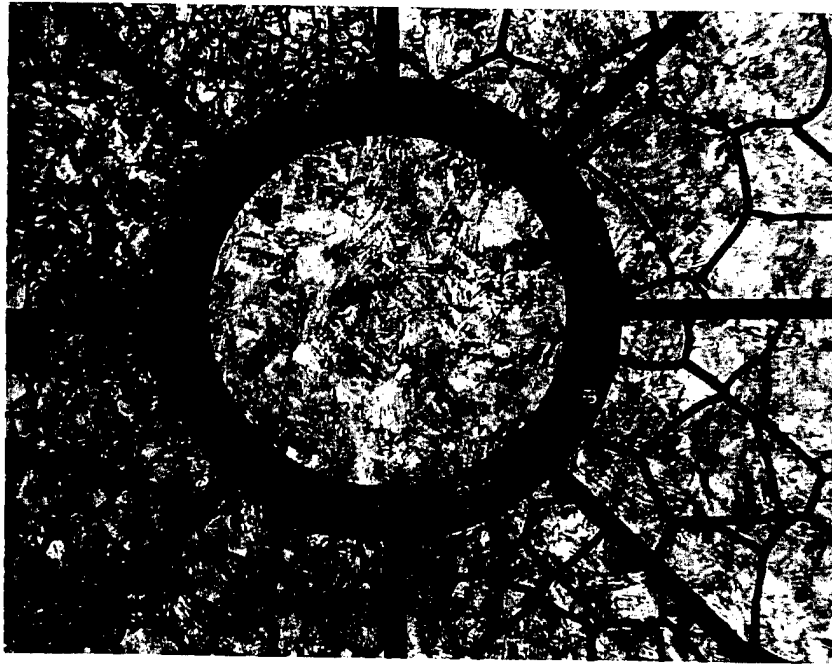
Figure D-5. Grain size of the Ft. Lewis specimen with reticle overlay. Compare to Figure D-1 (mag. 100 \times).
