## **Periodic Inspections of Kahului and Laupahoehoe Breakwaters, Hawaii**

**Armor Unit Monitoring for Period 1992/93-2001**

Robert R. Bottin, Jr., and Daniel T. Meyers

August 2002

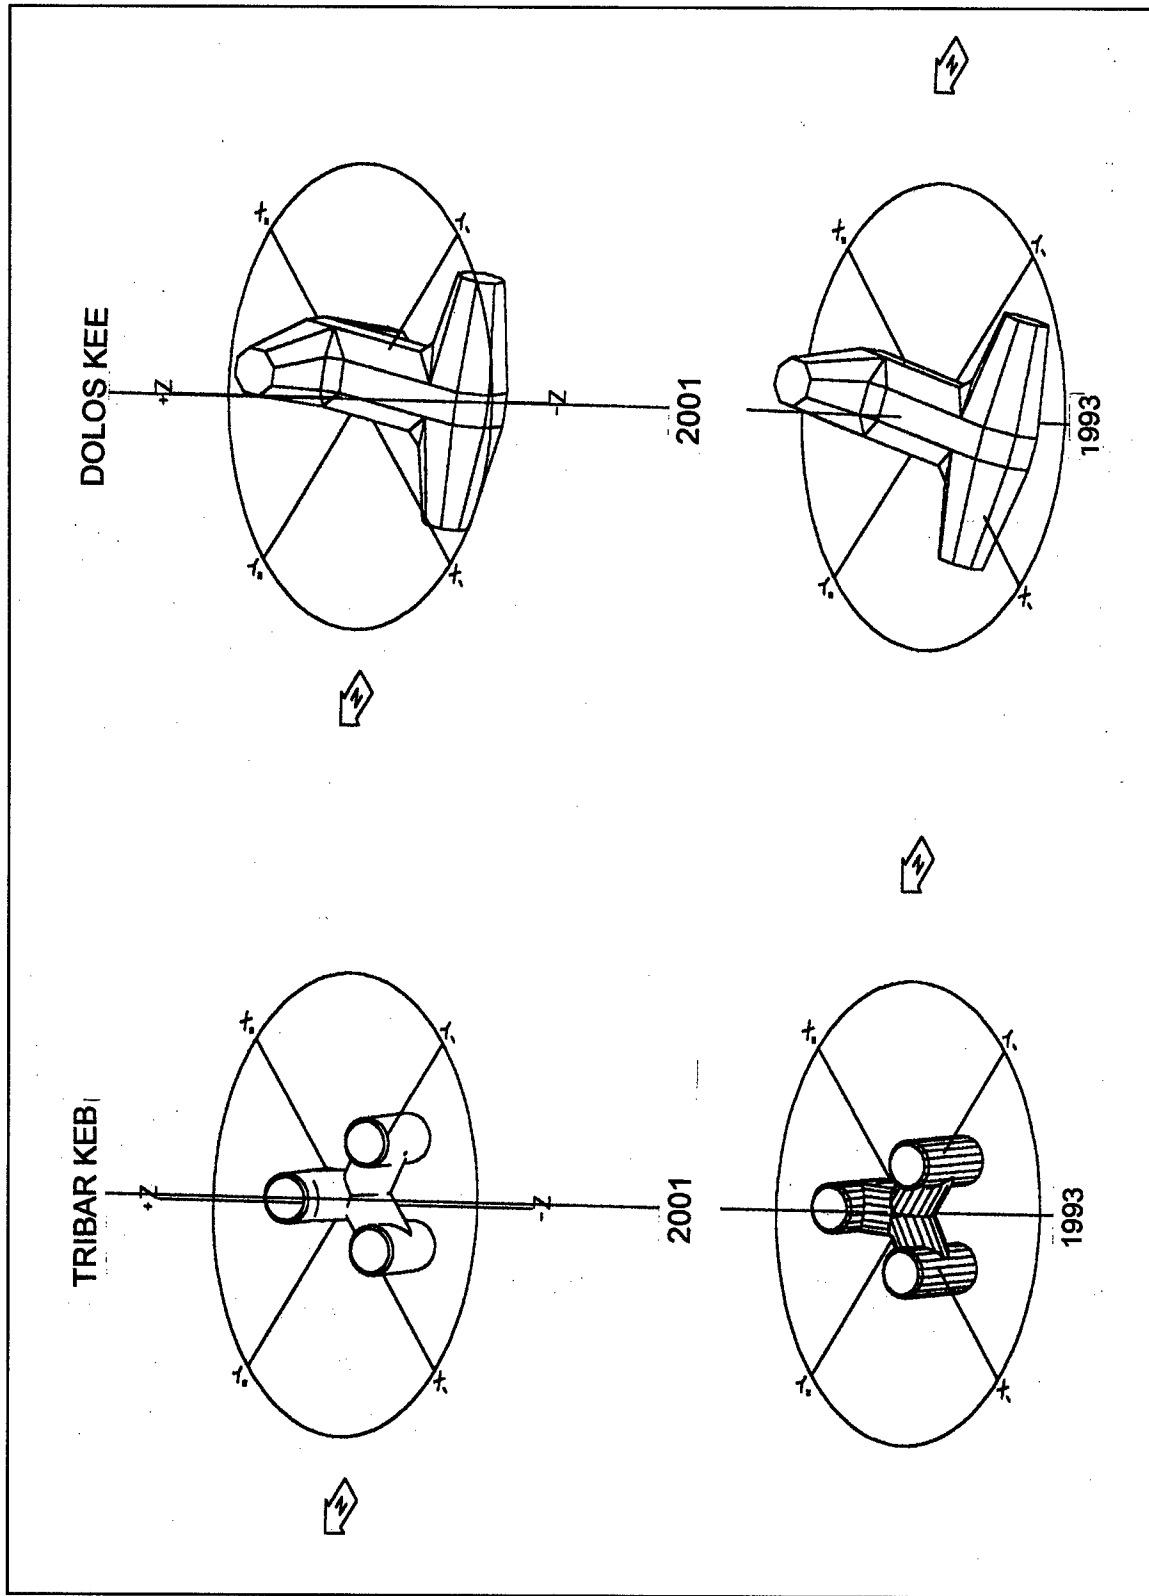
With the x, y, and z (easting, northing, and elevation) coordinates defined for each target on the various armor units, the coordinates of the centroid (center of mass) of each targeted armor unit were computed for the 2001 aerial survey. In addition, the position of each armor unit relative to the x, y, and z axes was determined and compared with previous data. Figure 22 shows, in three dimensions, the orientation and comparison of representative armor units to the three axes for the two surveys. The centroid coordinates of each targeted armor unit on the Kahului east and west breakwaters and the Laupahoehoe breakwater are shown in Tables 5-7 and compared with the aerial survey results of 1992/1993. Maximum movement of the centroids for the Kahului east breakwater was 0.536 m (1.76 ft) and 0.671 m (2.2 ft) in the horizontal and vertical directions, respectively, while average movements were 0.119 m (0.39 ft) and 0.17 m (0.57 ft) in the horizontal and vertical directions. As noted earlier, data were not obtained for two targets (KED1 and KEE2) on the Kahului east breakwater, however, based on information available and known dimensions of these armor units, their centroid positions were calculated. For the Kahului west breakwater, maximum horizontal and vertical centroid movements, respectively, were 0.64 m (2.1 ft) and 0.186 m (0.61 ft), while average movements were 0.113 (0.37 ft) and 0.64 m (0.21 ft) in the horizontal and vertical directions. Maximum movement of the centroids for the Laupahoehoe breakwater was 0.091 m (0.3 ft) and 0.085 m (0.28 ft) in the horizontal and vertical directions, respectively, while average movements were 0.03 m (0.1 ft) and 0.034 m (0.11 ft) in the horizontal and vertical directions. The targeted armor units' orientation (rotation angle relative to the x, y, and z axes) are presented in Tables 8-10 for the east and west Kahului breakwaters and the Laupahoehoe breakwater and compared with the aerial survey results of 1992/1993. For the Kahului east breakwater, changes in the rotation angle of the targeted armor units varied from 0.03 to 24.57 deg with an average of 3.09 deg. Changes in rotation angles varied from 0.0 to 17.32 deg for the Kahului west breakwater with an average of 2.02 deg. For the Laupahoehoe breakwater, changes in rotation angles varied from 0.01 to 0.36 deg with an average of 0.1 deg.

Figure 22. Comparison of representative targeted armor unit position relative to x, y, and z axes

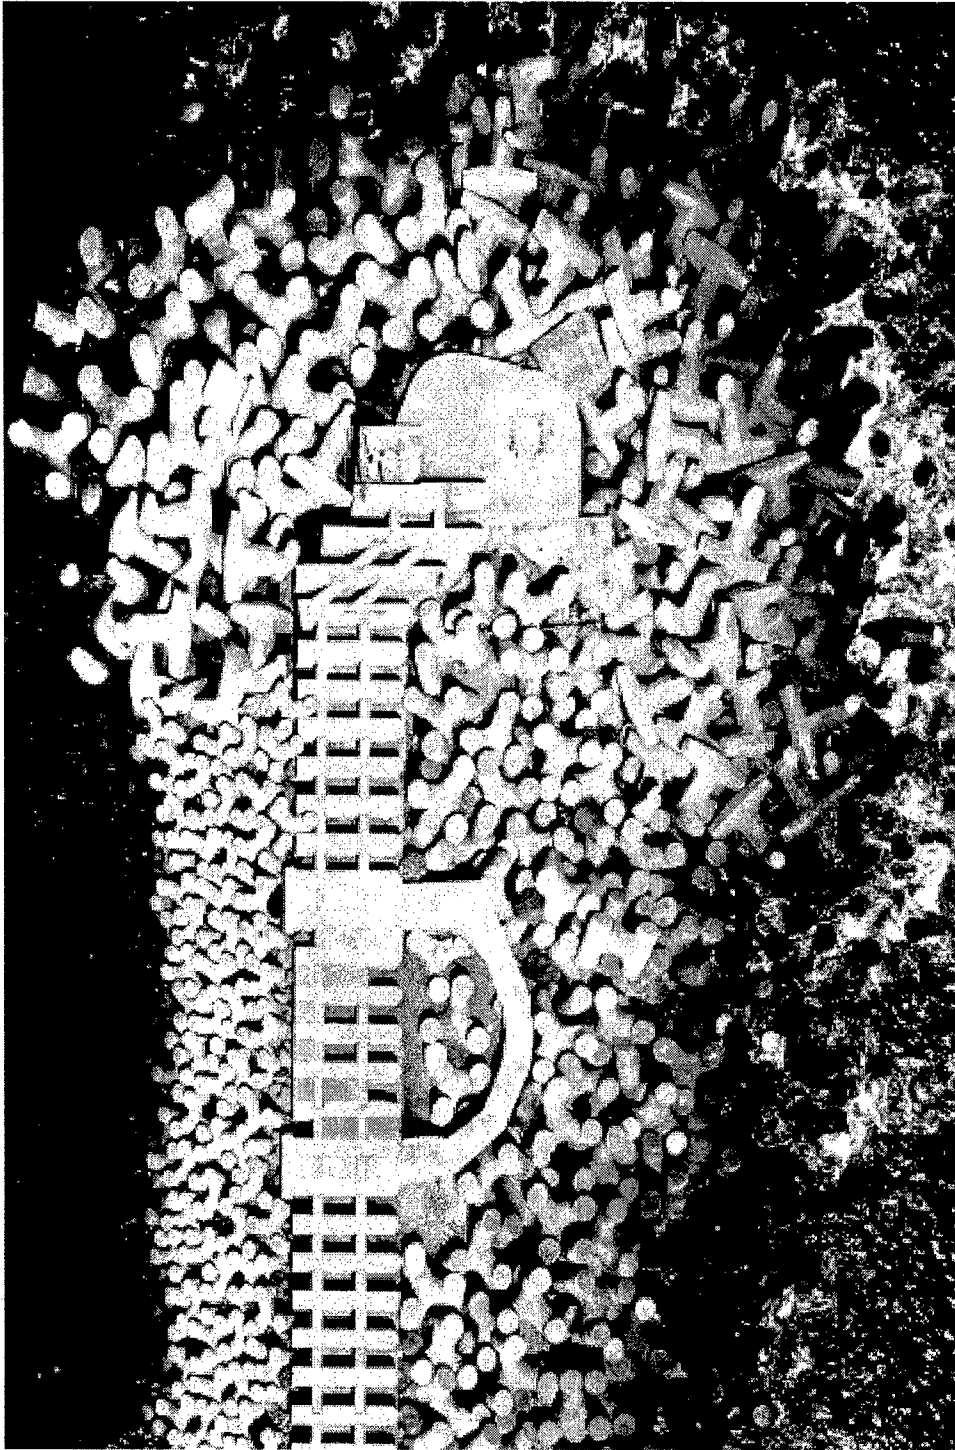
Figure 23. Photo map of head of Kahului east breakwater

Photo maps combine the image characteristics of a photograph with the geometric qualities of a map. The image is rectified and free from skewness and distortion, and therefore, precise horizontal measurements may be obtained using an engineer scale. Photo maps were prepared for the outer portions of the Kahului east and west breakwaters and the Laupahoehoe breakwater for the 2001 survey. They were produced on mylar sheets at a scale of 1:240. Examples of photo maps for the Kahului east and west breakwater heads and the Laupahoehoe breakwater are shown in Figures 23-25. In an effort to quantify horizontal movement of nontargeted concrete armor units on the Kahului and Laupahoehoe breakwaters, photo maps obtained for the 1992/1993 and 2001 were compared. Eight 27,215-kg (30-ton) dolosse around the seaward quadrant of the head of the Kahului east breakwater (including targeted units KED and KEE) appeared to have slightly changed positions. Movement appeared to be on the order of 0.3 to 0.9 m (1 to 3 ft). These units have not broken and are considered functional. Just a few additional units on the remaining portion of the Kahului east breakwater, as well as on the Kahului west breakwater, had moved slightly with no concentrations in any specific areas. Negligible movement of nontargeted units on the Laupahoehoe breakwater was detected between the surveys.
