# Cure Evaluation of Two Critical Composite Hybrid Flat Panels for use in a High-Dimensional Stability Satellite Application

20 July 2003

R. J. ZALDIVAR and R. CASTENEDA  
Space Materials Laboratory  
Laboratory Operations

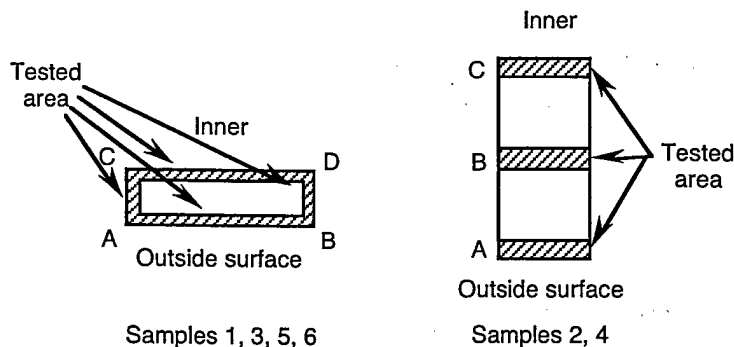
Figure 2. Schematic of tag ends prepared for dynamic mechanical testing. Hashed line region denotes sample area tested. Four segments are tested for samples 1, 3, 5 and 6. Three samples are obtained for samples 2 and 4. The longer dimension of each tag end is 2.0 in., and the shorter segment is 1.0 in.

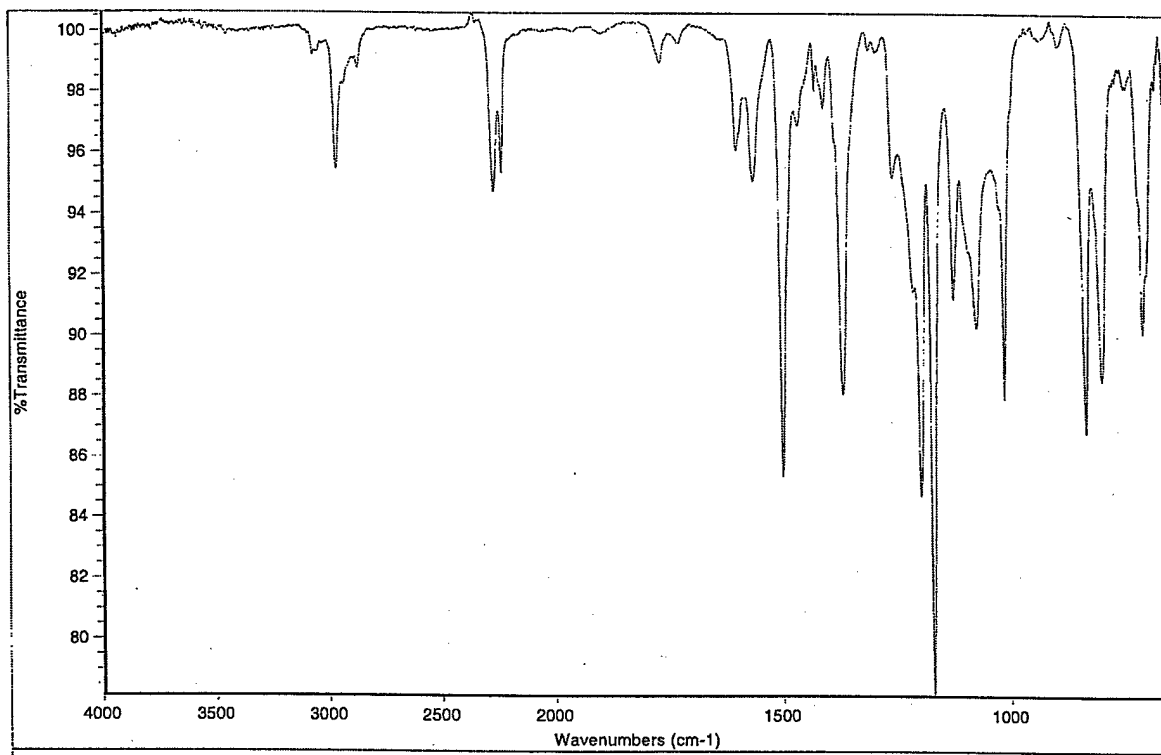
Figure 5. FTIR Spectra for typical siloxane modified cyanate ester resin.

three main areas of importance, as shown in the scans. The characteristic absorption bands of the cyanate ester groups are observed in the infrared spectrum between  $2200$  to  $2300\text{ cm}^{-1}$ . The band is usually split into a doublet or triplet, depending on the chemical environment of the cyanate. Monitoring the disappearance of the cyanate ester absorbance bands can follow the polymerization of the resin. Even though this is generally a very good indicator of the degree of the initial stages of cure, identifying variations at higher degrees of cure is more difficult. A second set of peaks at  $1560$  and  $1360\text{ cm}^{-1}$  reflects the absorption for the formation of the triazine ring as shown in Figure 6. The triazine ring is the primary polymerization route for this resin system. As this peak increases, the degree of cure increases; this is especially evident during the later stages of cure. Figure 6 shows an FTIR scan for the resin used in these composites as a function of the degree of cure. As shown from the figure, the polymerization can be followed quite readily for this system, especially at  $1560\text{ cm}^{-1}$ .

The third peak to focus on is located at approximately  $1750\text{ cm}^{-1}$ . This is a carbonyl peak that is usually indicative of hydrolysis of the cyanate ester occurring during the polymerization process. This type of carbamate contamination is the primary cause for large variations or decreases in the glass-transition temperature of the resin, even after heat treatment to high temperature. Figure 7 shows a typical FTIR with limited contamination.

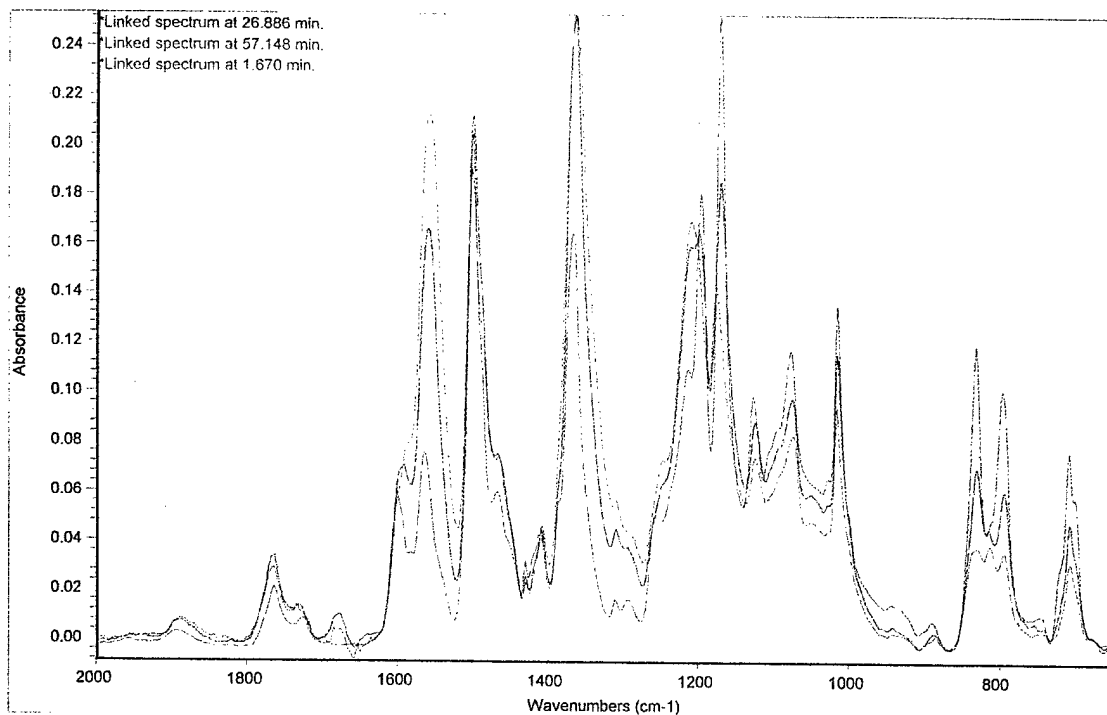
In parts from both composite panels evaluated, the cyanate peak at  $2250\text{ cm}^{-1}$  was completely consumed. This is typical in samples that are cured over 70% unless there has been moisture contamination. In those cases, the cyanate peak can be completely consumed due to hydrolysis with a limited degree of polymerization. The degree of cure was further evaluated, normalizing the peak located at

Figure 6. FTIR Spectra showing development of triazine ring formation during cure as indicated by peaks located at 1560 and 1360  $\text{cm}^{-1}$ .

1560  $\text{cm}^{-1}$  for all parts taken from Panel 1 and Panel 2. Panel 2 appeared fully cured for all specimens and showed no evidence of hydrolysis contamination, which corroborates our measured Tg data. Panel 1, however, indicated a composite part that ranged in the degree of cure from 70 to 90%, depending on the location measured. The areas with the lowest degree of cure showed indications of carbamate formation. Even though by-products of hydrolysis were observed, the degree could not be easily quantified due to the convoluted nature of the peak.
