NRL/MR/7130--03-8685

## **Preliminary Observations Regarding LDV Scans of Panels Excited by Broadband Actuators at the U.S. Capitol**

November 7, 2003

The following represents a short synopsis of several observations we have made regarding measurements made at the U.S. Capitol using a scanning LDV to map normal velocity of two panels when each was excited at one point by a broadband force actuator. The panels are identified as 6W1S (panel 1) and 6S1W (panel 2), the latter being what is called a pilaster. Regarding panel integrity, Panel 1 is

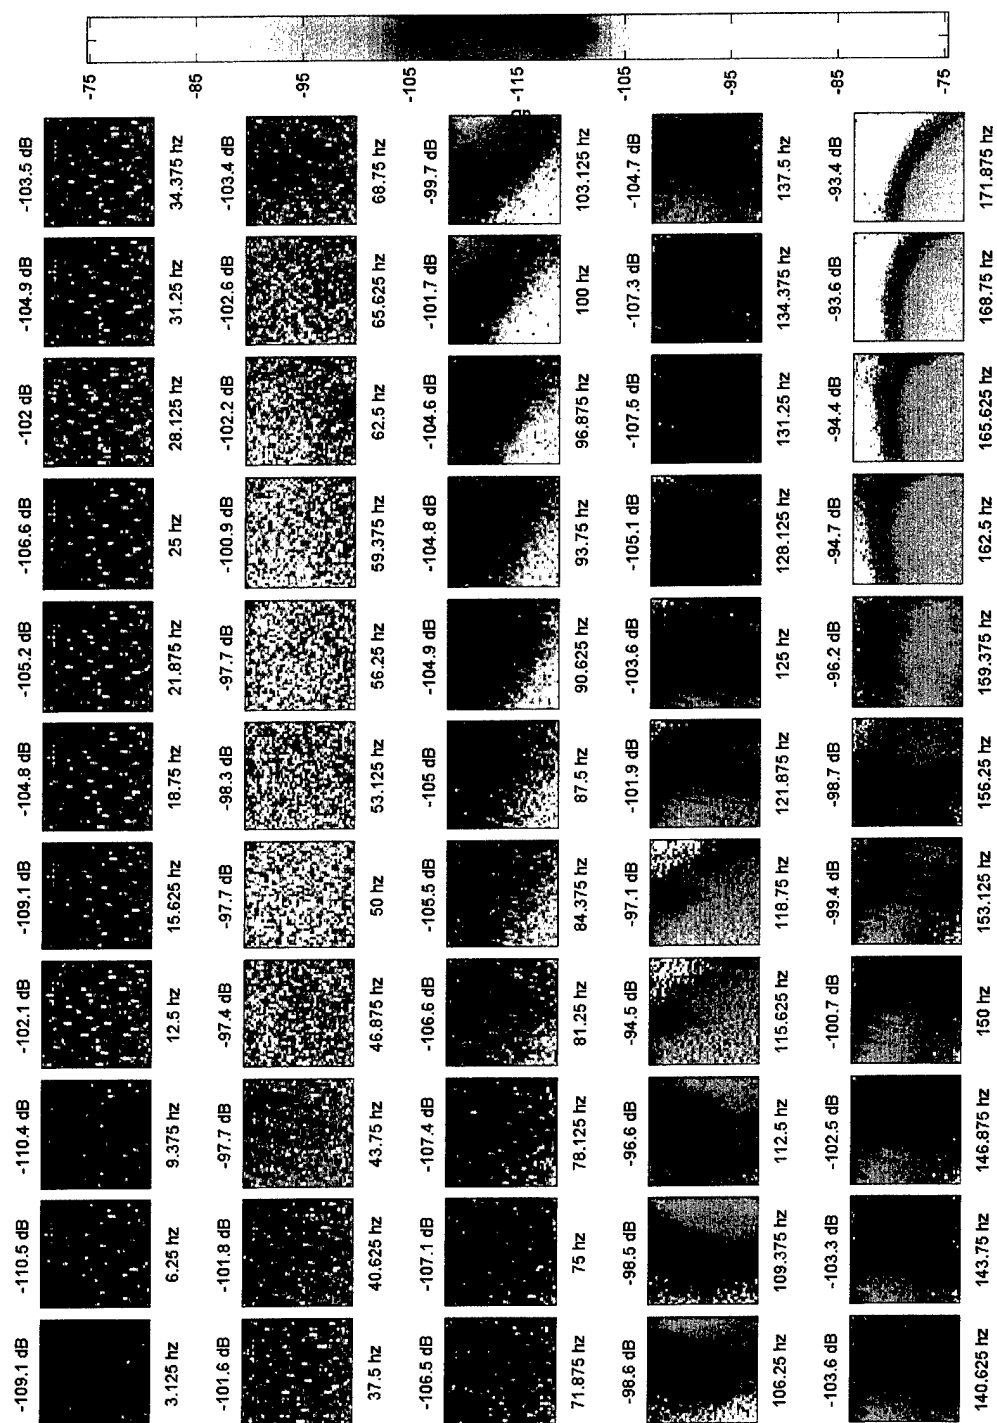
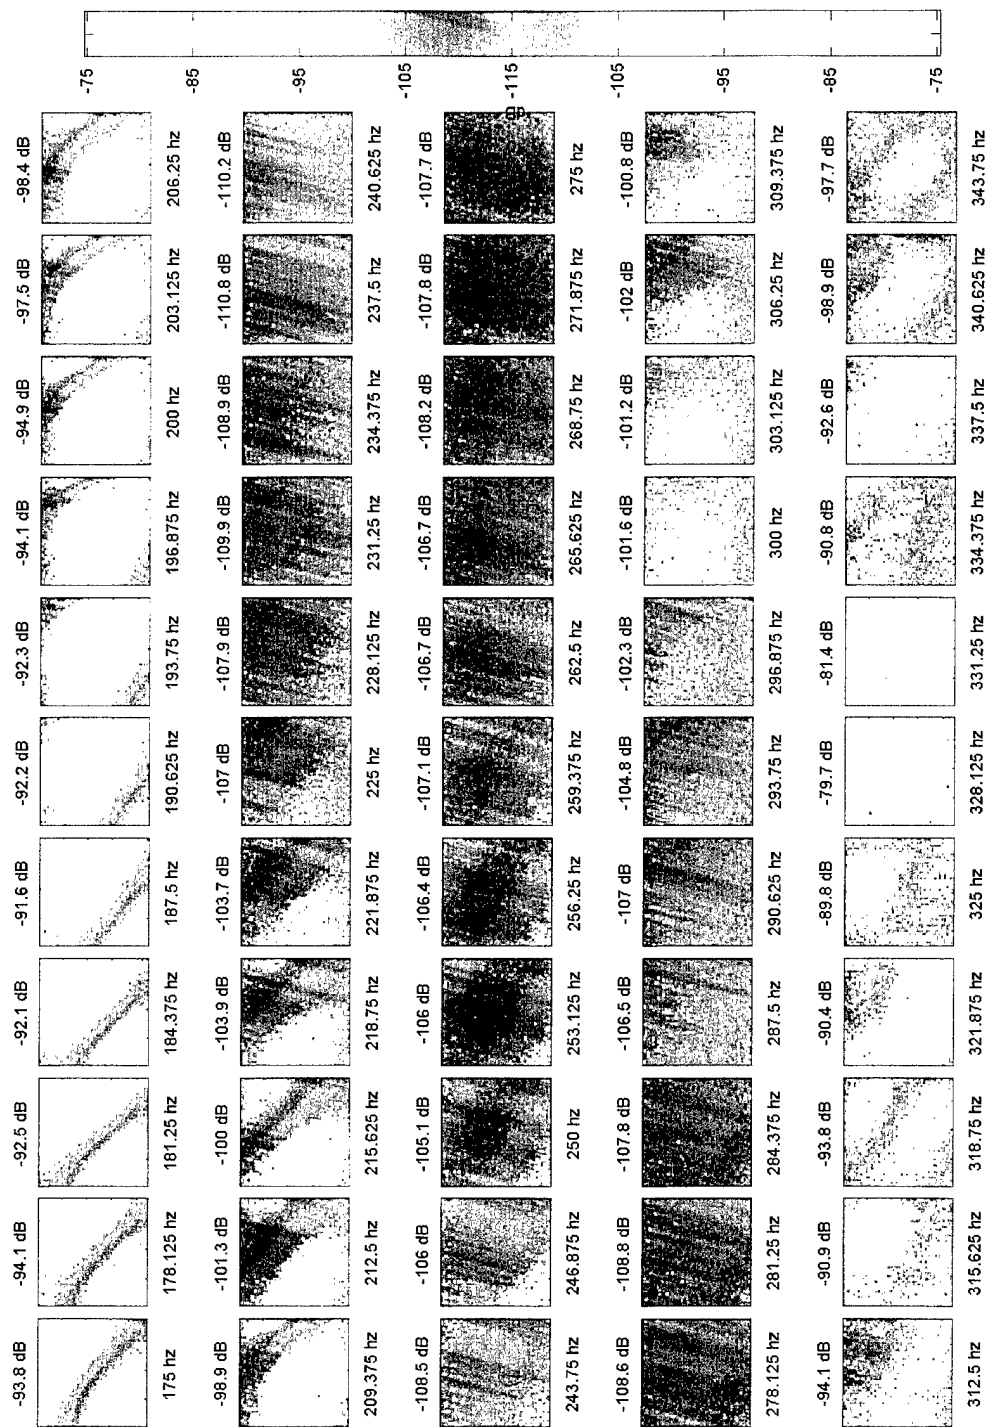
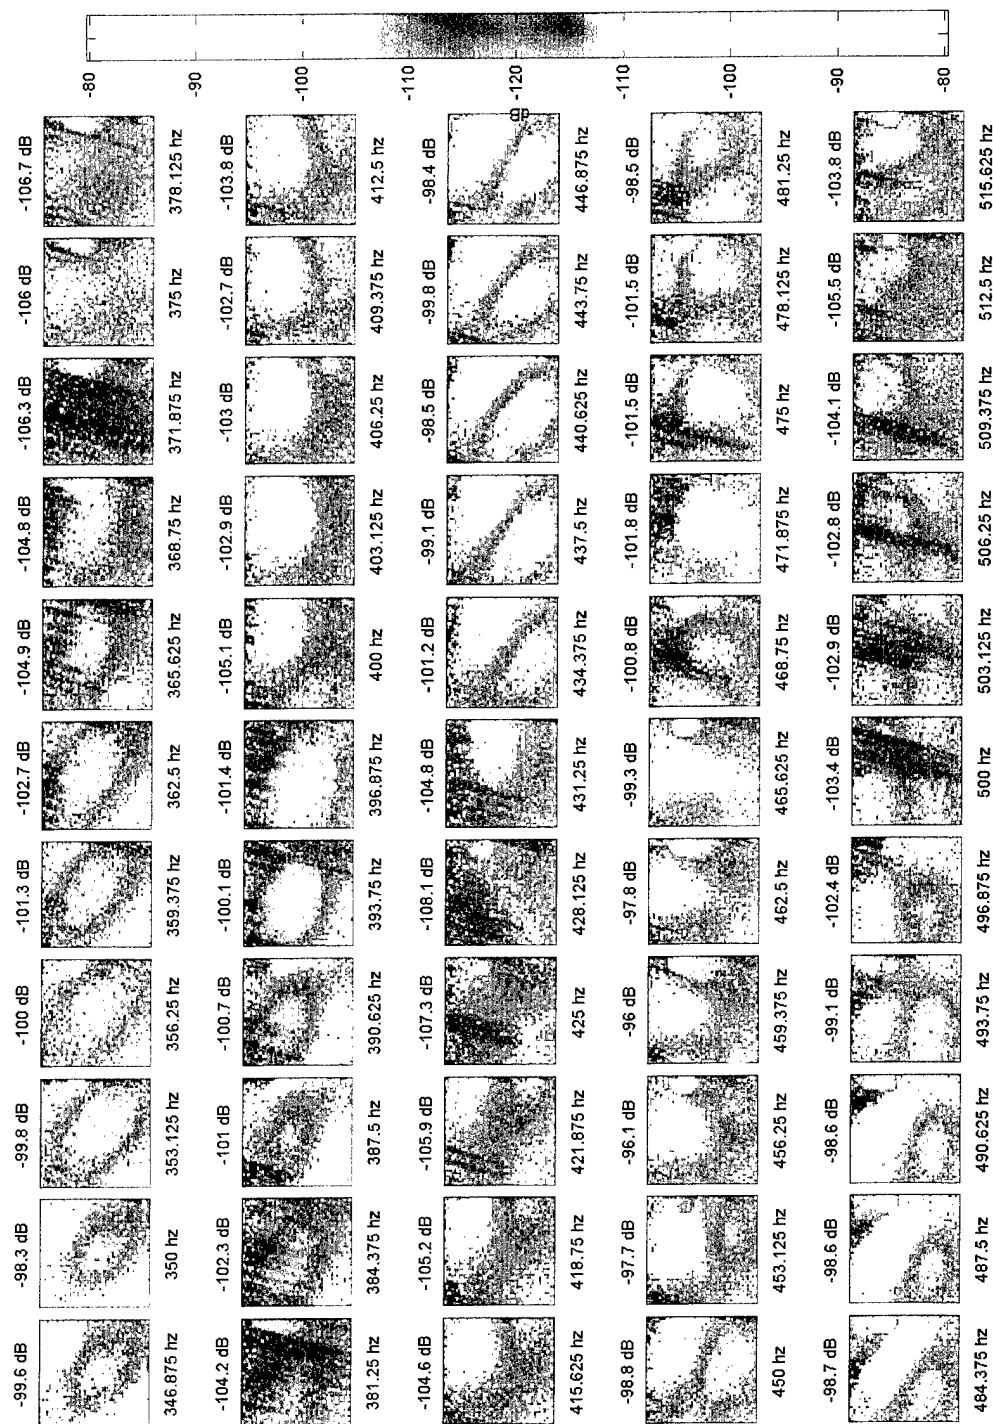
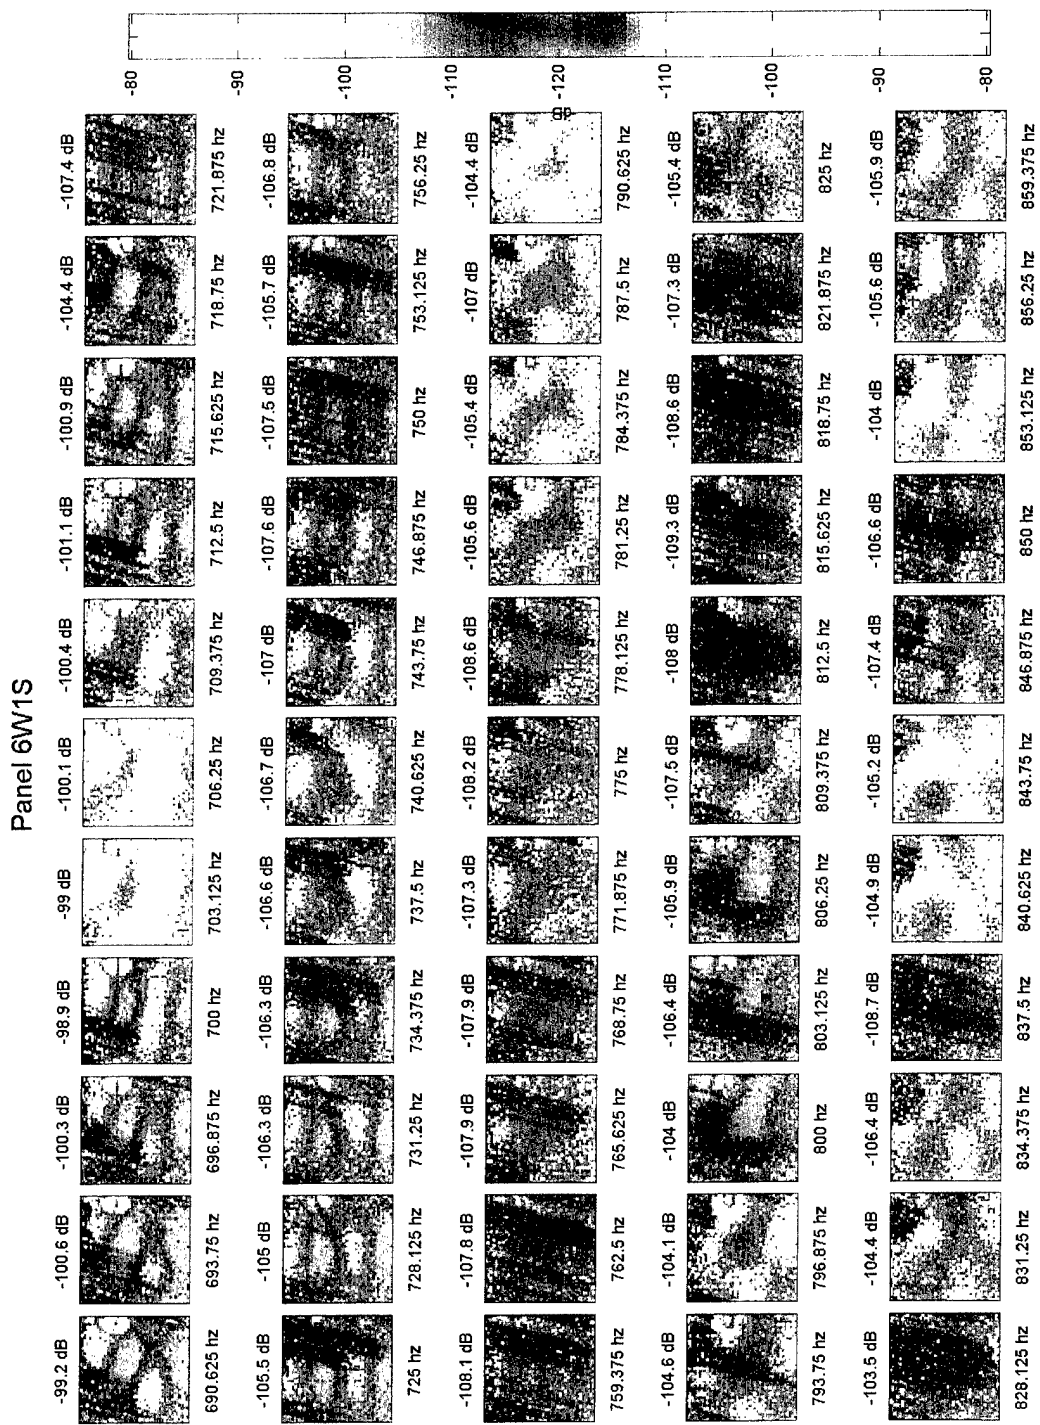
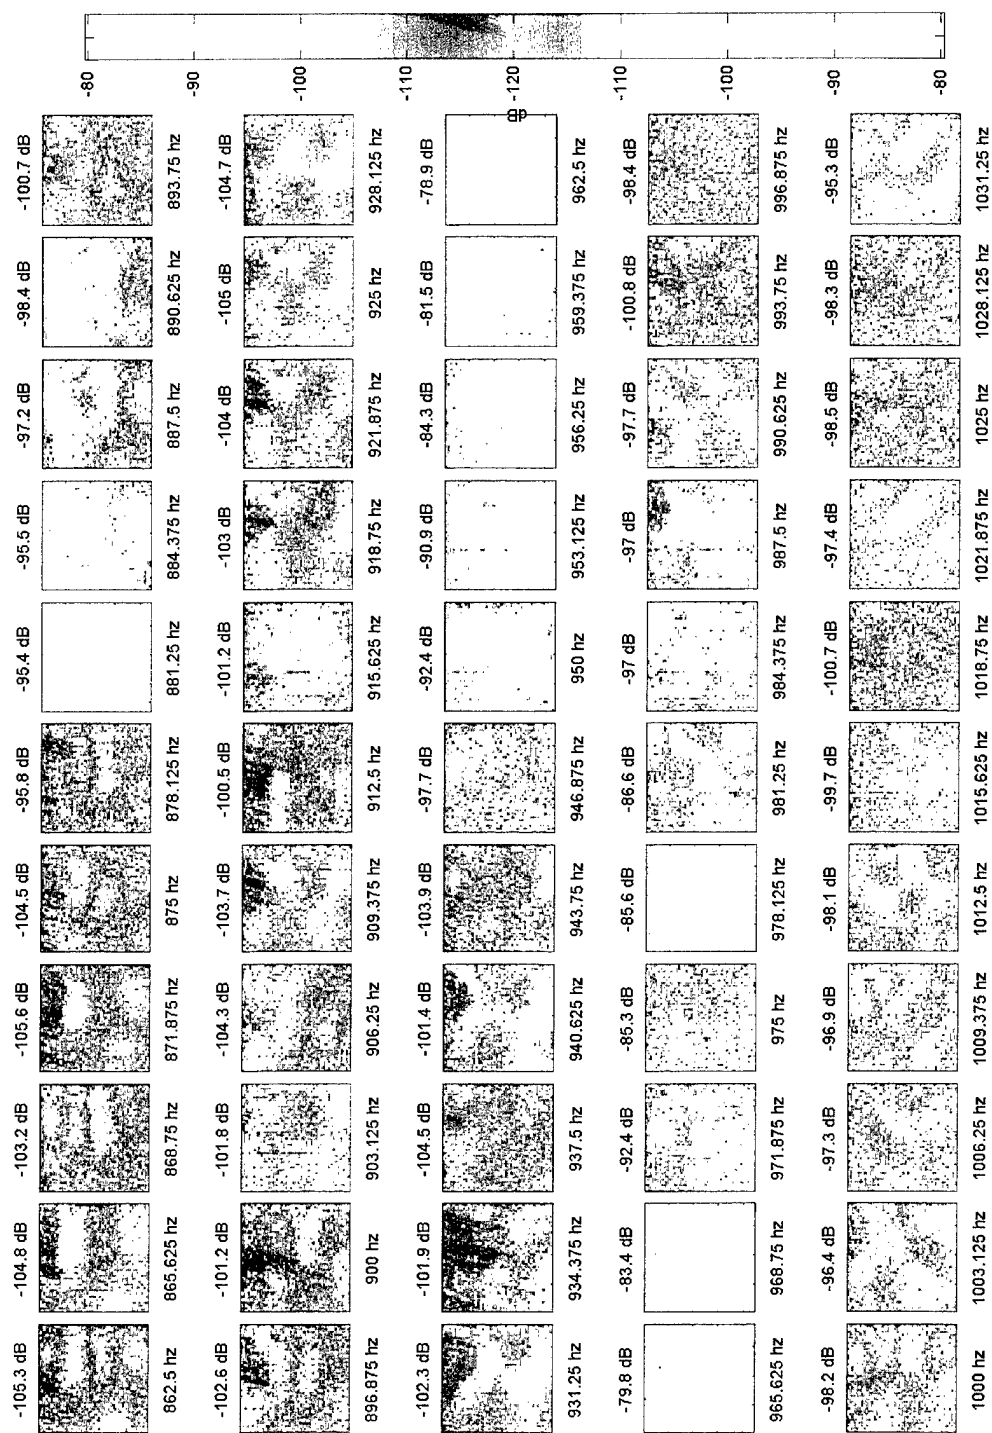
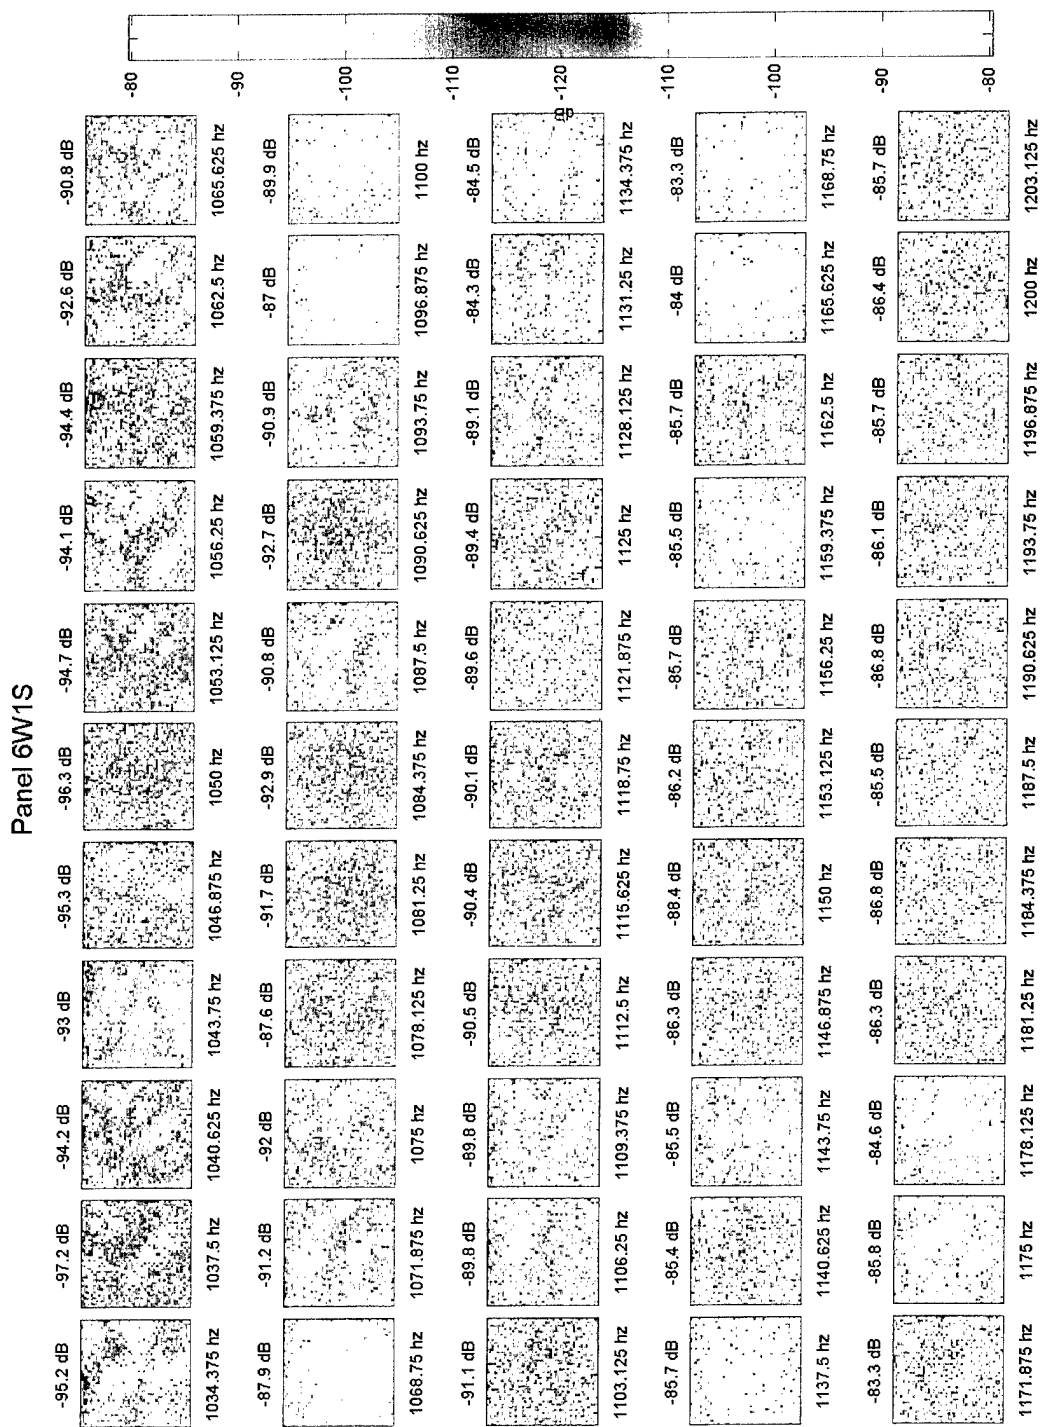
We first discuss the measurements taken on Panel 1 (see Fig. 1). Simple sequential observations (see Figs. 2a - 2g and Figs. 3a - 3f) of the velocity scans (phase and amplitude) at each three Hertz increment indicate that we have obtained meaningful data on panel 1 over the band from about 80Hz to 1KHz. From 80Hz to about 400 Hz we can observe what appears to be simple wave propagation from the lower left corner where the actuator is located up toward the upper right hand corner. This seems especially clear from the phase plots. The wave speed is very crudely estimated to be about 700 m/sec over this lower band, suggesting shear wave propagation in the plaster. Beginning just below 400 Hz one can see even higher motions over a smaller patch size (about 18cm by 26 cm) near the right edge just above the scanned panel center. It appears strongest at about 460 Hz and seems to fade in and out with something like a 25-40 Hz period. At about 670 Hz, the motion over this patch breaks into a two-lobe mode pattern. Both the extent and location of this mobile patch coincides with a defect area discovered earlier in the tap test data. We should point out, however, that the same tap test data seems to indicate another defect area on the left, a location where we do not see any obvious localized high levels of motion in the LDV maps in this frequency band.
