ERDC/GSL TR-03-24

## E-Krete™ Polymer Composite Micro-Overlay for Airfields: Laboratory Results and Field Demonstrations

November 2003

Final report

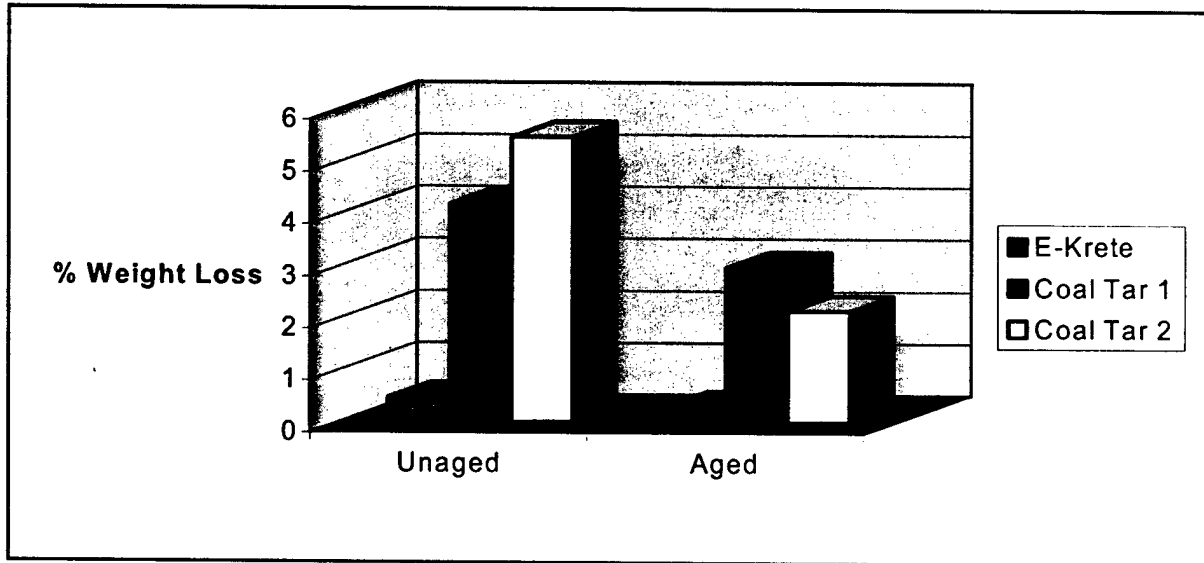
The results of the abrasion testing indicate that the unsealed E-Krete™ material is approximately 8 to 10 times more abrasion resistant than a standard coal tar emulsion. The sealed E-Krete™ is approximately two times more abrasion resistant than the CTE. The difference between the sealed and unsealed E-Krete™ indicates that the surface sealer is abraded more rapidly than the E-Krete™ base. Although the abrasion resistance of the CTE's is higher after aging because of the embrittlement, it is well documented that these materials exhibit severe "chicken-wire" or "map" cracking with age and must be resealed every 3 to 6 years (Shoenberger 1993 and Saraf, Majidzadeh, and Kumar 1992). There is no statistical loss in abrasion resistance after aging of the E-Krete™ material. The reduced variation in the test results for E-Krete™ indicates the consistency of the product.

Figure 1. Abrasion resistance of E-Krete™ compared to coal tar emulsion using a modified form of the wet track abrasion test
