**Failure Analysis of an AH-64 Main Rotor Damper  
Blade Rod End, P/N 7-211411186-5**

**by Scott M. Grendahl and Marc S. Pepi**

**ARL-TR-3100**

**December 2003**

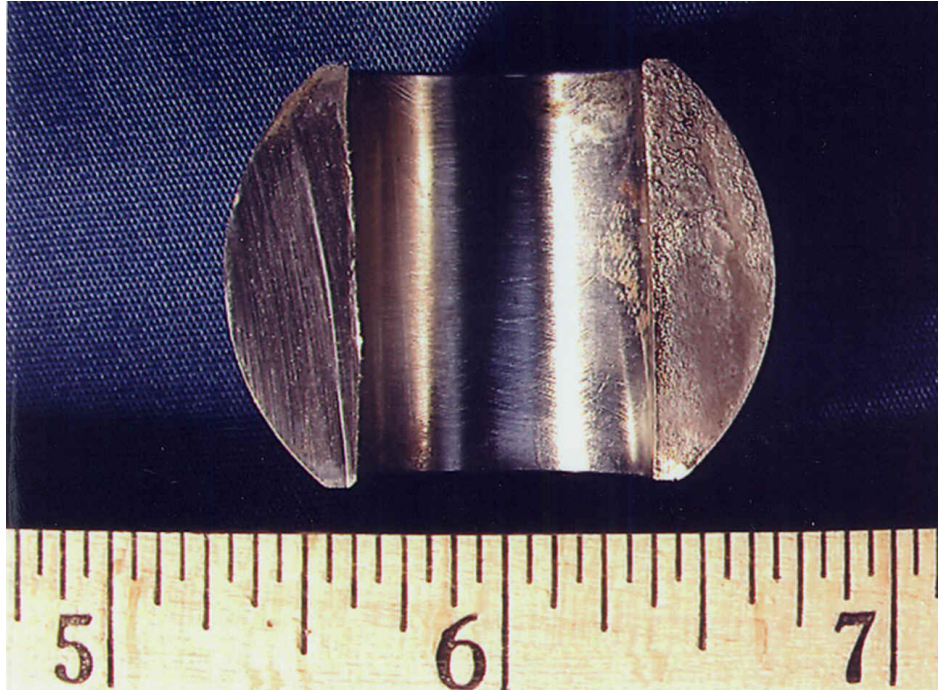
Figure 5 shows half “B,” which remained in the as-received condition for further analysis (see SEM/EDS section 9).

Off-axis views of the ball halves are presented in figures 6 and 7 to detail the corrosion observed along the internal bore of the ball near the through crack. This corrosion may have formed after the crack propagated entirely through the ball.

Figure 5. Fracture half "B," left in the as-received condition (scale in inches).

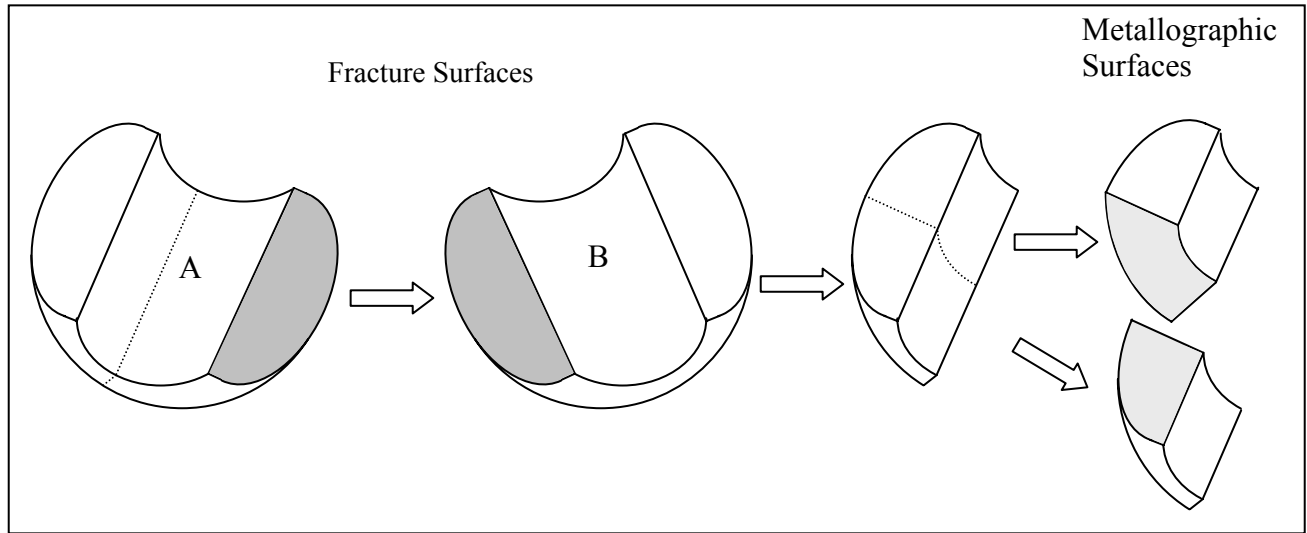
Longitudinal and transverse sections of the failed component were metallographically prepared with silicon carbide papers, ranging in grit from 120 to 600, followed by 12 and then 9 micron diamond, and finished with 0.05-micron alumina. The specimens were sectioned as shown in figure 15.

Figure 15. Sectioning schematic of the failed type 440C ball.

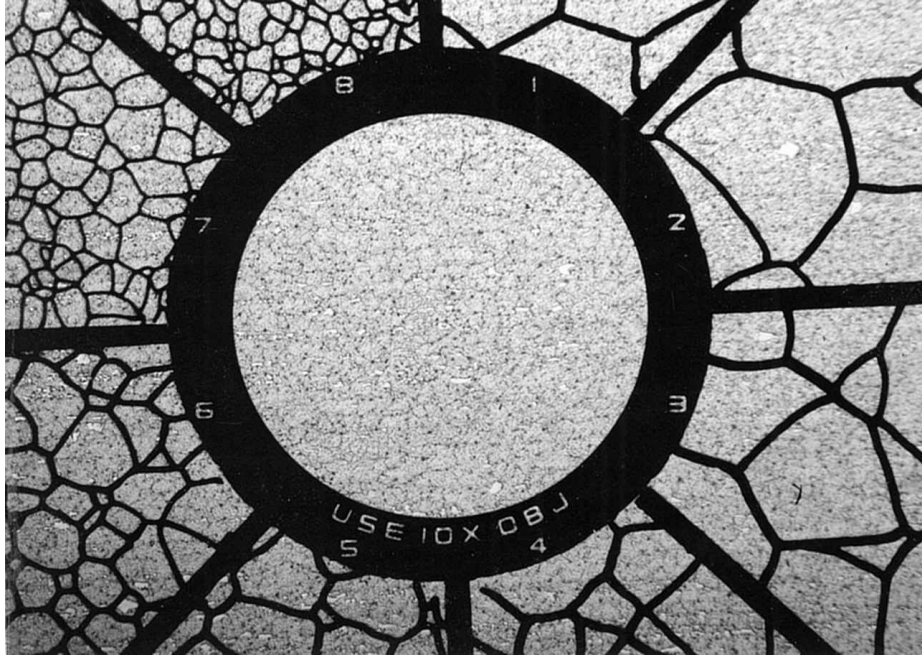
The grain size of the material was determined to be 8 or finer with the reticle overlay shown in figure 24. The regions of inter-granular attack were observed after the etchant was applied. Figures 25 through 30 correspond to the respective regions depicted in figures 17 through 22. The inter-granular nature of the attack became enhanced upon etching.

Figure 24. Etched microstructure demonstrating the grain size to be 8 or finer (mag 100x).

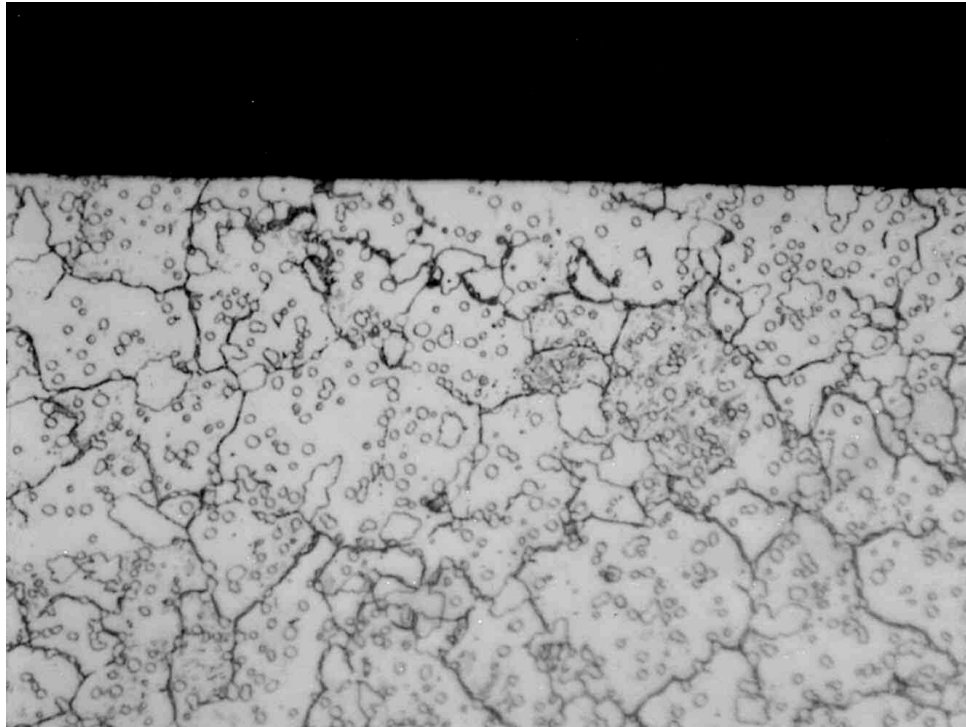
Figure 25. Etched transverse metallographic section area "A," (mag. 1kx).

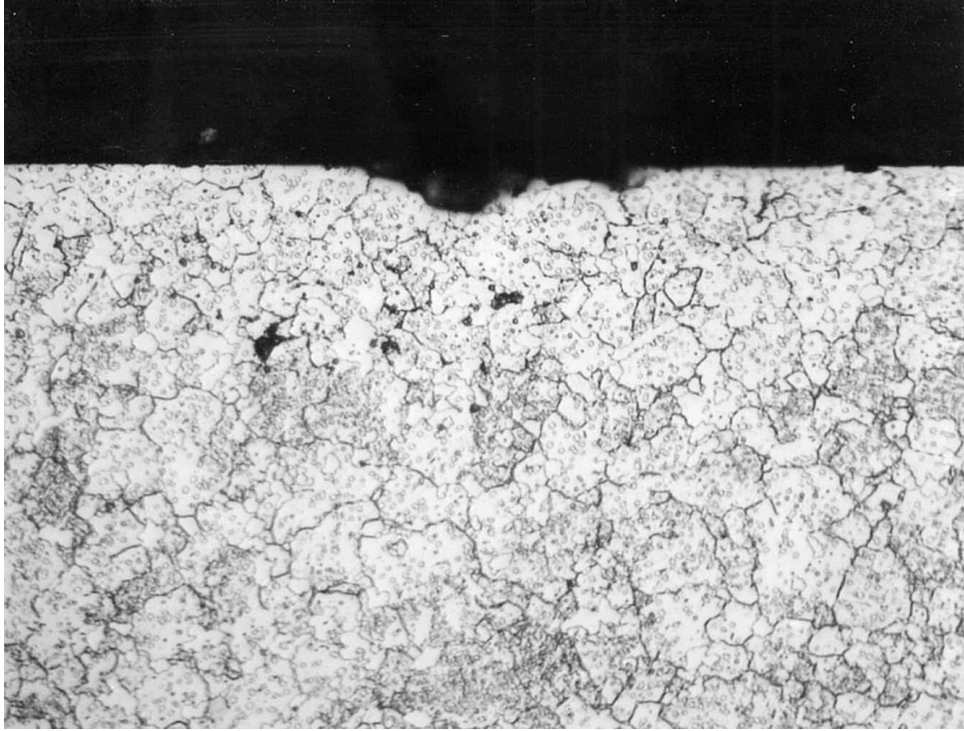
**Figure 26. Etched transverse metallographic section area "B," (mag 500x).**

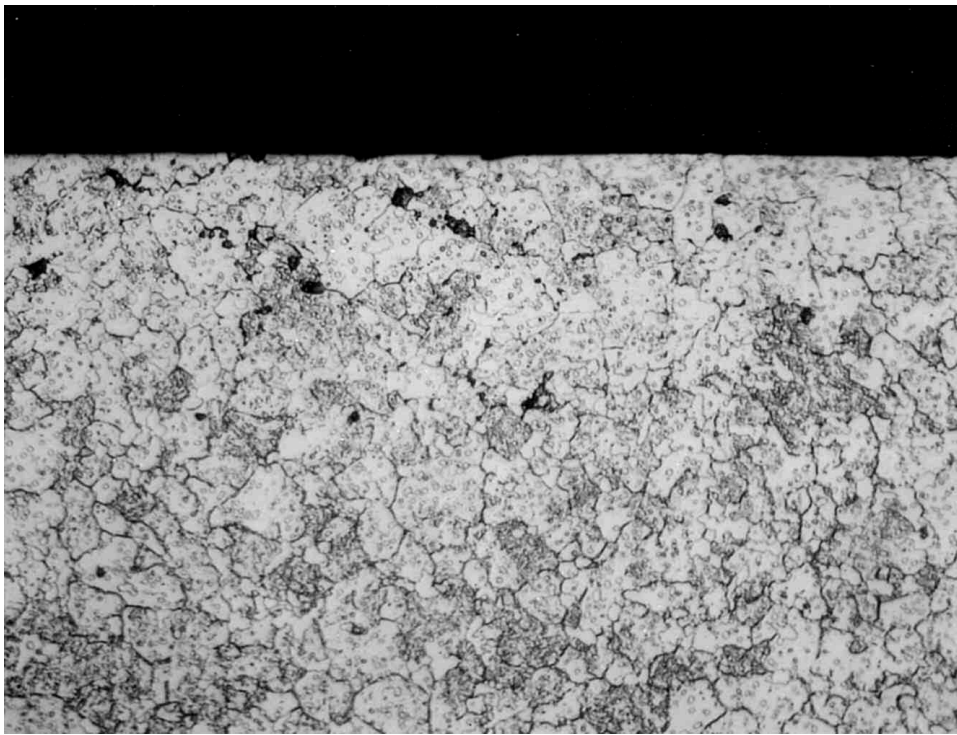
**Figure 27. Etched transverse metallographic section area "C," (mag 500x).**

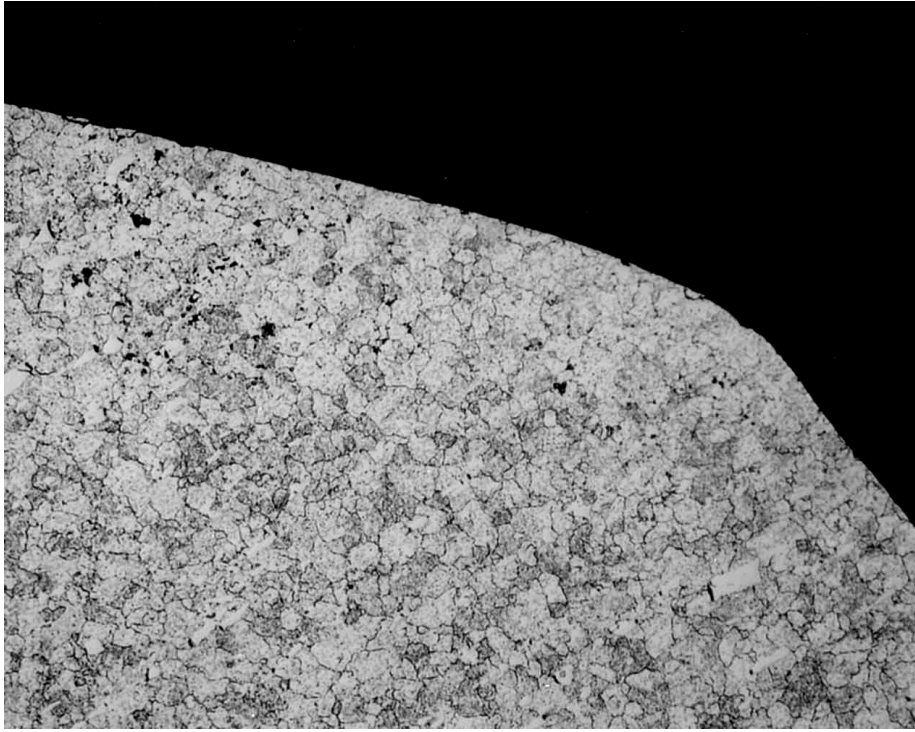
**Figure 28. Etched longitudinal metallographic section area "A," (mag 200x).**

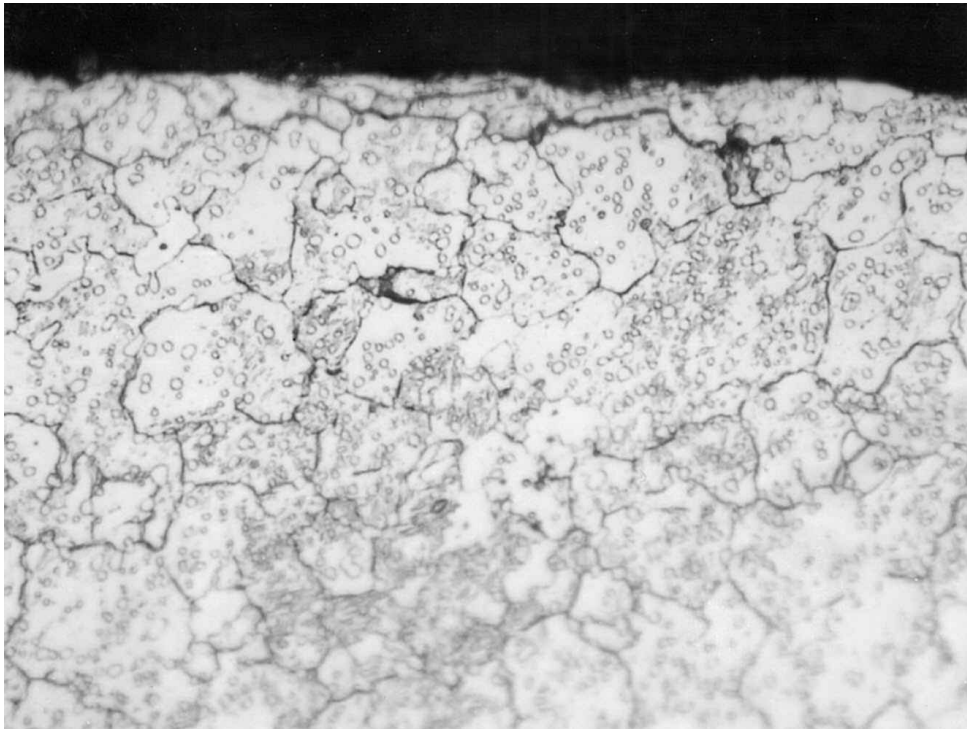
**Figure 29. Etched longitudinal metallographic section area "B," (mag 1kx).**

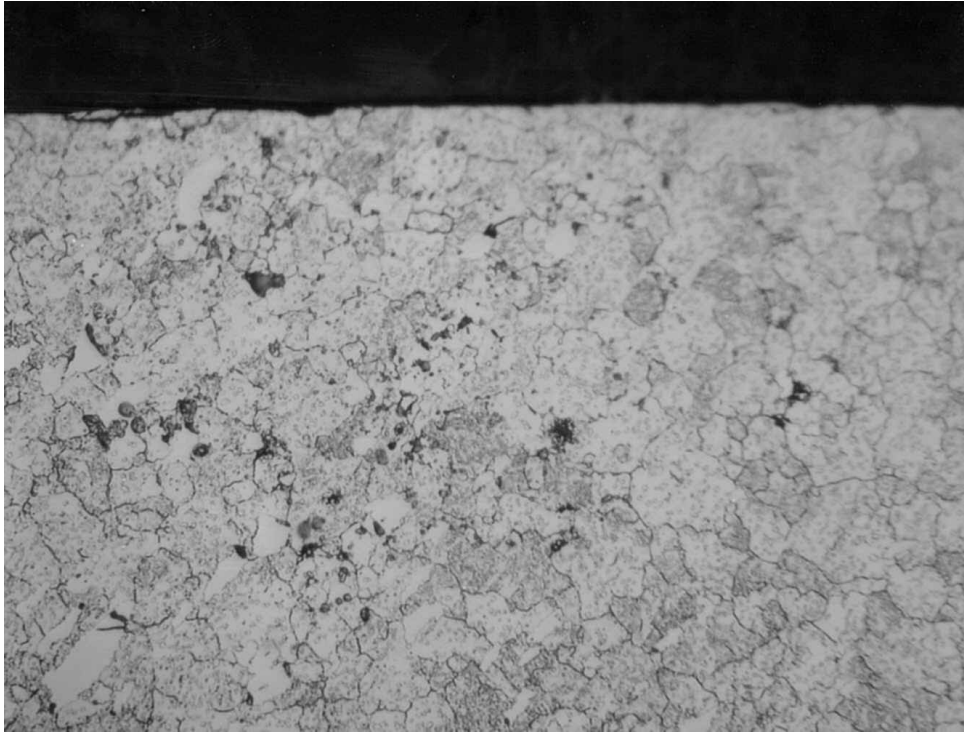
**Figure 30. Etched longitudinal metallographic section area "C," (mag 400x).**

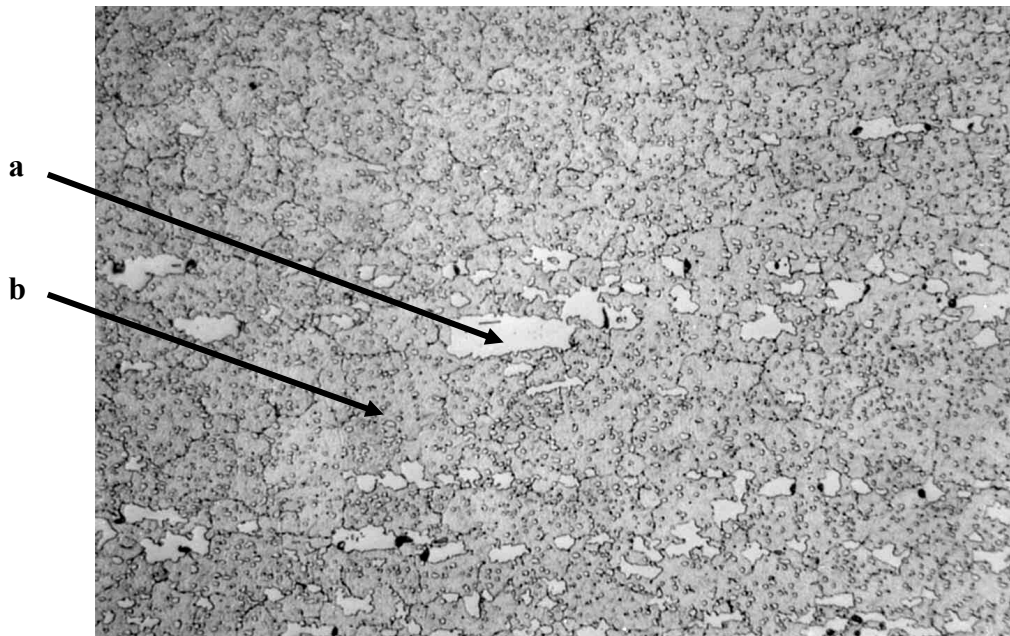
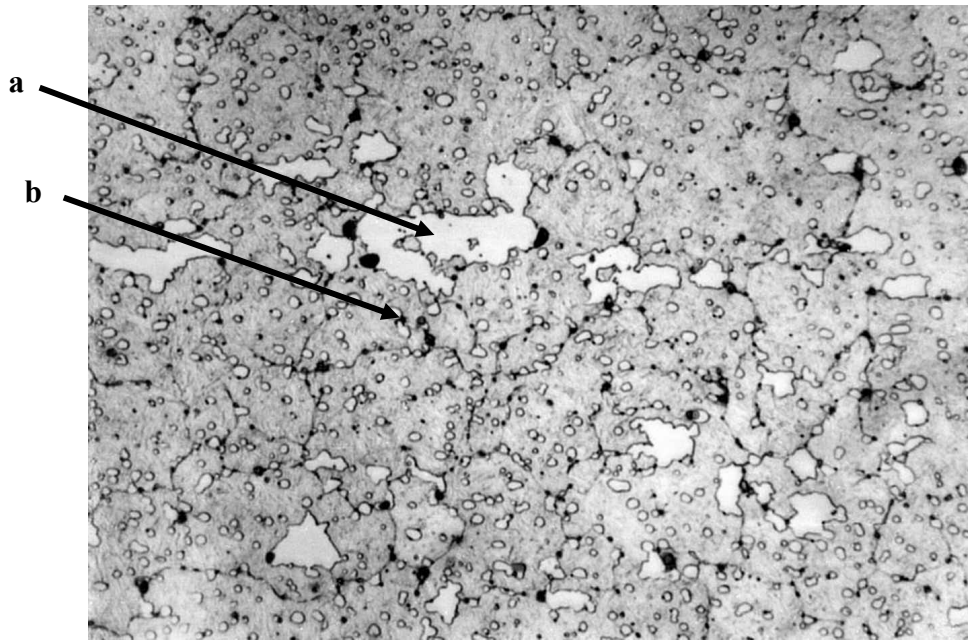
The microstructure was subsequently observed at 500x and 1000x magnification (see figures 31 and 32, respectively). The structure consisted of primary  $M_7C_3$  carbides (figures 31a and 32a) and secondary carbides (small spheroidal particles shown in figures 31b and 32b) in a matrix of tempered martensite. Note, however, that Vilella's reagent does not reveal the tempered martensitic structure in this material as it appears in other common steels. The lathe-like structure is noticeably obscured. The primary carbides ranged in size, measuring as long as 0.0012 inch (30  $\mu\text{m}$ ). This size was well within the nominal size (as long as 60  $\mu\text{m}$ ) to be expected for this alloy. The structure was typical of type 440C stainless steel that has been austenitized, quenched, and tempered.

**Figure 31. Etched longitudinal microstructure of 440C ball (mag 500x).**

Figure 32. Etched longitudinal microstructure of 440C ball (mag 1kx).

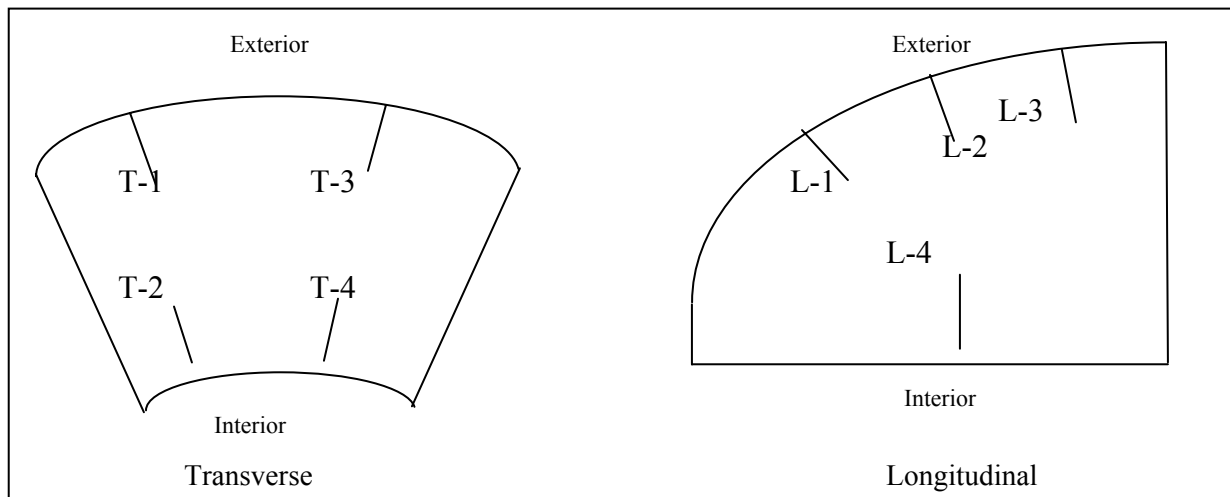
Micro-hardness profiles were taken on the metallographically polished transverse and longitudinal cross sections of the failed ball. This was performed in order to determine the presence and thickness of any possible surface chemistry gradients. Paragraph 3.3.2.4 of HP1-1 states that the depth of carburization, decarburization, or nitriding shall be determined by a micro-hardness traverse. Carburization and/or nitriding are disallowed per HP1-1. The boundary of the carburization, decarburization, or nitriding shall be at the depth at which the hardness rises/falls to the equivalent of 20 points Knoop above/below the core hardness. The Knoop hardness scale was used for this testing, and the readings were obtained in a staggered traverse to maximize the amount of readings that could be taken close to the surface, while maintaining the rule-of-thumb distance between indents. Four sets of readings were taken on each specimen. Figure 33 illustrates the location of the hardness profiles on the metallographic cross sections.

**Figure 33. Schematic of hardness profile traverses.**

Profiles T-1, T-2, T-3, T-4, L-1, L-3, and L-4 (see tables 6 through 13) were all softer within the first 1 to 3 mils' depth than the core hardness. This depth was within the requirement set forth in Paragraph 2.1.1.2 of HP 1-1, "*Such partial decarburization shall be judged excessive if greater than 0.003 inch deep on any finish-machined surface.*" However, this gradient may have been attributed not only to a difference in surface chemistry but also to the fact that the first reading on each specimen was only 1 mil from the surface. Edge effects may have played a role in the resultant first hardness readings on each profile. Disregarding the first reading, profiles T-1, T-2, T-3, T-4, L-3, and L-4 showed no appreciable gradient. In most cases, each value in a given profile was within 20 to 30 points Knoop, when the first three readings were disregarded.

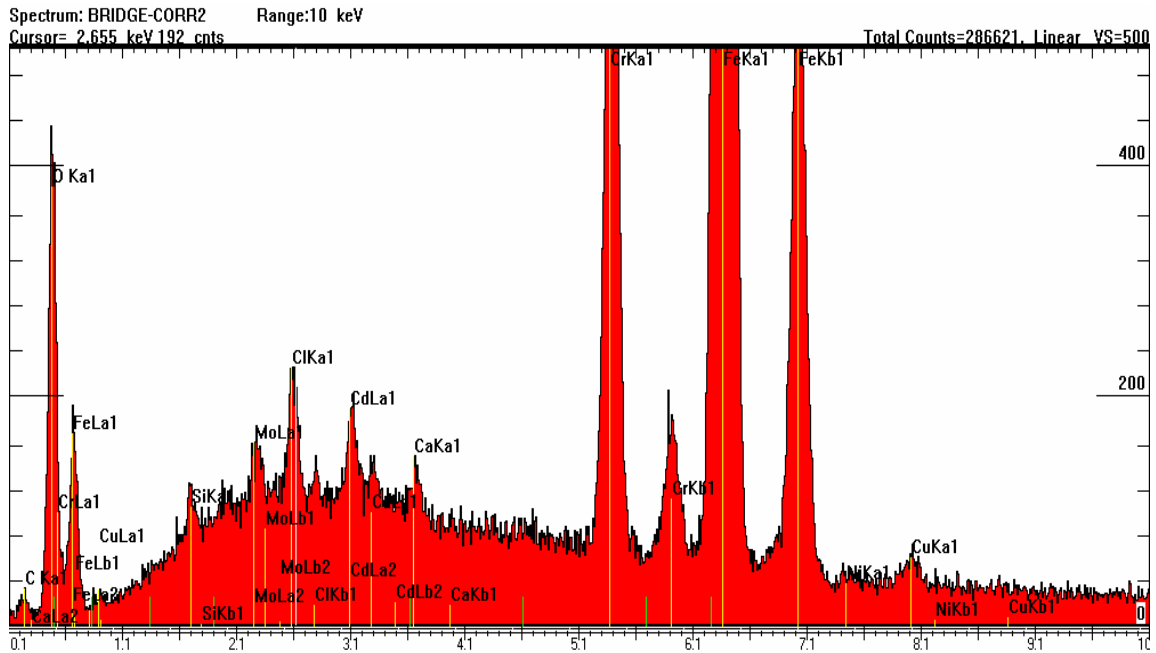
The attacked area was filled with corrosion product. This product was analyzed with EDS. The EDS spectrum produced from this product can be observed in figure 37. It was similar in chemistry and composition to the other attacked areas on the ball. However, it was slightly different from the corrosion product on the fracture surface that is presented later.

Figure 37. EDS spectrum collected from the product within the inter-granular attack.

Naturally occurring chloride salts can explain the presence of calcium and chlorine. The copper, nickel, and molybdenum are alloying elements within the material, so it is understandable that they are revealed within the corrosion product. The cadmium, however, must have originated from a foreign source to this ball. This is discussed in more depth later.

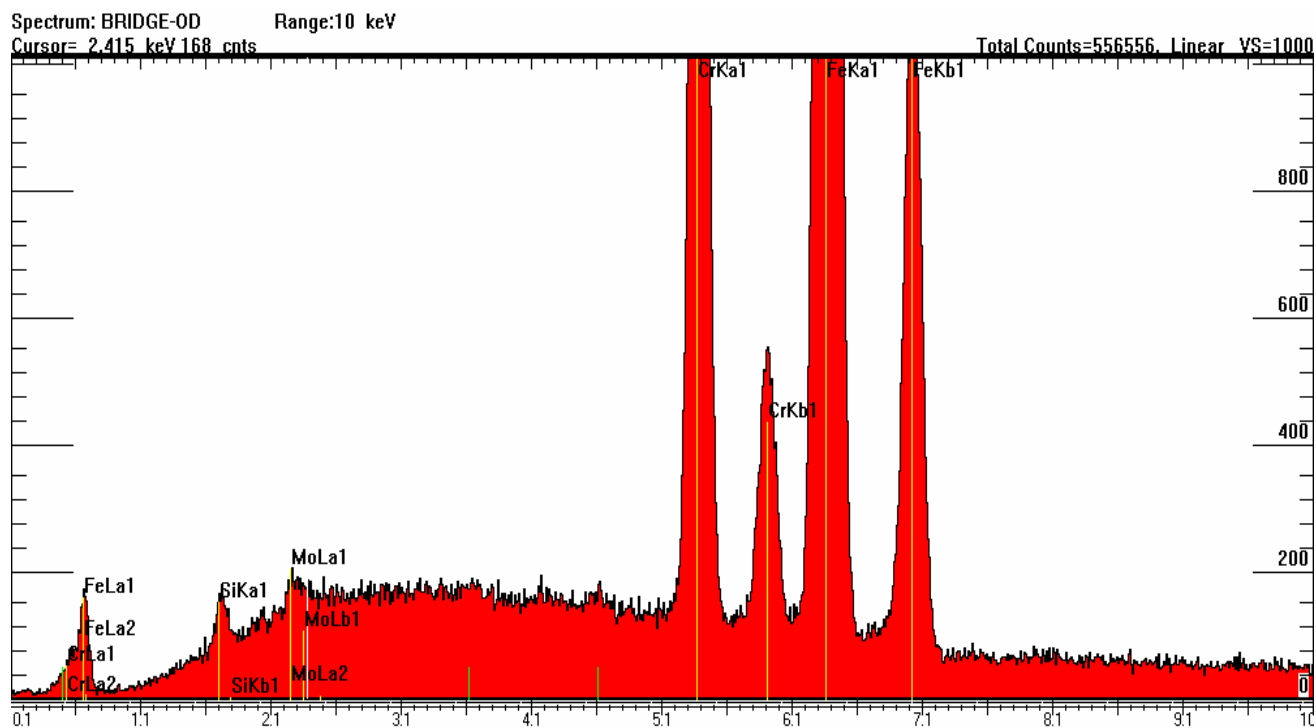
The corresponding quantitative analysis of this product is presented in table 14. This spectrum, along with the other EDS data presented, can be contrasted with the base material spectrum that is presented in figure 38 along with its corresponding qualitative and quantitative analysis in table 15.

Figure 38. EDS spectrum collected from the base material of the failed component.

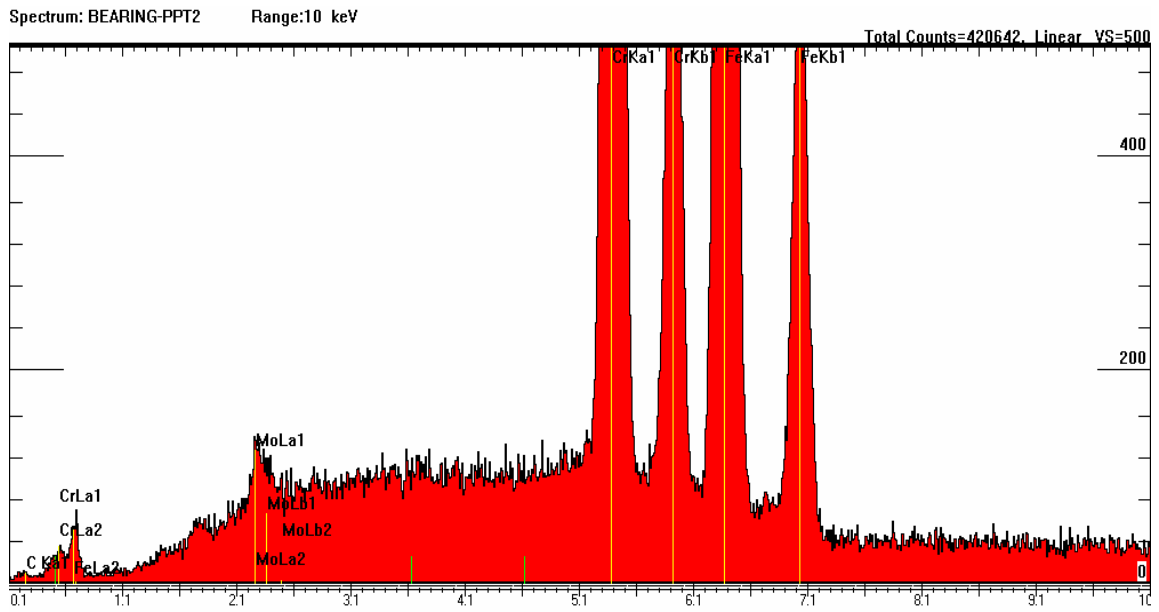
Figure 45. EDS spectrum of the precipitates within the matrix.

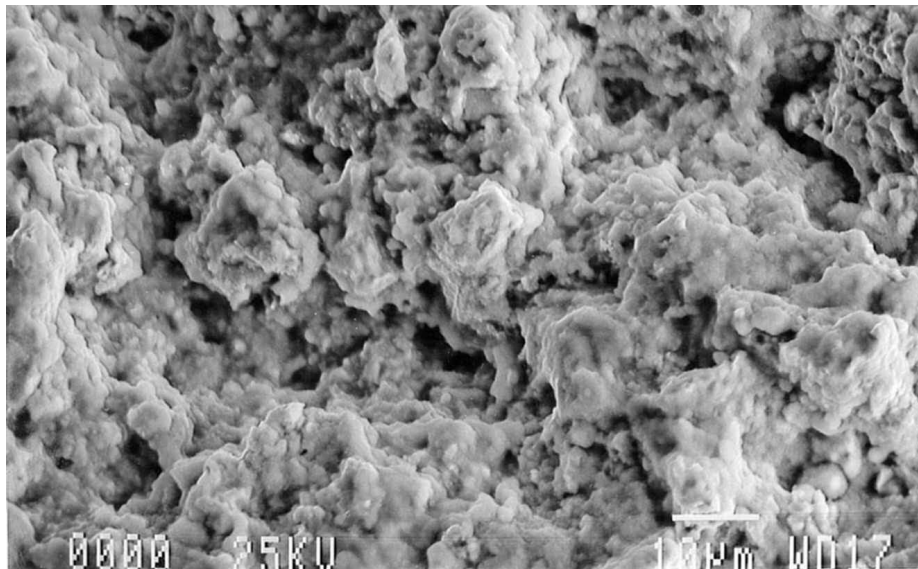
The fracture surface did not add considerable significant information to that which was concluded from the surface of the ball. Five fractographs were taken evenly spaced across the fracture surface to identify differences as the fracture progressed. The fracture mode, however, was mixed transgranular favored by fatigue and inter-granular favored by corrosion. These fractographs are presented in figures 48 through 52, from the origin. Within these fractographs, it is discernible that the fracture progressed in a mixed mode (trans-granular/inter-granular), aided by alternating stresses and corrosive action. The preferential cracking around the precipitates is readily discernible since several precipitates and cavities are easily recognized. The severity of the corrosion increased with age, toward the origin, as would be expected. The fracture was notably

**Figure 48. Fractograph 1 of 5, nearest the origin (mag. 1kx).**

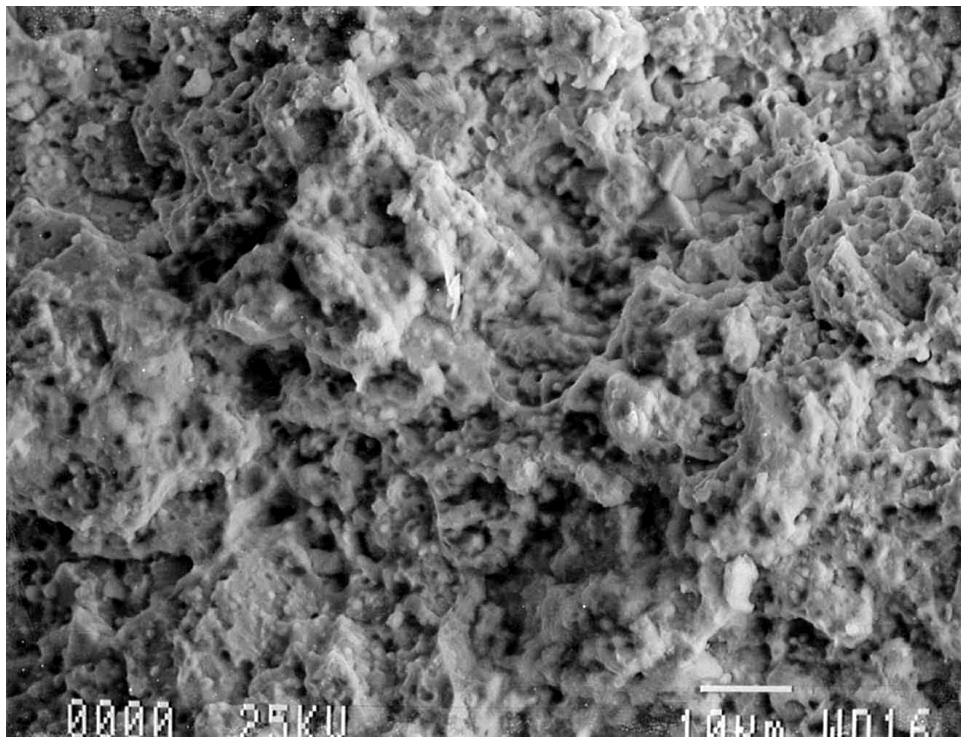
**Figure 50. Fractograph 3 of 5, at the midpoint of fracture (mag. 1kx).**

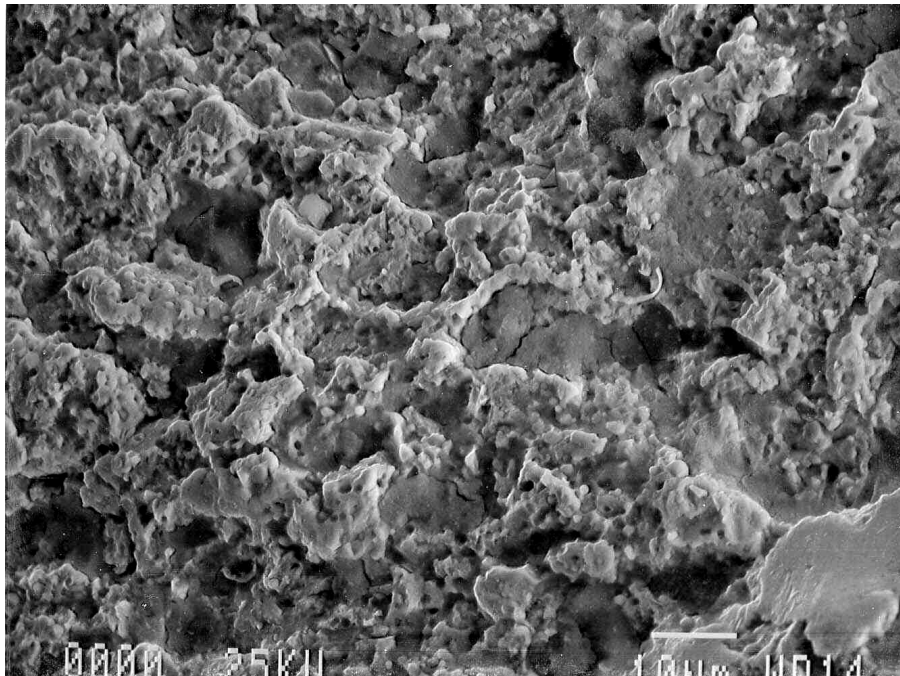
Figure 52. Fractograph 5 of 5, farthest from the origin (mag. 1kx).

The corrosion observed coupled with the fact that noticeable fatigue beach marks were discernible, would lend evidence to corrosion fatigue being the failure mechanism. EDS analysis of the corrosion products on the surface proved slightly different from the corrosion products observed on the surface of the ball. Figure 53 presents the EDS spectrum of the corrosion products on the fracture surface. Table 17 presents the chemical analysis data acquired from that EDS spectrum.

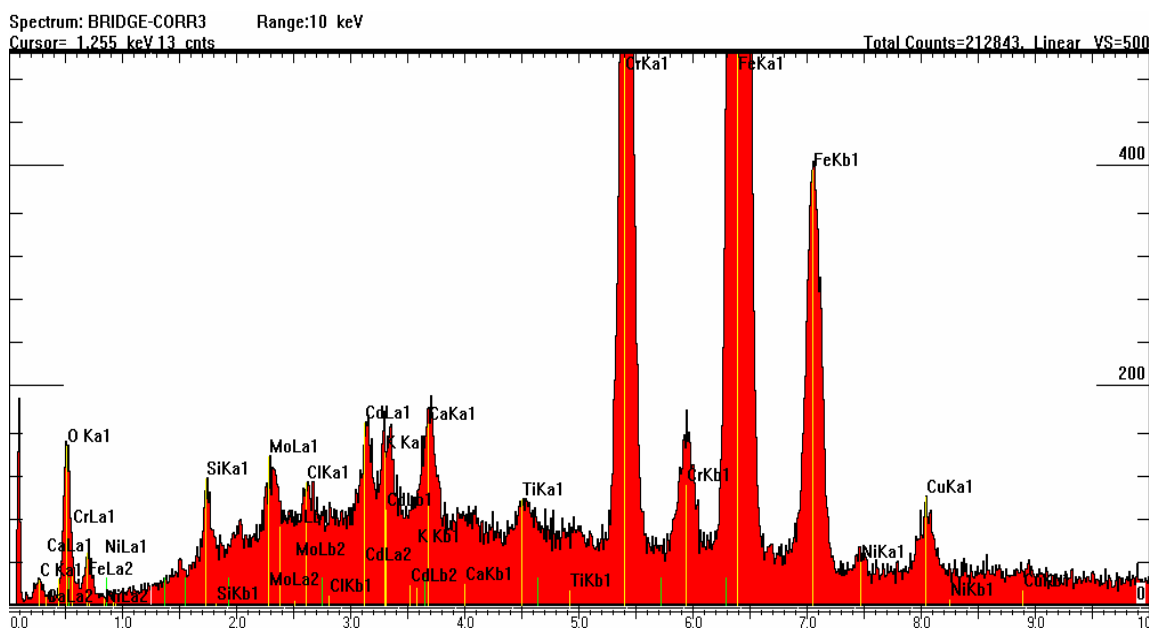
Figure 53. EDS spectrum of the corrosion product on the fracture surface.

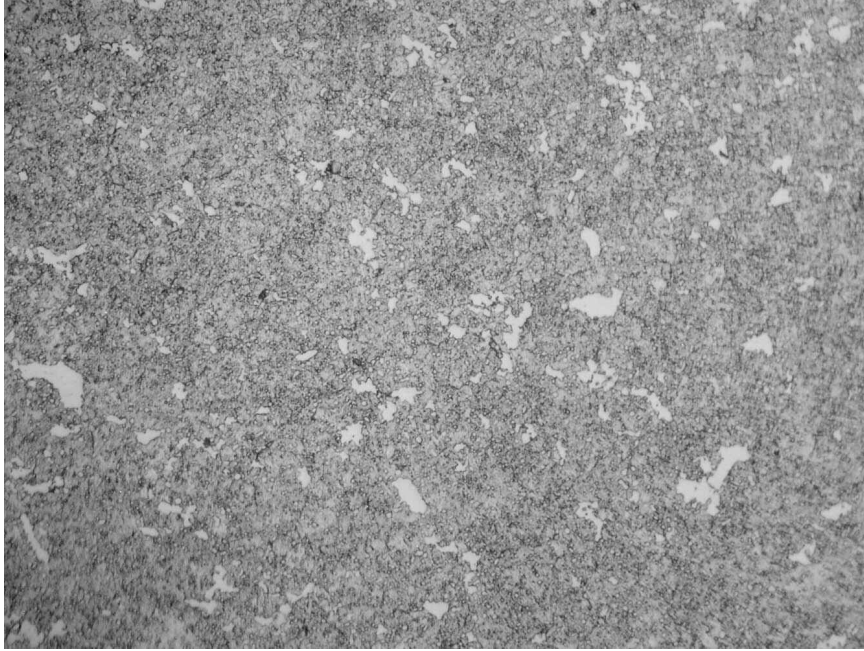
It was speculated that this component was perhaps sensitized during production because of the presence of inter-granular attack at the surface. Specification HP 1-1 summarizes a laboratory test that was used by ARL to determine whether the component had been sensitized. Paragraph 3.3.2.5 states that type B steels (type 440C) shall be metallographically prepared and etched for 1 to 2 minutes in a freshly prepared solution consisting of 1 gram of picric acid, 5 ml of hydrochloric acid, and 100 ml ethanol. Paragraph 2.1.1.4 indicates that components with ultimate tensile strength greater than 220 ksi shall not exhibit inter-granular attack greater than 0.0005 inch in depth. The sample showed negligible evidence of inter-granular attack as a result of this test (see figure 54), which did not exceed the depth requirement. In addition to the metallographic sample, ARL subjected a piece of the actual component in the as-received condition to the etchant. Photographs were taken before and after the application of the etchant (figures 55 through 58, respectively) on both the as-received surface and a machine cut surface. There was no evidence of inter-granular attack on any of these surfaces.

**Figure 54. Structure of type 440C steel after sensitization testing (negligible inter-granular attack was noted as a result of this testing) (mag. 400x).**

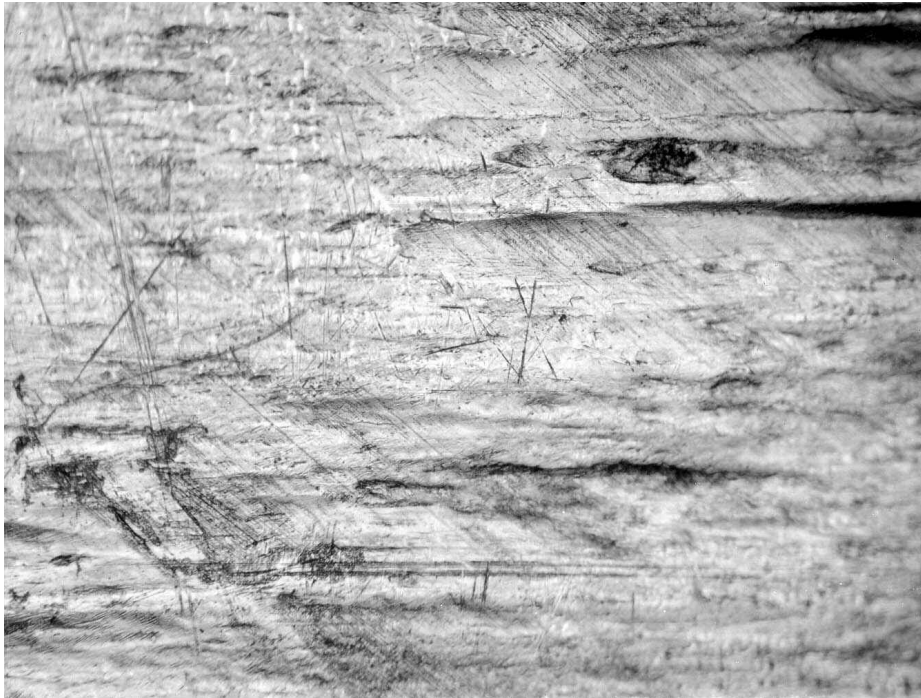
**Figure 55. Macrograph of as-received surface of rod end fitting ball (mag. 100x).**

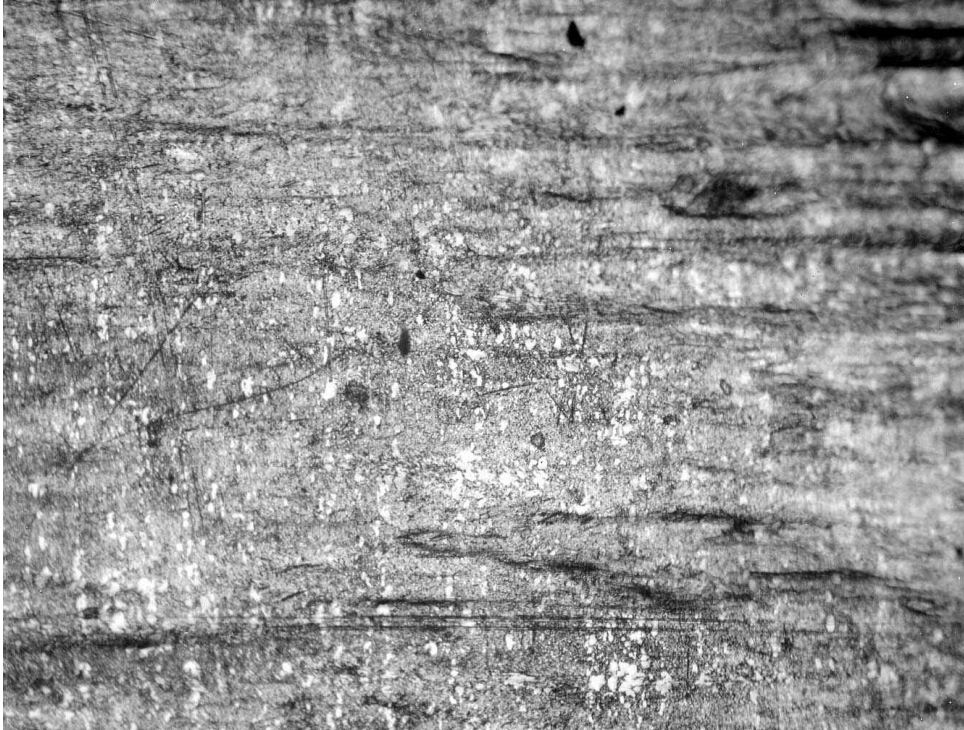
**Figure 56. Macrograph of as-received surface of rod end fitting ball subjected to sensitization testing (no inter-granular attack was noted) (mag. 100x).**

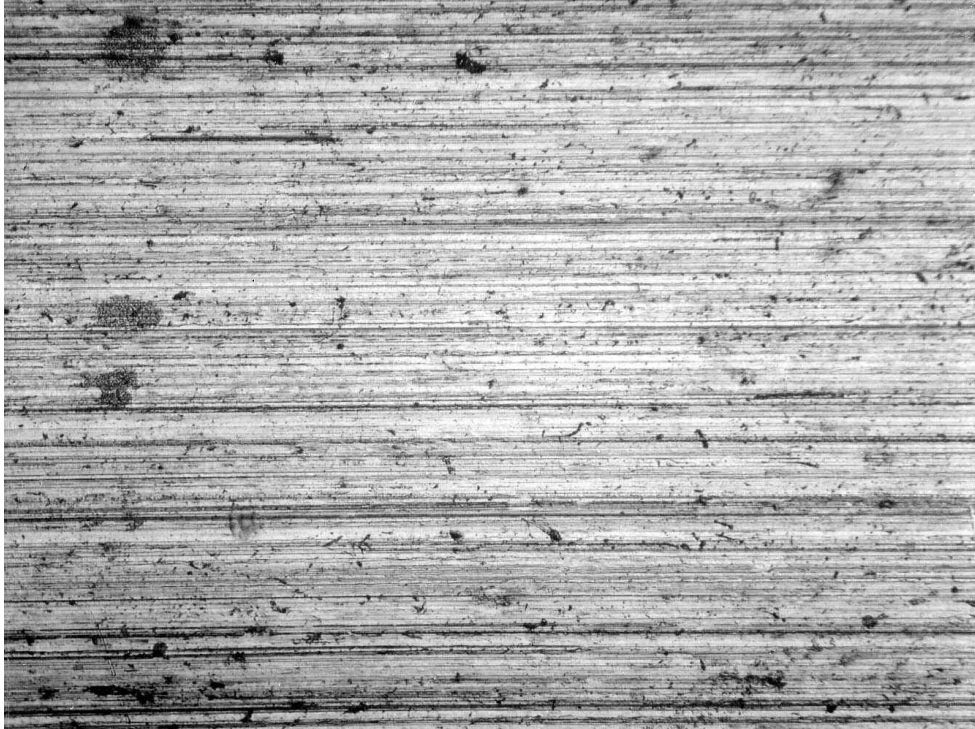
**Figure 57. Macrograph of machined surface of rod end fitting ball (mag. 100x).**

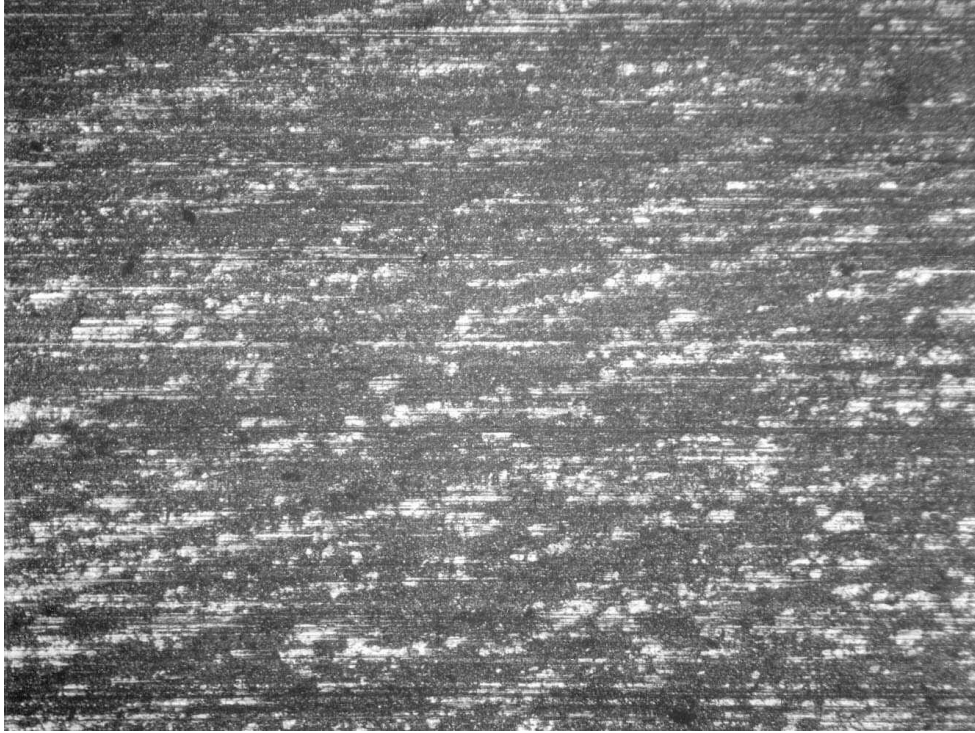
**Figure 58. Macrograph of the machined surface of rod end fitting ball subjected to sensitization testing (no inter-granular attack was noted (mag. 100x).**
