NSWCCD-65-TR-2003/37 September 2003

## SIDER Testing of Royal Navy Vessel P292 HMS *Trumpeter*

SUBJ: STRUCTURAL IRREGULARITY AND DAMAGE EVALUATION ROUTINE  
(SIDER) INSPECTION OF SHIP STRUCTURES

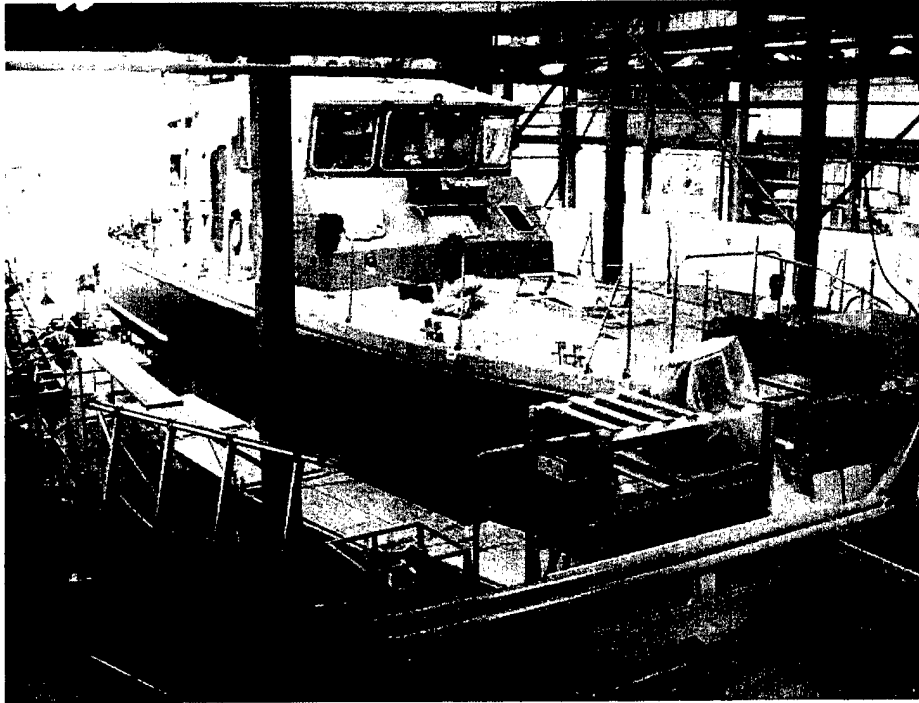
**Figure 2. General View of HMS *Trumpeter* (P292) During Testing**

After several conference calls between the U.S. representatives and representatives of the MoD, it was decided that the SIDER technique may have the capability of locating damage in the *Archer*-Class decks, as well as other composite ship components. A mutually agreeable date and length of stay were determined. The MoD requested that several ship structures be inspected at two shipyards. On the first ship, located at Camper & Nicholsons Yachting Ltd, Mumby Road, Gosport, Hampshire, the forecastle of HMS *Trumpeter*, an *Archer*-Class ship, was to be inspected for any structural irregularity. This report details the results of the testing of HMS *Trumpeter's* forecastle. Figure 1 shows HMS *Raider* (P275), sister ship to HMS *Trumpeter*. Figure 2 shows a general view of HMS *Trumpeter* during testing in the facilities at Camper &

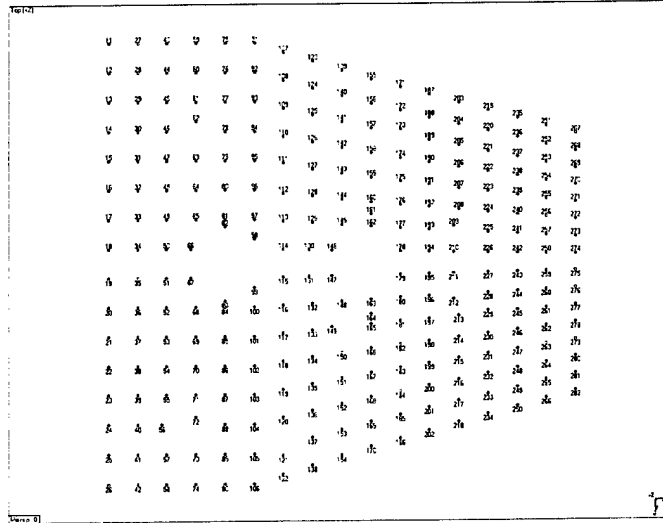
Figure 3. Test Grid for HMS *Trumpeter*

Figure 3 shows the test grid with grid point numbering. This grid is repeated in Figure 4, which shows a photograph of the forecastle with the mesh digitally overlaid in black crosses. The locations of the crosses are not exact, but are indicative of the test positions. The mismatch is due to the foreshortening in the photograph, as well as the vertical curvature of the foredeck, which is not modeled in the SIDER test grid.

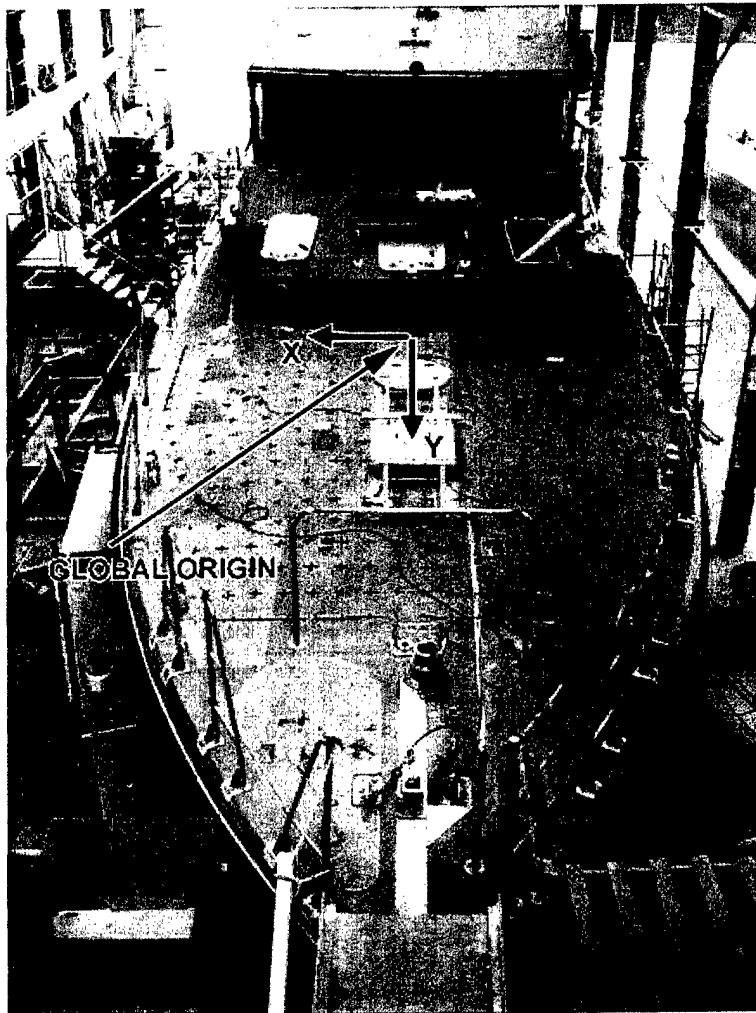
Figure 4. SIDER Test Grid, Origin and Axes Overlaid on the Foredeck

As shown in the figures, the global origin for measurements was the amidships point, coincident with where the wheelhouse met the surface of the foredeck. The X-direction was forward, the Y-direction was to port, and the Z-direction was up. The slight curvature of the deck was ignored, with all test points being given a Z-value of zero.

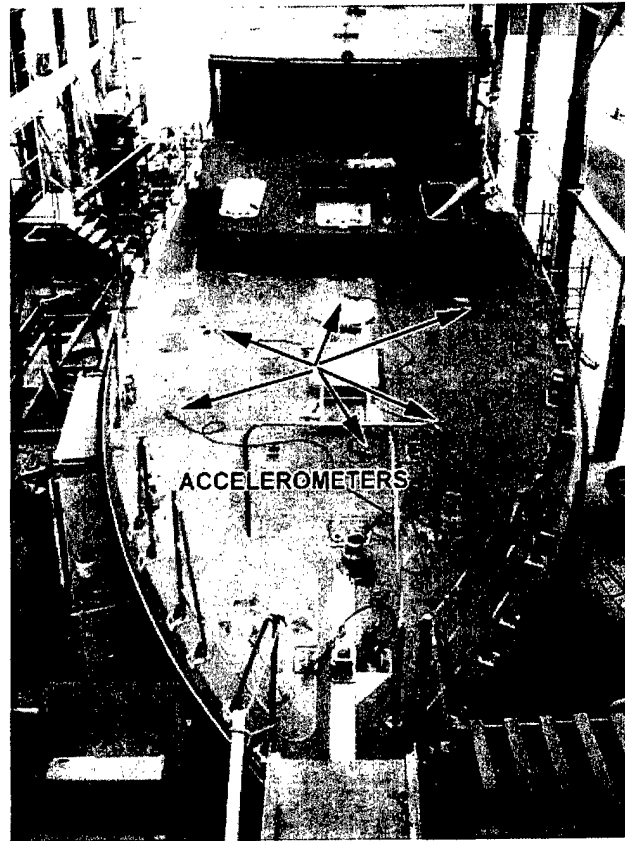
**Figure 5. Accelerometer Positions Are at the Head of Each Arrow**

The locations of the accelerometers are shown in Table 1. They can also be seen in Figure 5. The absolute location of the transducers is estimated to have an accuracy of  $\pm 1.0''$ .

Accelerometer mounting bases were bonded with cyanoacrylate superglue to the cork nonskid surface, which covered the foredeck. The accelerometers were then mounted by stud to the mounting bases.
